Sun Blade 6000 Disk Module

Product Notes

Part No. 820-1709-14
May 2010, Revision A

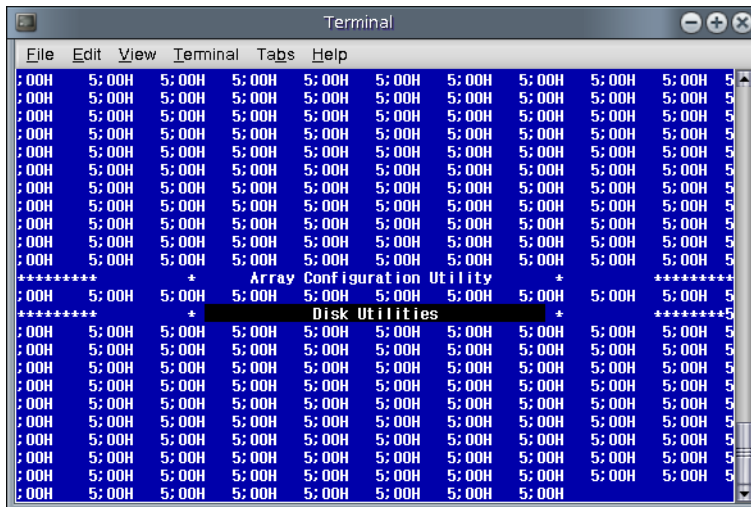
FIGURE 2-1 Scrolling Characters in Adaptec BIOS Main Menu

On the SP Console, Scrolling Characters Cause Difficulty in Cursor Navigation (6812100)

When a Sun Blade 6000 Disk Module is connected to a Sun Blade RAID 5 Expansion Module (X4620A) and you attempt to connect to the BIOS through the SP the screen will be obscured by scrolling "5;00H" characters.

1. Don't use the SP. Connect to the host blade directly.
2. Use the Sun Blade G2 RAID 0/1 Expansion Module (X4607A).

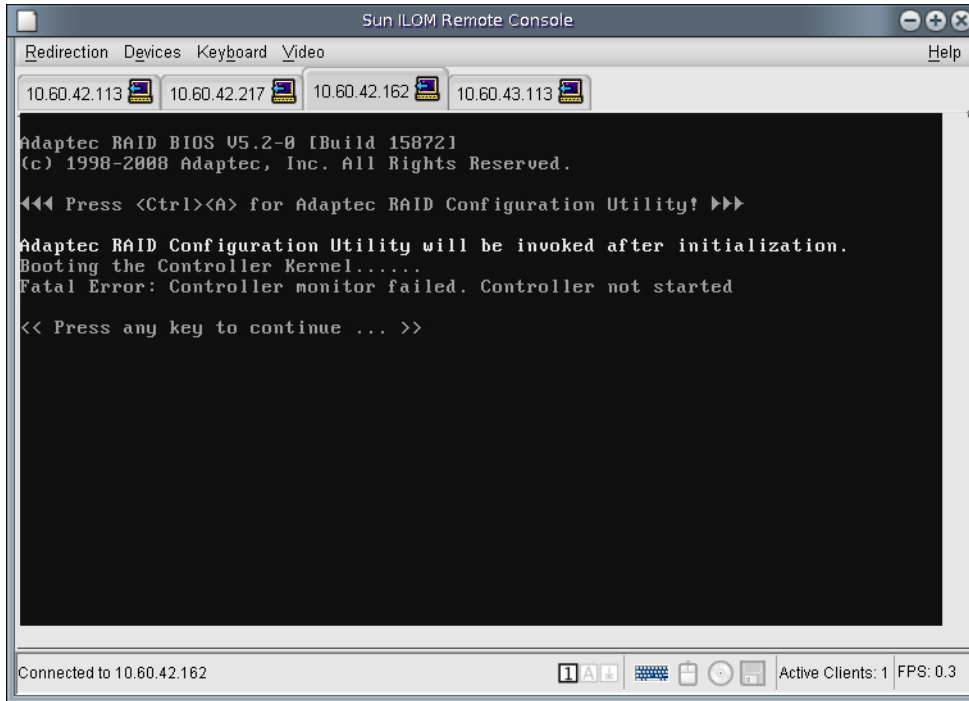
FIGURE 2-2 Reboot Hang

Controller Kernel Stops Running After Reset (6793466)

The HBA hangs during system reboot or boot up.

▼ To reset the controller:

1. Shut down the CPU blade by pressing the power button in the front panel.
2. Eject the Sun Blade 6000 away from the chassis backplane.
3. Eject all internal HDDs from the backplane (if any).
4. Power up the CPU blade.
5. Press <Ctrl-A> at the RAID BIOS to enter BIOS CU. Make sure that there is no disk in the system.
6. Press <Esc> to exit RAID BIOS and reboot the system. Repeat Step 5, and continue to step 7
7. Press the CPU blade power button to shut down the system.

▼ To reboot the system after reset:

1. At the power off, insert Vela back to the same slot configuration.
2. Insert all internal hard disk drives back to their own slots (If any)
3. Power up the CPU blade.

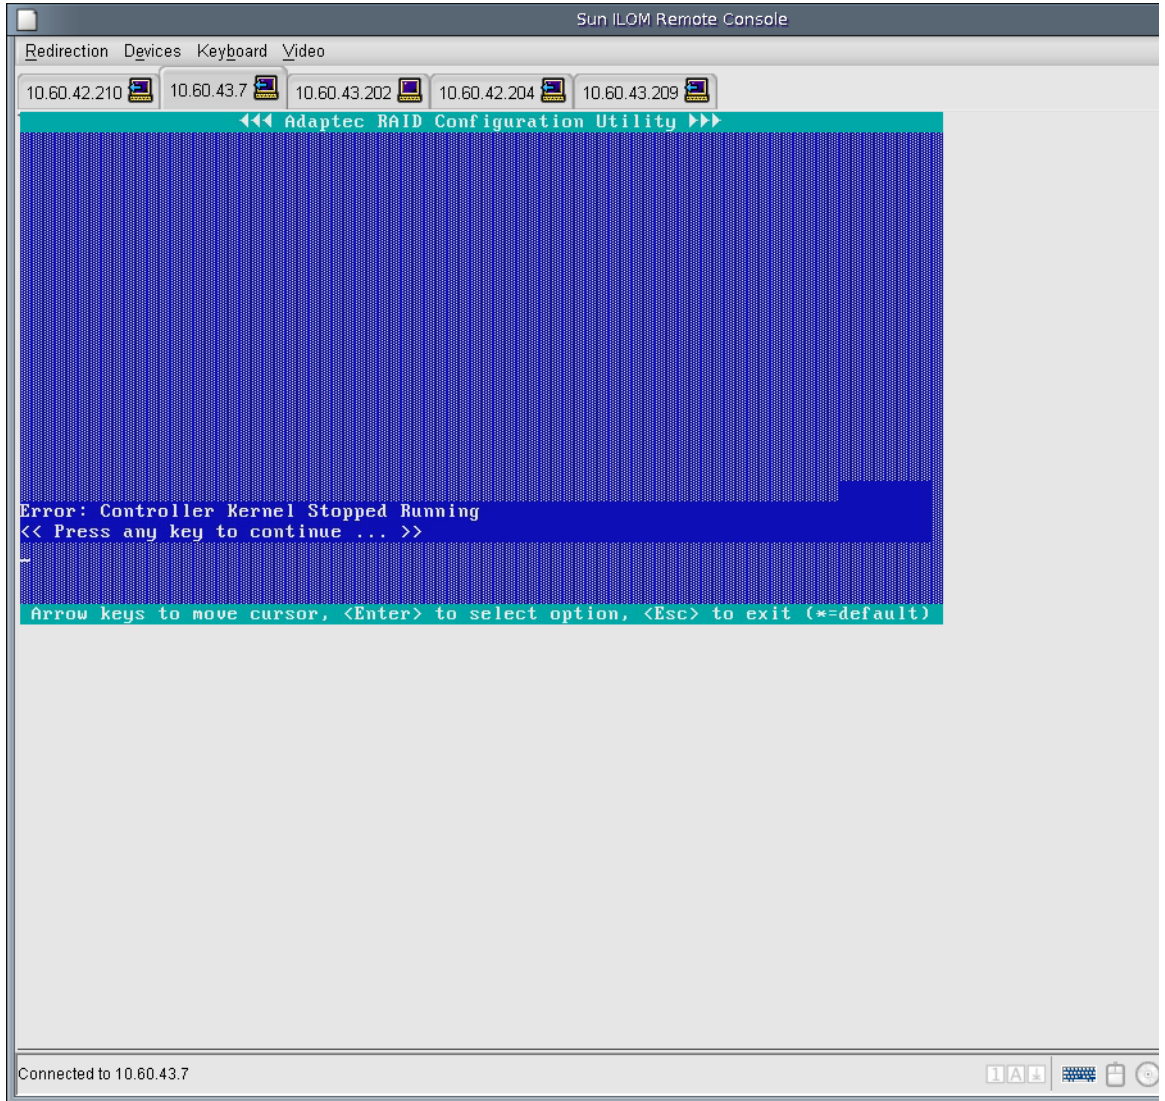
FIGURE 2-3 Controller Error

The HBA crashes in the Adaptec BIOS RAID manager.
