Sun Fire™ X4100 and Sun Fire X4200 Servers Product Notes

Part No. 819-1162-28
December 2007, Revision A

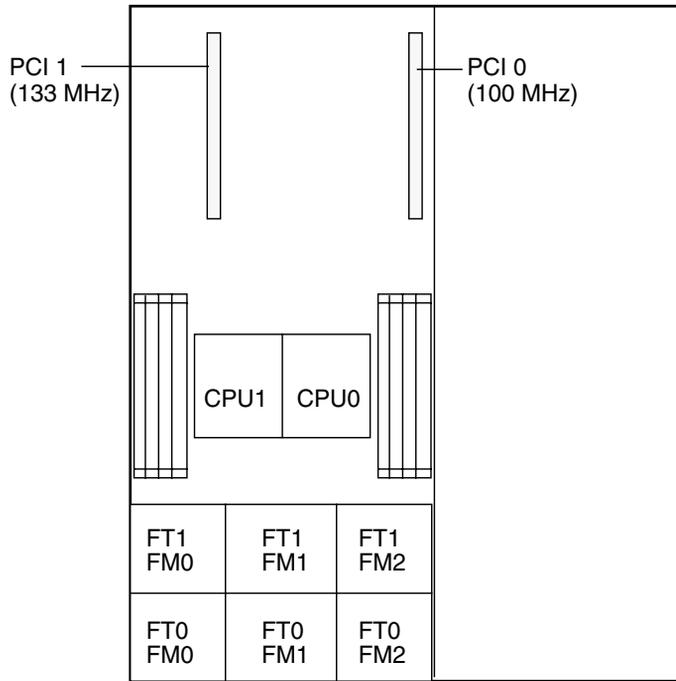
FIGURE 2-1 Sun Fire X4100 Designation and Speeds of PCI Slots

When installing RHEL3 U7 32-bit on Sun Fire X4100 or Sun Fire X4200 servers that have a PCI card installed in any slot other than PCI 0, installation might hang. This problem is not observed when installing RHEL3 U7 64-bit.

Use RHEL3 U8 32-bit if you have a PCI card installed in any PCI slot other than PCI 0. (This limitation was fixed in Update 8).
