Sun SPARC® Enterprise M4000/M5000 Servers Product Notes

For XCP Version 1081

Part No. 820-7235-11
January 2010, Revision A

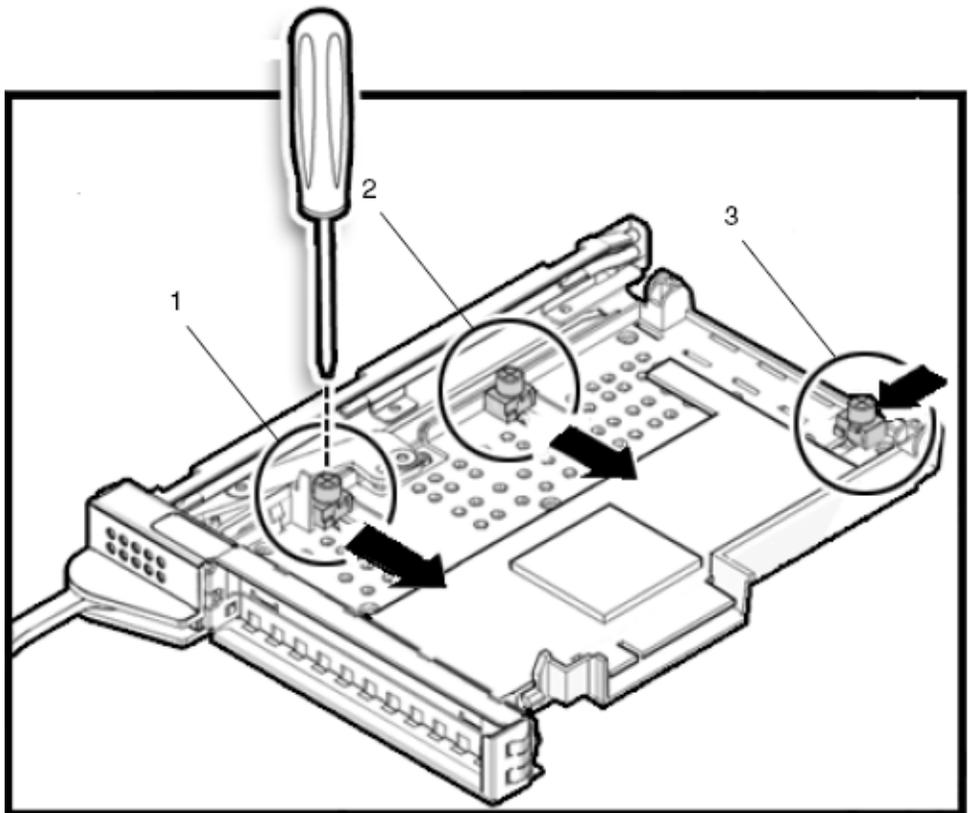
FIGURE 8-6 Sequence of Fixing the PCI Card in Position

The description here corrects section 8.2.2, "Installing the PCI Card."

Note – The adjustable stops should be snug against the card and securely tightened to ensure the card seats correctly. Also, fix the PCI card in position by following the 1-2-3 sequence in FIGURE 8-6.
