Product Release Notes for SANtricity® ES Storage Manager Version 10.77

May 2011

51472-00, Rev. A

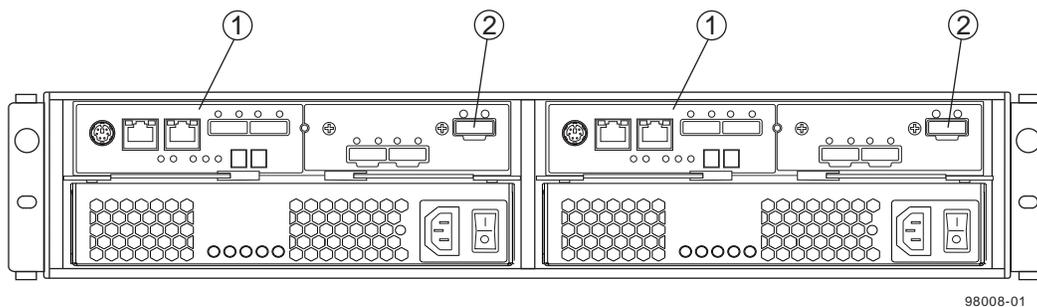
Figure 1 Drive Channel Ports on the ST2500 M2 Array Module

- Step 1 – Preparing for ST2500 M2 Array Module Installation, Gathering Items, ST2500 M2 Cables and Connectors – The serial cable shown in the graphic shows the wrong connector. It should show a DB-9 connector.
- Step 7 - Connecting the ST2500 M2 Array Module to the Drive Modules, Things to Know – The graphic "Drive Channel Ports on the ST2500 M2 Array Module" is missing. Figure 1 shows the missing graphic.
