Sun Blade™ X6450 Server Module Product Notes

Part No. 820-3538-23
September 2010, Revision A

This document describes hardware issues, software issues, and documentation issues for the Sun Blade™ X6450 server module.

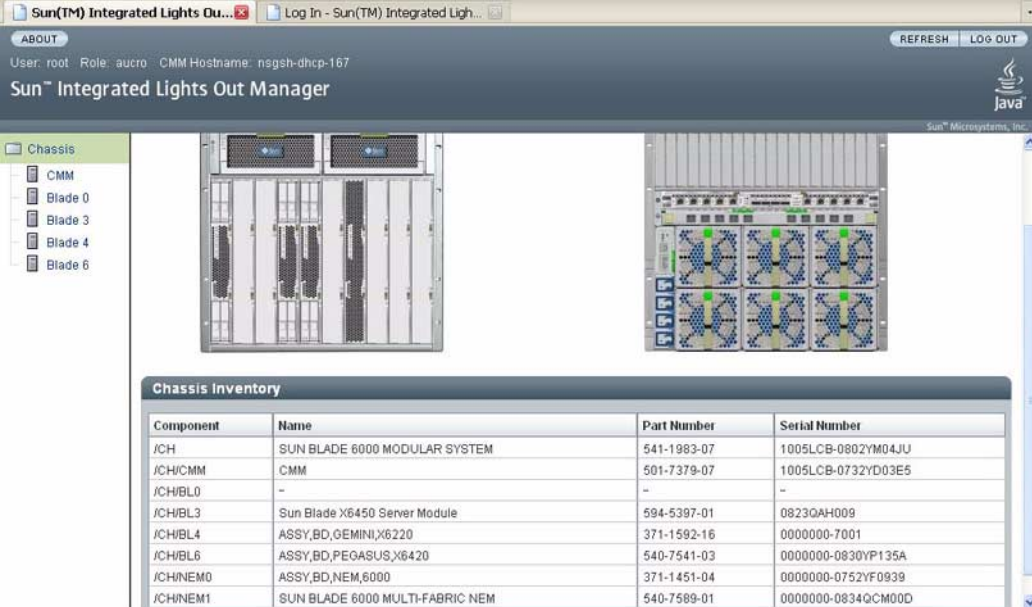
FIGURE 6-1 CMM With Incorrect Picture of X6450 Server Module

- The chassis inventory shows an X6450 server module in BL3.
- The picture of the front of the chassis shows (incorrectly) a server module with hard disk drives in BL3.
