# Sun Fire™ V20z and Sun Fire V40z Servers Release Notes

Part No. 819-1771-25  
August 2008, Revision A

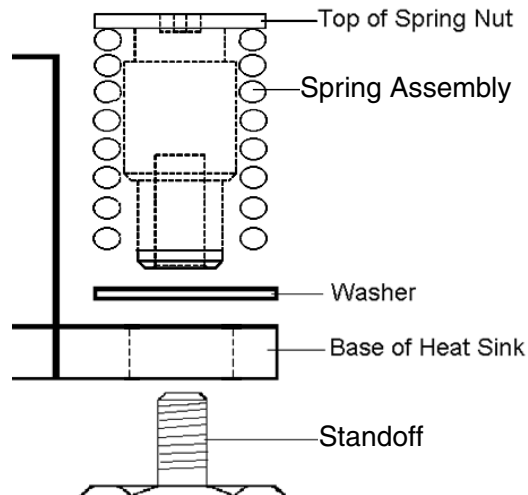
**FIGURE 1-1** Relationship of Heat Sink, Spring Assy., Washer, and Standoff

Improper removal and installation of the heat sink can strip the threads on the heat sink spring assemblies. To ensure that this does not occur, remove and install the heat sink according to the instructions below.

**Caution** – Failure to center the heat sink holes and washers over their respective standoffs can cause the spring assembly to bind on the washer or on the heat sink. This can cause improper spring tension and can damage the threads of the spring assembly or the standoff.

5. Carefully press down firmly and evenly on the heat sink, to hold it securely in place while you install the spring assemblies.  
Continue to press down on the heat sink.

6. Place the rear spring assembly (the one nearest the PCI support post) over the rear standoff, and without the use of any tools, hand-tighten it as far as the spring assembly allows.
