Sun Fire™ X4140, X4240, and X4440 Servers Product Notes

For Software Release 3.1

Part No. 820-2396-18
September 2010, Revision A

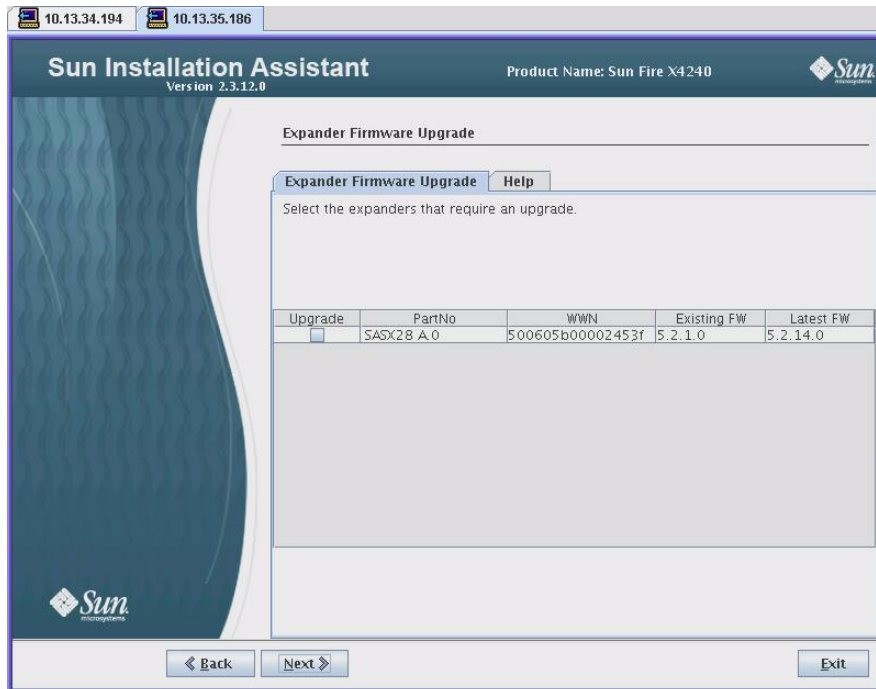
FIGURE 3-2 Expander Firmware Update Screen

4. Click Next and SIA performs the upgrade process.
5. Click Exit and reboot system.
6. Open the SIA Web interface and check the expander firmware version. The firmware version has not changed.

3. Select SASX28 and make sure the firmware version is right.

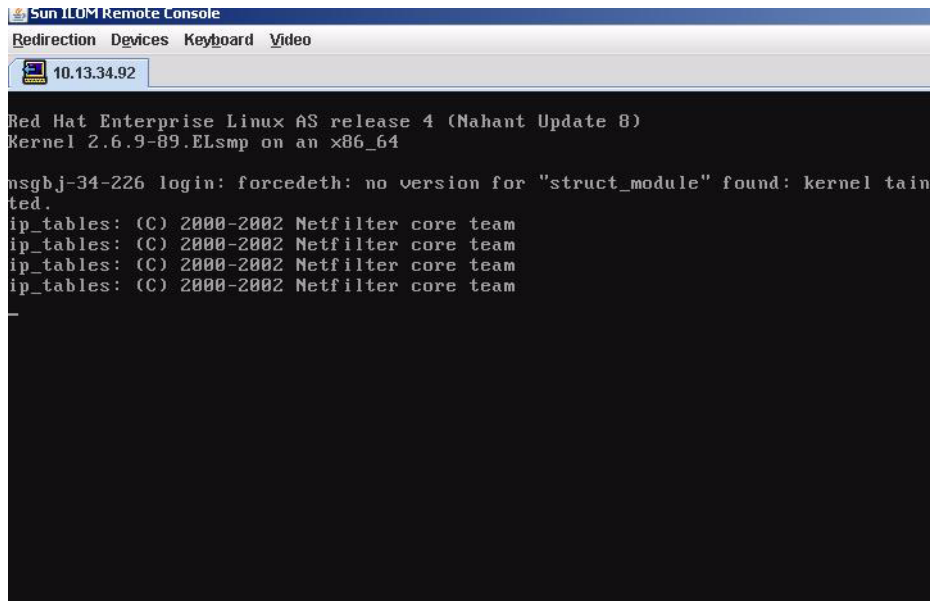
FIGURE 6-1 RHEL Linux OS Release 4 Errors

After the OS boots up there may be some errors as seen in the following figure:

Note – This warning message does not affect the functionality of the NIC drivers and can be regarded as harmless.
