Sun Fire™ X4600 Server Product Notes

Part No. 819-4347-19
February 2009, Revision A

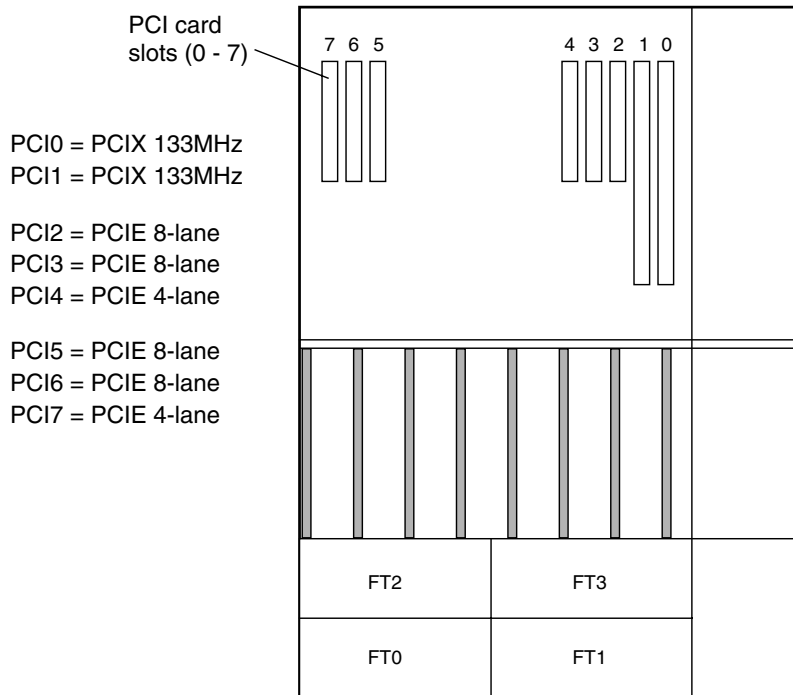
FIGURE 1-1 Sun Fire X4600 Designation and Speeds of PCI Slots

- Cannot PXE boot through the Ethernet ports and the following error message is displayed: Not enough space to copy PCI Option ROM
- Cannot PXE boot through the Ethernet ports and the following error message is displayed: Base-Code ROM ID structure not found
- PCI cards cannot PXE boot as desired if they are installed in a PCI slot that is scanned after the option ROM space is exhausted.
- HBA card and its attached HDD array are not detected if installed in a PCI slot that is scanned after the option ROM space is exhausted.

Perform Option 1 below so that the device appears in the list, then perform Option 2 to change the scanning order.
