## **SPARC T3-2 Server**

### Product Notes

Part No.: E20794-08  
August 2012

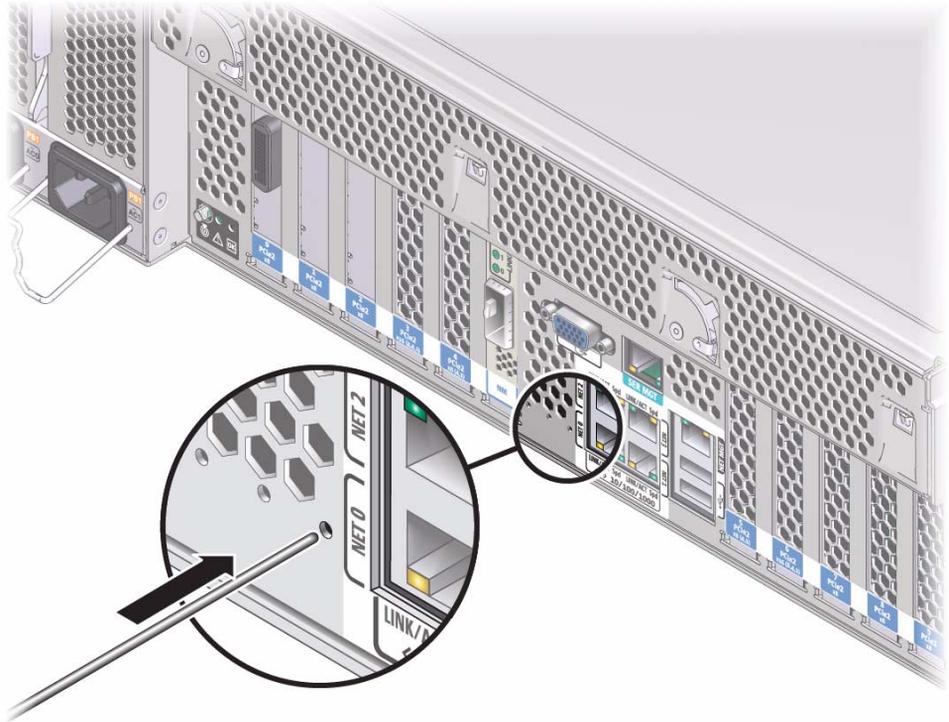
To prove physical presence, insert an unbent paperclip into the pinhole to the left of the NET0 Ethernet port.

After proving that you are physically at the system, continue with the procedure to recover the lost SP password. Refer to the Oracle ILOM documentation for the complete instructions.
