Sun Fire X4540 Server Product Notes

Part No. 820-4869-16
February 2010, Revision A

This document contains late-breaking information and issues for the Sun Fire™ X4540 server.

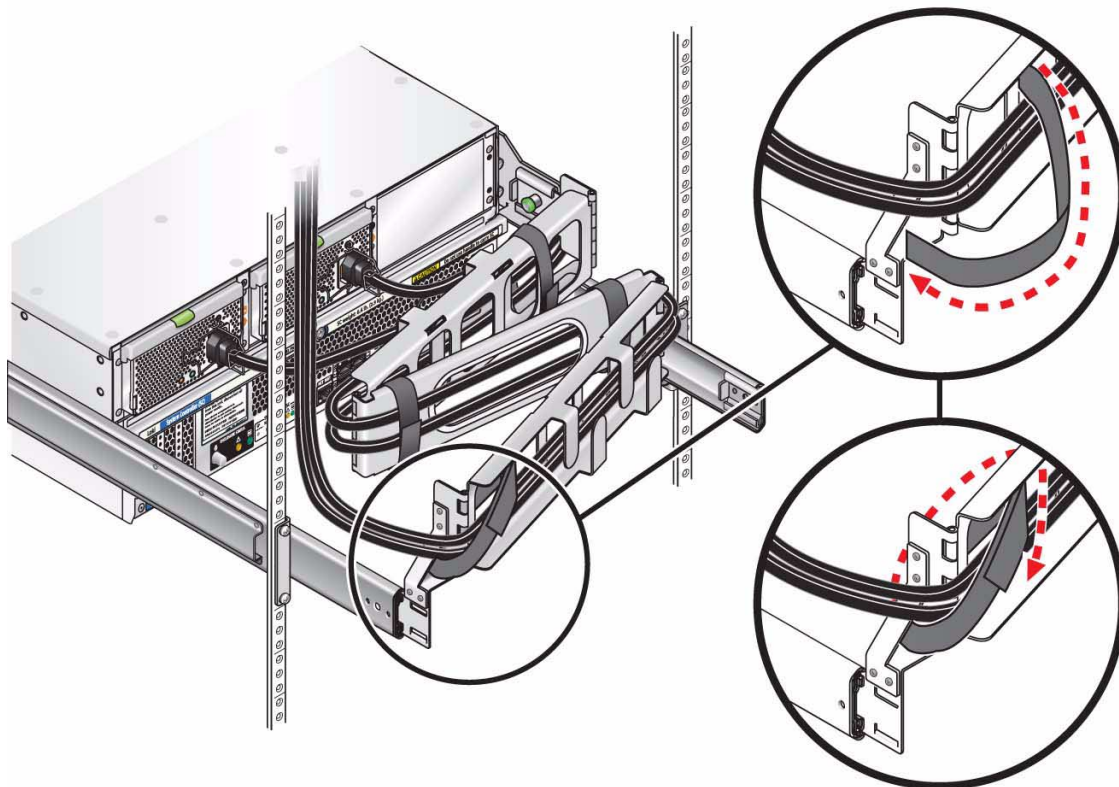
FIGURE 0-1 CMA Strap Procedure to Prevent CMA from Unfolding

5. If the CMA tends to extend past the rear of the rack when at rest, reposition the last (left-most) hook-and-loop strap as follows:
 - i. From the front of the rack, pull the server out of the rack approximately 12 inches, then go to the rear of the rack.
 - ii. With the CMA in the slightly folded position, pull the last strap through the opening of the CMA so that it comes toward you.
 - iii. Pull the strap toward the left side and route the strap around the hinge also capturing the cables so they are secured in place.
 - iv. Route the cable around the back of that CMA section and through the opening in the CMA. Tightly secure the end of the strap into place so that it forces the left hinge to stay at a right angle. This procedure allows the CMA to freely unfold, as it was designed, for procedures that require that the system is pulled out from the rack from the front.

Caution – Release the strap before pulling the CMA outwards to add more cables. Failure to do so stresses the CMA and may result in bending the left bracket.
