Sun StorageTek[™] 2500 Series Array Release Notes

Release 1.2

Part No. 820-3511-10 October 2007, Revision A

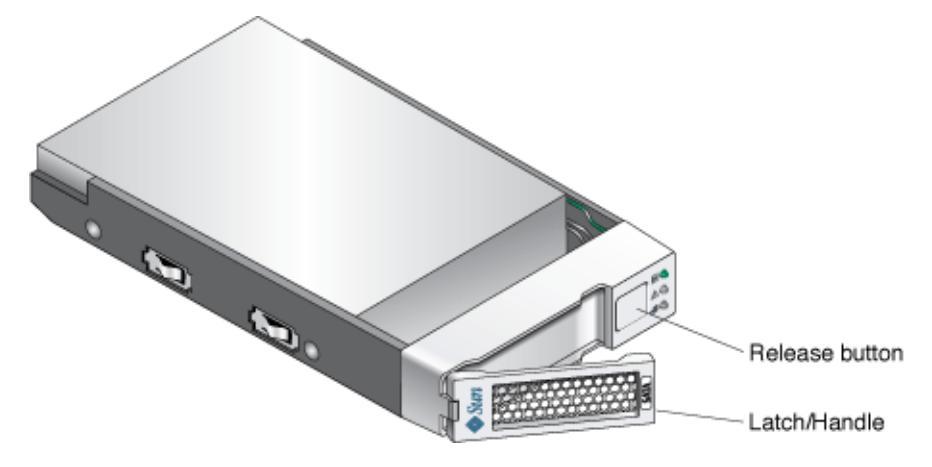
FIGURE 1 Releasing the Latch Handle

Bug 6514411 – Inserting a disk drive into a tray by pushing on its housing until it is all the way in causes the drive to stop without being fully inserted and with the drive handle protruding.

1. Push the release button next to the disk drive to release the latch handle.

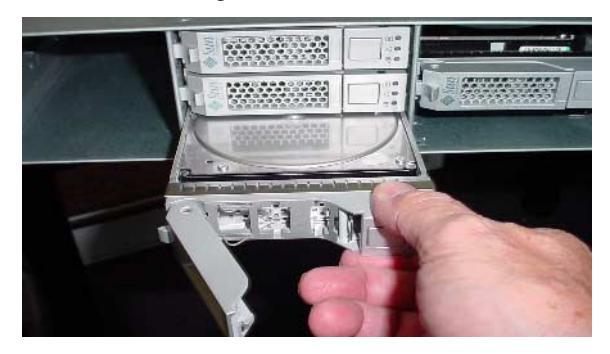
FIGURE 2 Inserting the Drive.

Caution – In some drive bays, full insertion at this point without controlling the motion of the lever may cause the lever to bind.
