Sun Blade X6270 Server Module Product Notes

Supplemental Release 2.5

Part No.: E36356-02
February 2013

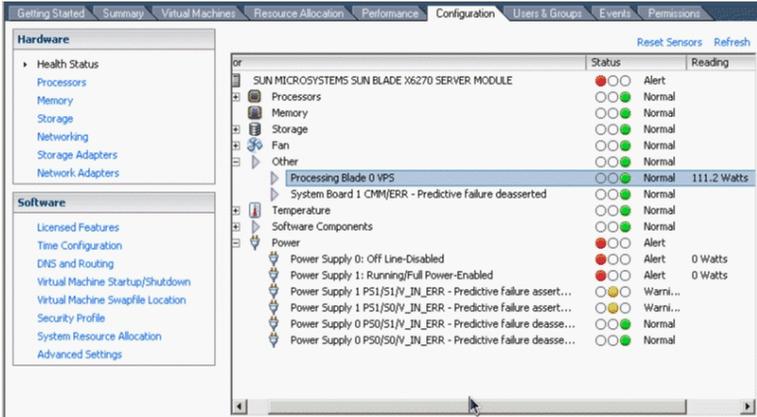
CR	Description																																																						
6779112	<p data-bbox="496 326 1325 378">Misleading Status for Power Supplies Is Reported by VMware Health Status Screen</p> <p data-bbox="496 401 558 421">Issue:</p> <p data-bbox="496 432 1325 513">The VMware Virtual Infrastructure client Health Status screen under the Power component reports the server power supplies in an Off-Line Disabled state and 0 watts, even though the power supplies are on-line and enabled.</p> <p data-bbox="496 532 943 557">Affected Operating Systems and Software:</p> <ul data-bbox="496 565 1236 623" style="list-style-type: none"> • VMware ESX 3.5u4 • Supplemental Software Releases 1.0, 1.1, 1.2, 1.4, 2.0, 2.0.1, 2.1, 2.3, 2.4 <p data-bbox="496 644 634 668">Workaround:</p> <p data-bbox="496 678 1286 760">To view the correct power status while in the VMware Virtual Infrastructure client Health Status screen, click on the Other component from the list of available options and view the blade <i>n</i> VPS (where <i>n</i> is the blade number).</p>
