# Sun SPARC Enterprise T5140 and T5240 Servers

## Product Notes

Part No.: Mfg. No.: E21413-04  
February 2012

# SPARC Enterprise T5140 and T5240 Product Notes

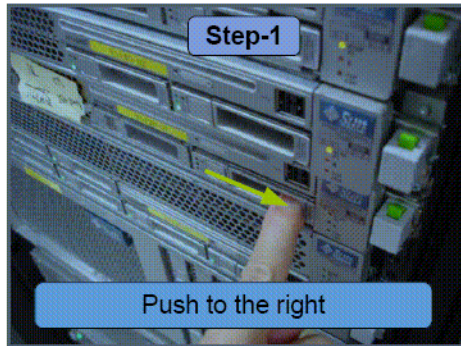
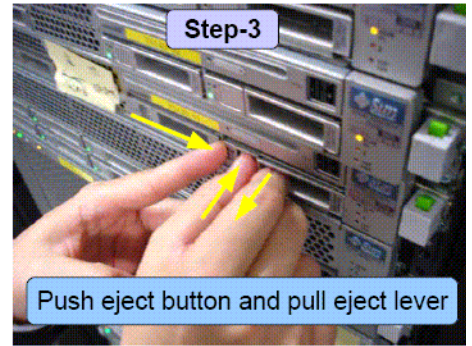
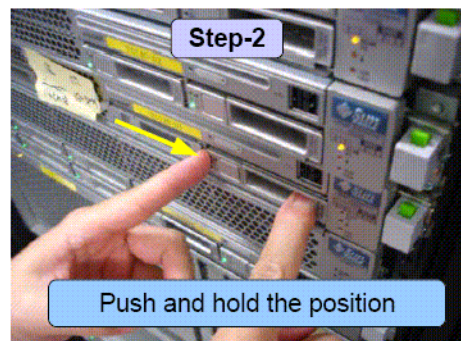
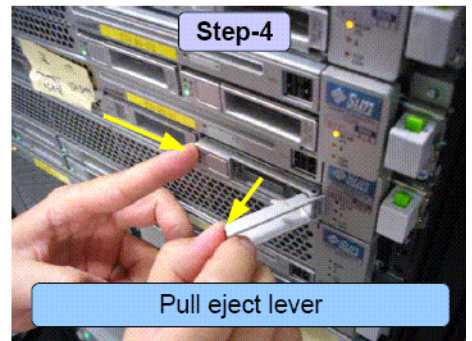
## ▼ Hard Drive Removal Procedure

# Hard Drives Can Be Difficult to Remove From Right-Side Drive Bays

Hard drives in the right-side drive bays can be difficult to remove.

*Workaround:* Until a mechanical fix is implemented, use the following procedure to remove hard drives from right-side drive bays.

- 1. Press the drive to the right.**  
See Step 1 in the following figure.
- 2. Push in on the drive, while holding it pressed to the right.**  
See Step 2 in the following figure.
- 3. Press the drive eject button and pull the eject lever.**  
See Step 3 in the following figure.
- 4. Use the eject lever to slide the drive out of the bay.**  
See Step 4 in the following figure.

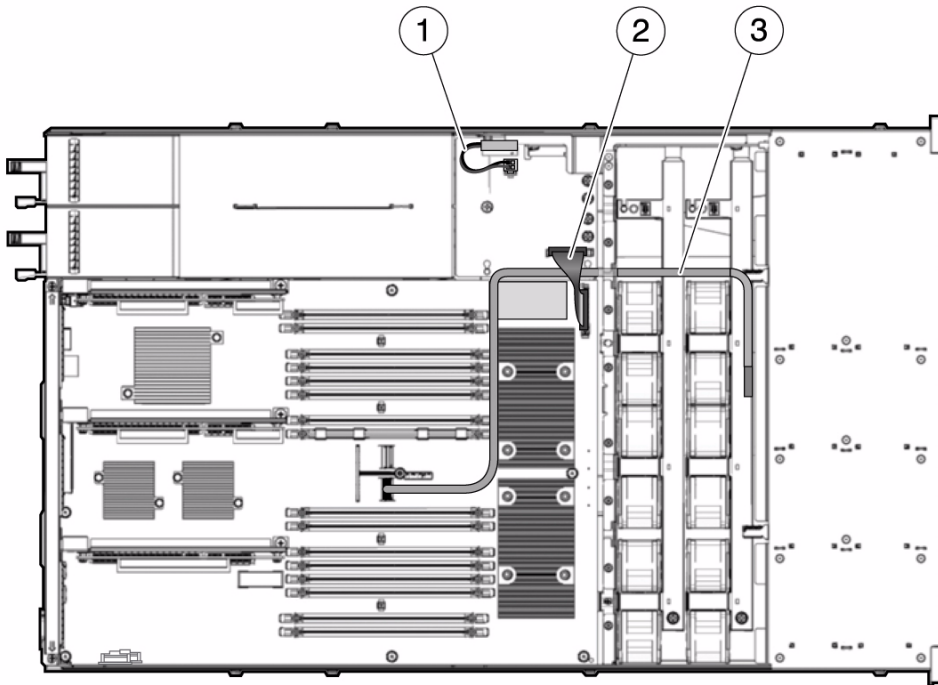
**FIGURE 1** Internal Cables for the Onboard SAS Controller Card (Four-Disk Capable SPARC Enterprise T5140 Servers)

The service manual data cable routing diagram for 4-disk capable backplanes is wrong. It shows the cable connected to SAS1. It should be connected to SAS0. This is the correct diagram:

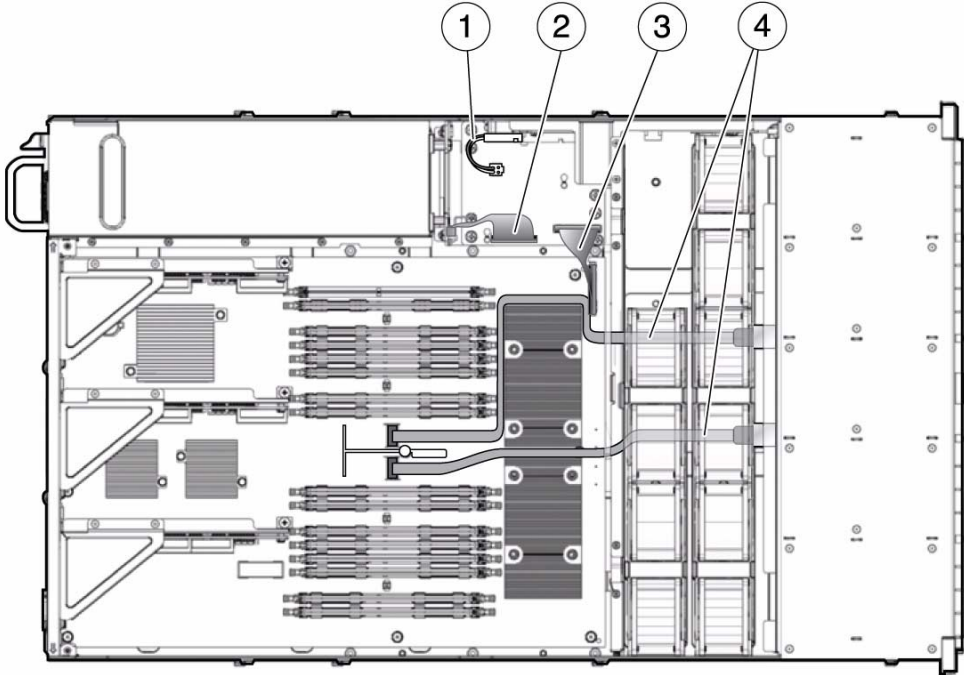
**FIGURE 2** Internal Cables for Onboard SAS Controller Cards (Eight-Disk Capable SPARC Enterprise T5240 Servers)

The service manual data cable routing diagram for 8-disk capable backplanes in T5240 servers is wrong. It shows a single data cable. There should be two. This is the correct diagram:

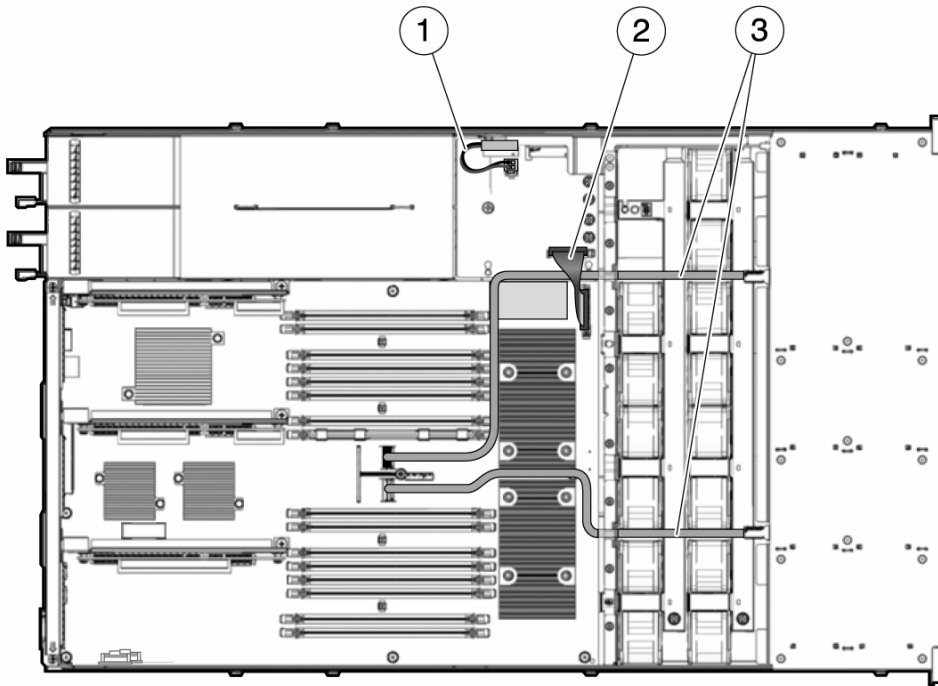
**FIGURE 3** Internal Cables for the Onboard SAS Controller Card (Eight-Disk Capable SPARC Enterprise T5140 Servers)

The service manual cable routing diagram for 8-disk capable backplanes in T5140 servers is missing a fan module in the upper right corner. This is the correct diagram:

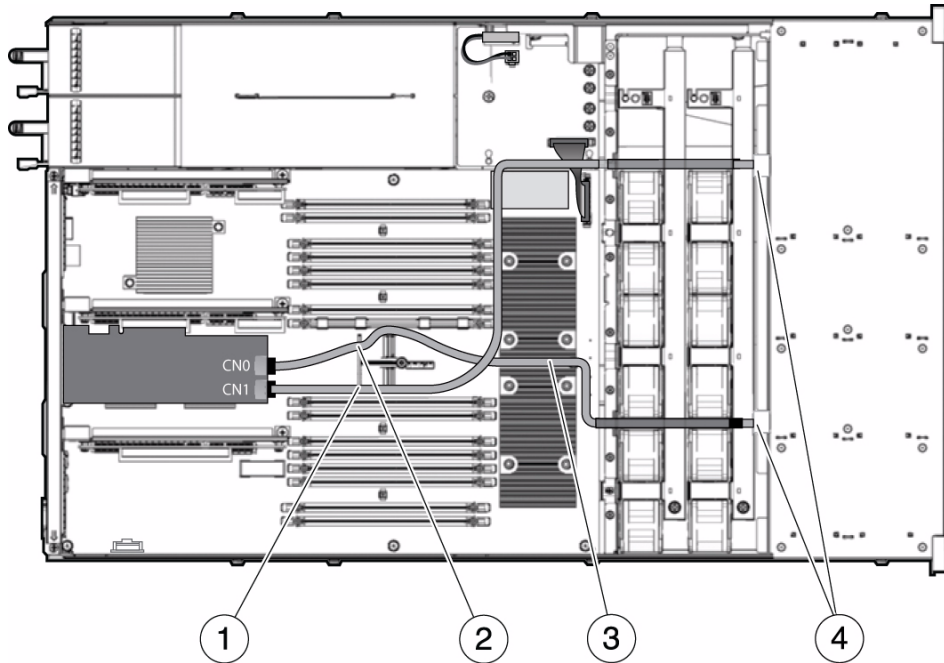
**FIGURE 4** HDD Data Cable Routing for SAS RAID Controller Card in Eight-Disk Capable SPARC Enterprise T5140 Servers

## Incorrect SAS RAID HBA Data Cable Routing Information for Systems With 8- or 16-Disk Capable Backplanes (CR 6776592)

- CN0 <--> P2 (J0301)
- CN1 <--> P3 (J0302)
- [FIGURE 4](#) in this manual shows the correct cable routing information for eight-disk capable T5140 servers. Use it in place of the figure shown on page 194 of the Service Manual.
- [FIGURE 5](#) in this manual shows the correct cable routing information for eight- or sixteen-disk capable T5240 servers. Use it in place of the figure shown on page 207 of the Service Manual.
