Sun SPARC Enterprise T5120 and T5220 Servers

Product Notes

Part No.: E21877-04
December 2011

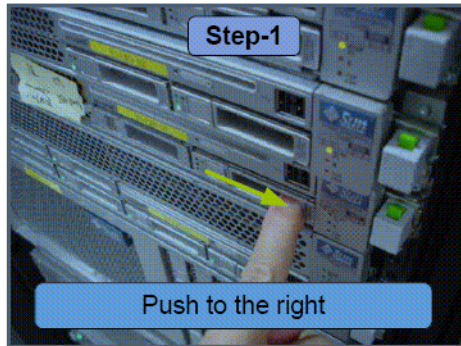
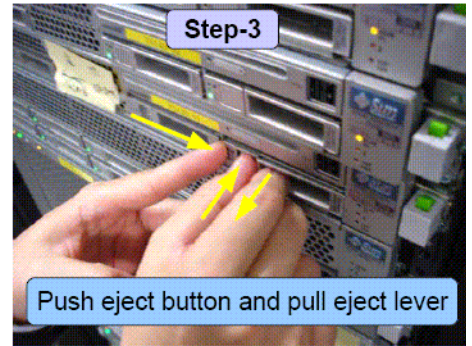
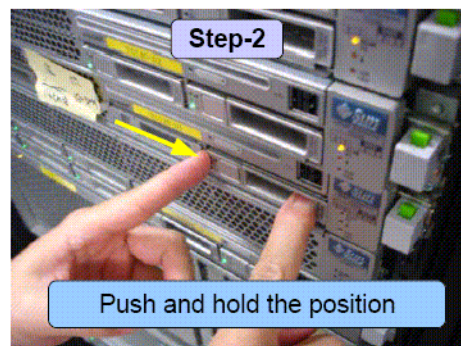
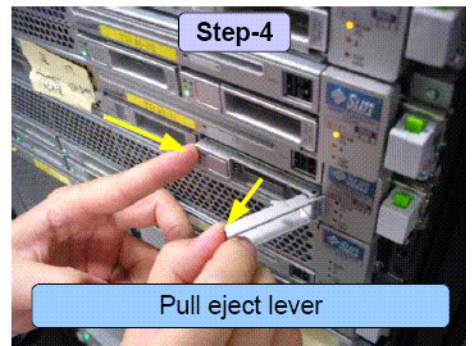
Hard Drives Can Be Difficult to Remove From Right-Side Drive Bays

Hard drives in the right-side drive bays can be difficult to remove.

Workaround: Until a mechanical fix is implemented, use the following procedure to remove hard drives from right-side drive bays.

1. Press the drive to the right.
See *Step 1* in the following figure.
2. Push in on the drive, while holding it pressed to the right.
See *Step 2* in the following figure.

3. Press the drive eject button and pull on the eject lever.
See *Step 3* in the following figure.

4. Use the eject lever to slide the drive out of the bay.
See *Step 4* in the following figure.

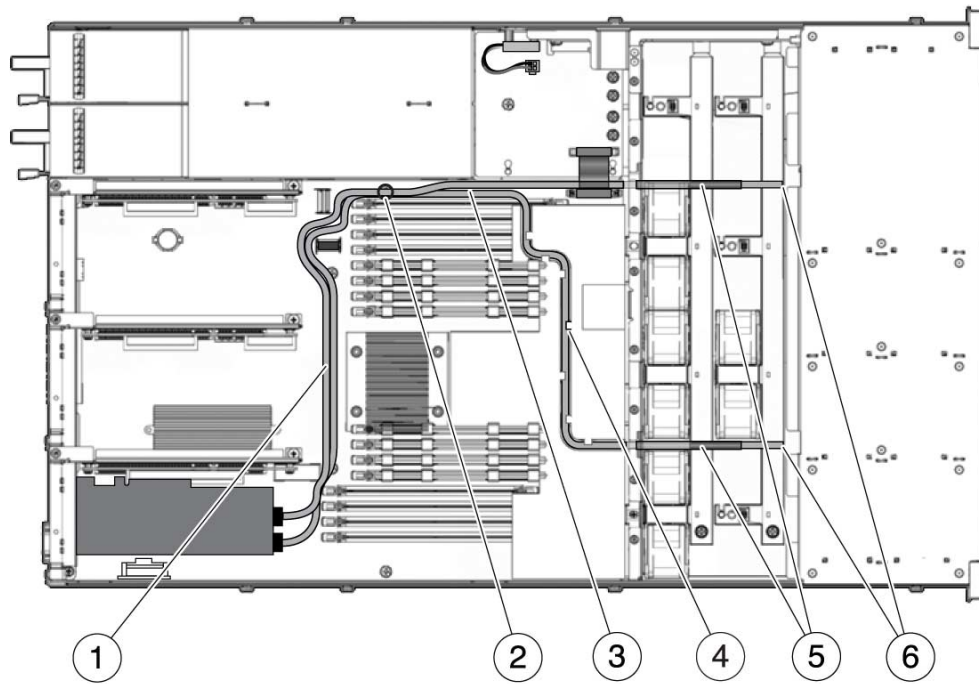
FIGURE 0-1 Hard Drive Data Cable Routing for SAS RAID Controller Card in 8-Disk Capable Sun SPARC Enterprise T5120 Servers

- CN0 <--> P2 (J0301)
- CN1 <--> P3 (J0302)
- [FIGURE 0-1](#) in this manual shows the correct cable routing information for eight-disk capable T5120 servers. Use it in place of the figure shown on page 194 of the Service Manual.
- [FIGURE 0-2](#) in this manual shows the correct cable routing information for eight-disk capable T5220 servers. Use it in place of the figure shown on page 207 of the Service Manual.
