# Sun Dual 10GbE XFP PCIe ExpressModule Release Notes

Part No. 820-4013-11  
March 2008, Revision A

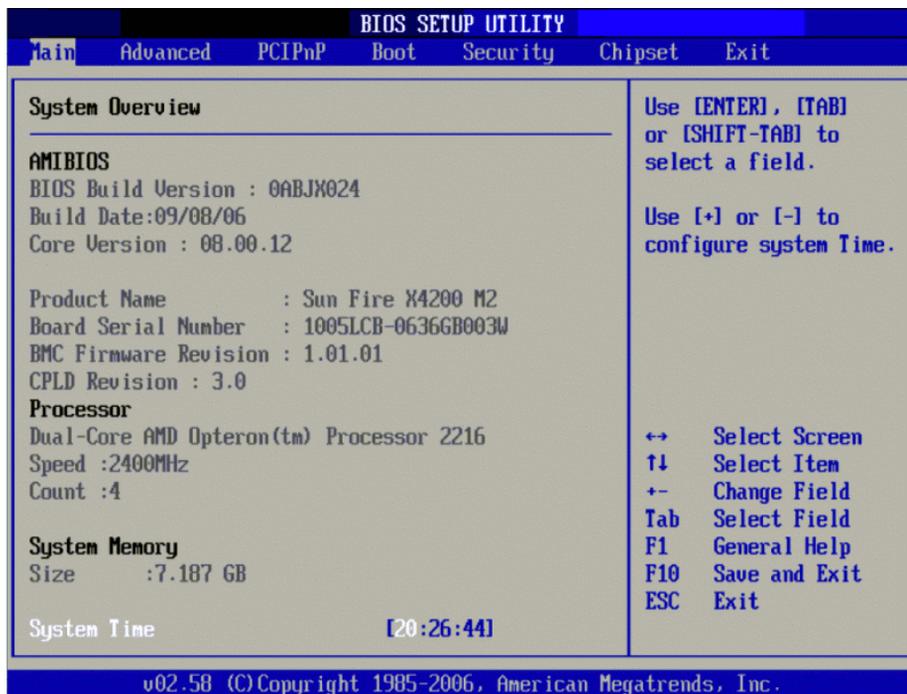
No enough Space to copy PCI Option ROM [04:00:01]
No enough Space to copy PCI Option ROM [04:00:02]
No enough Space to copy PCI Option ROM [04:00:03]
No enough Space to copy PCI Option ROM [80:0A:00]
No enough Space to copy PCI Option ROM [86:01:00]
No enough Space to copy PCI Option ROM [86:01:01]
No enough Space to copy PCI Option ROM [86:02:00] 0085
BMC Responding
Press <ESC> to continue...5                                DE87
```

1. Press F2 to get to the BIOS Setup screen:
