**SPARC Enterprise M3000/M4000/M5000/
M8000/M9000 Servers**

Product Notes for XCP Version 1112

Part No.: E29470-02
October 2012

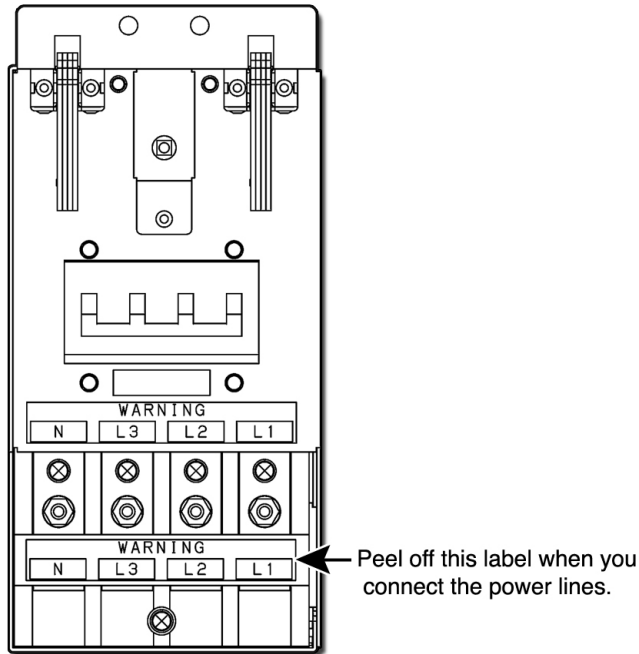
Warning Label on M9000 Server AC Section

The warning label on the AC section indicates that the terminal connection sequence has been changed. Connect in accordance with the terminal sequence described on the warning label.
