Sun Dual 10GbE XFP PCI Express Card Release Notes

Part No.: E36396-01
August 2012

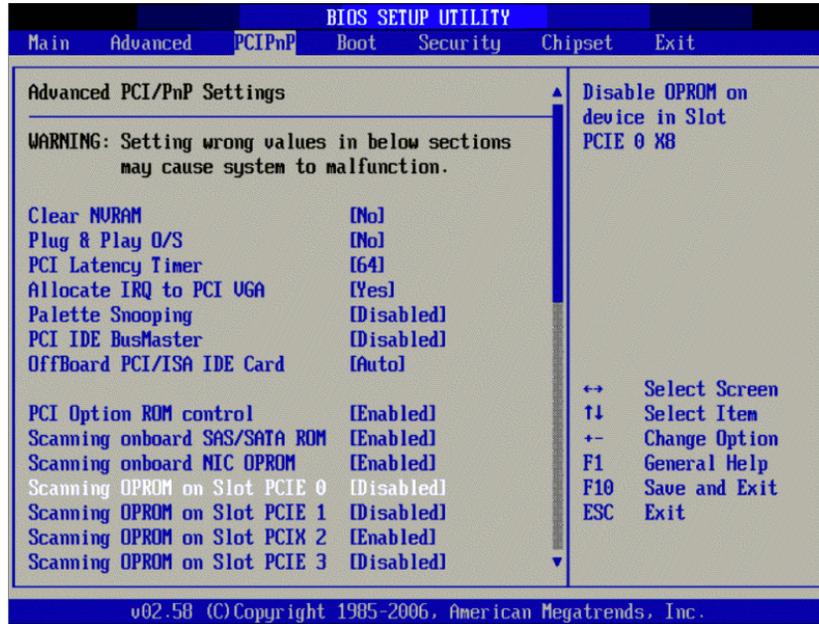
pci_menu.gif

This example shows PCIe slot 0.

2. Press the right arrow key to get to the PCIPnP menu and disable the OPROM scanning for the slot that has the Sun Dual 10GbE XFP PCI Express card.
