# Sun Blade 6048 Modular System

## Product Notes

Part No. E23072-01  
April 2011

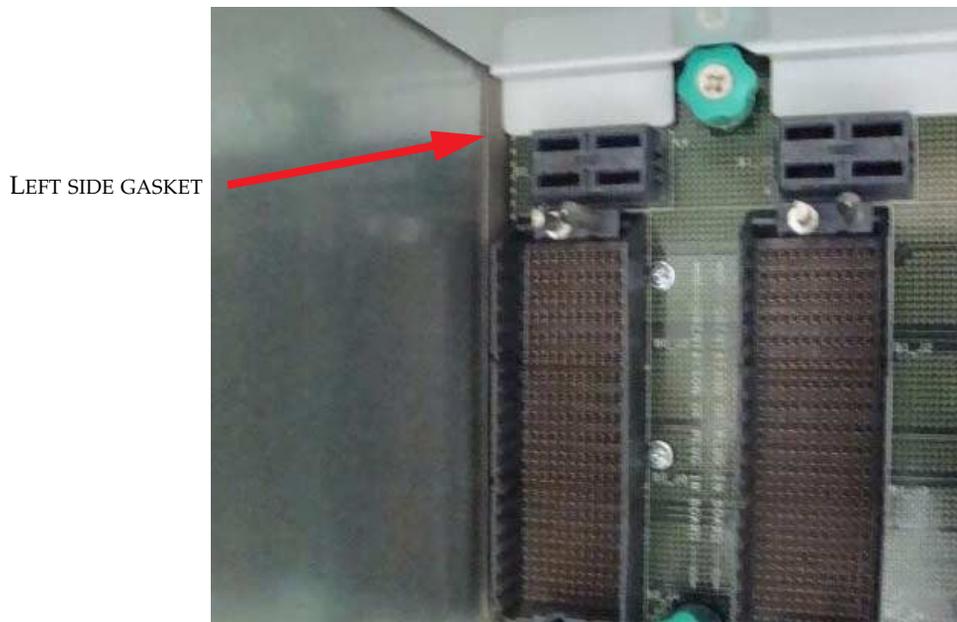
**FIGURE 2-1** Position of Gasket on Left Side of the Chassis

**Caution** – Thermal damage to the chassis can occur. Failure to remove the gasketing material prior to installing the midplane might result in damage to chassis.

1. Remove the chassis midplane.
2. Pull off the gasketing material attached to the left and right sides of the chassis.  
See [FIGURE 2-1](#) and [FIGURE 2-2](#) for the positions of the gasketing material in the chassis.
3. Install the new midplane.  
Do not re-install the gasketing material.
