## Memory Riser Assembly Tool

Part Number: 806-2892-11  
September 1999, Revision A

## Memory Riser Assembly Damage Caution

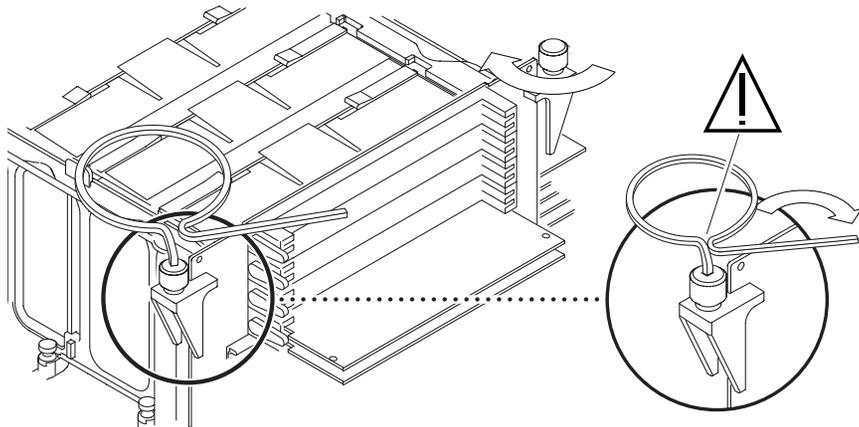
**Caution** – When the torque indicator tool gap closes, and the edges of the tool begin to touch as shown in the illustration below, the proper torque value has been reached. Stop applying force at this point. Do not continue tightening the thumbscrew beyond this point.

When you replace the memory riser assembly, you must use the supplied torque indicator driver tool, part number 340-6091, to tighten the memory riser assembly thumbscrews to the correct torque.
