Storage System

Product Release Notes for Version 9.16

EC1667-1-E2, Second Edition

Document EC1667-1-E2, Second Edition. April 2006.

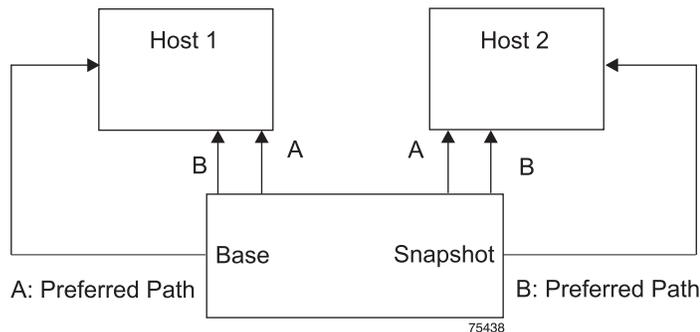
Figure 6-1 Invalid Preferred Path Configuration

In [Figure 6-1 on page 6-7](#), the base volume is mapped to Host 1, and the snapshot volume is mapped to Host 2 (this is a typical setup when creating a point-in-time backup). Host 1 is set up with Controller A as the base volume's preferred path. Host 2 is set up with Controller B as the snapshot volume's preferred path.

In this case, each time Host 1 sends I/O to the base volume, the auto volume transfer (AVT) mechanism on the controller moves both the base volume and snapshot volume to Controller A. Then, for each I/O to the snapshot volume, the controller moves both the base volume and snapshot volume to Controller B. So, for every I/O, both the base volume and snapshot volume move. The result of this is thrashing that, depending on load, can lead to host hang, stale data, and data corruption.
