Sun Server X2-8 (formerly Sun Fire X4800 M2) Product Notes

Part No: E20818-31
September 2018

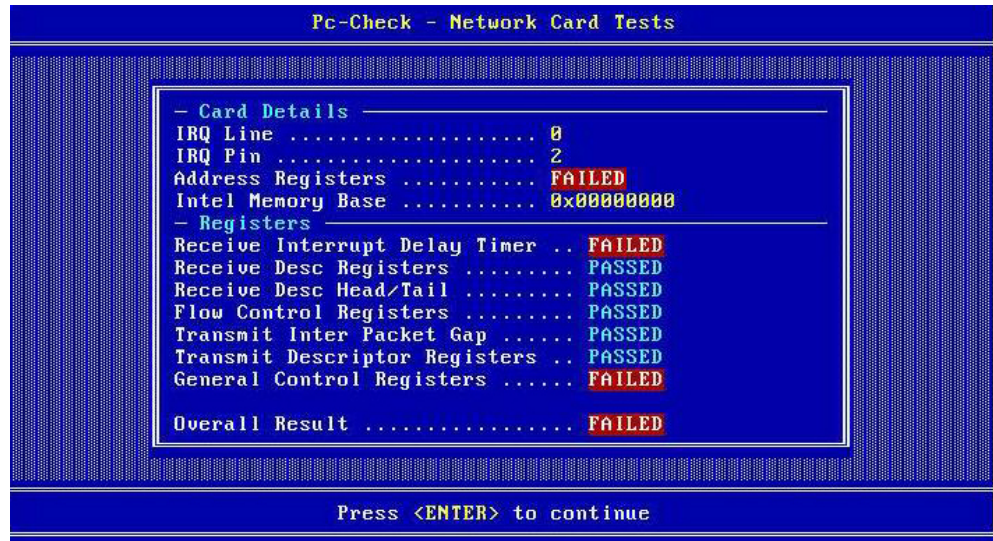
When you run Pc-Check:

- In extended mode, the PCCHECK.JNL file states that the network controller failed.
- In manual mode, the following display appears:

Overall Result ..... FAILED
