Sun Server X3-2 (formerly Sun Fire X4170 M3) Product Notes

Part No: E22356-30
August 2019

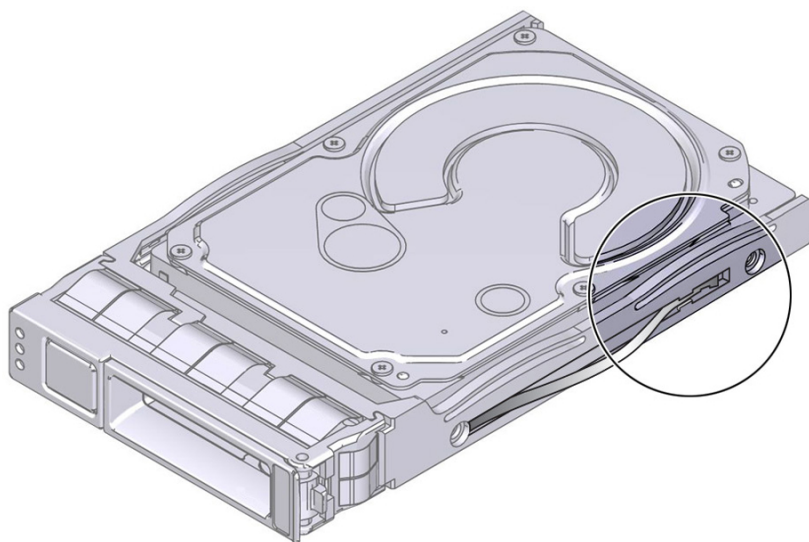
FIGURE 1 Grounding Strap Seated Correctly in the HDD Bracket

The 3.5-inch hard disk drive (HDD) bracket that is used in the Sun Server X3-2 incorporates a spring-loaded metal grounding strap, which is located on the right side of the HDD bracket. A deflection in the grounding strap can cause the strap to catch on the server disk cage, which can further damage the grounding strap. Once damaged, the grounding strap cannot be repaired and the HDD bracket must be replaced.

Before installing a 3.5-inch HDD into your system, visually inspect the grounding strap to ensure that the end of the strap is seated correctly in the HDD bracket. See the following figure for an example of a grounding strap that is seated correctly.

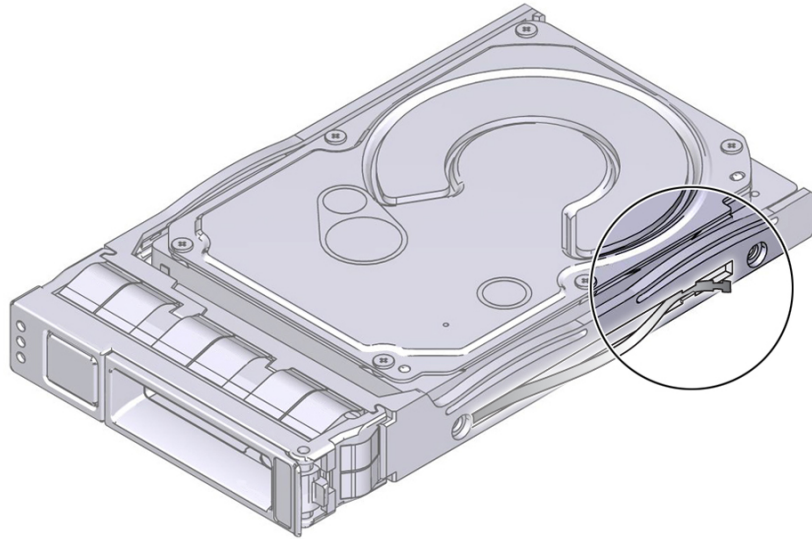
FIGURE 2 Grounding Strap Not Seated Correctly in the HDD Bracket

If the grounding strap is not seated correctly, or is protruding past the outer edge of the HDD bracket, the HDD bracket should be replaced. See the following figure for an example of a grounding strap that is not seated correctly.
