SPARC T4-1 Server

Product Notes

Part No.: E22987-15
July 2014

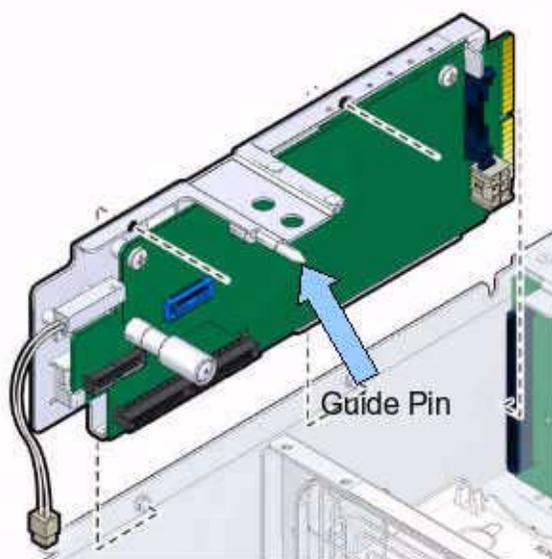
Caution Needed When Handling the Connector Board

Use caution when handling the connector board to avoid pressing your hand against the pointed end of the guide pin that's located below the mounting bracket. The guide pin is indicated by an arrow in the following figure.
