Sun Server X3-2L (formerly Sun Fire X4270 M3) Product Notes

Part No: E23397-30
August 2019

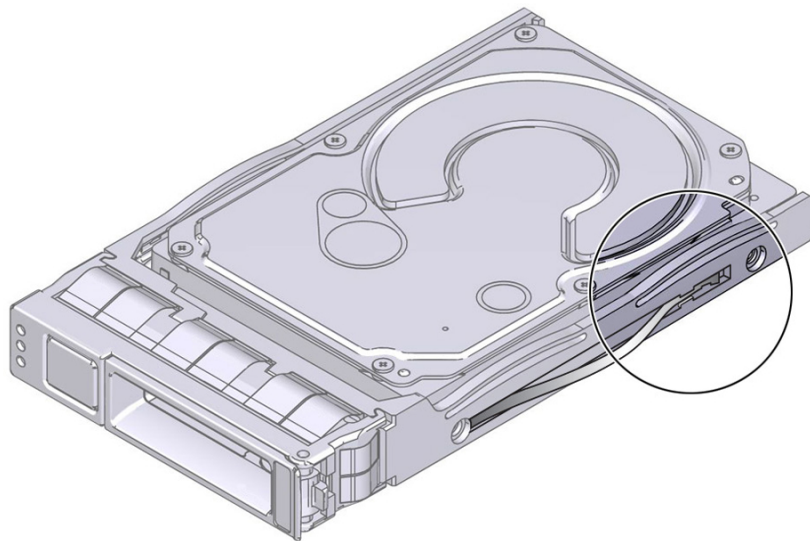
FIGURE 1 Grounding Strap Seated Correctly in the HDD Bracket

Before installing a 3.5-inch HDD into your system, visually inspect the grounding strap to ensure that the end of the strap is seated correctly in the HDD bracket. See the following figure for an example of a grounding strap that is seated correctly.

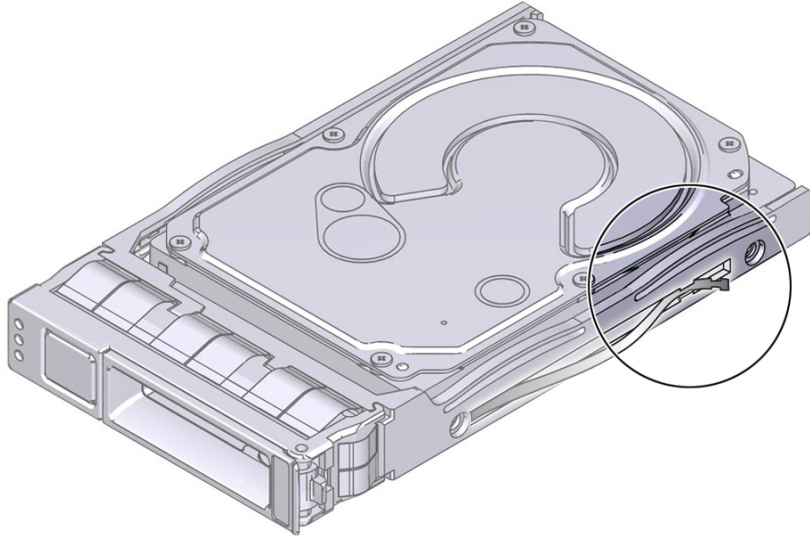
FIGURE 2 Grounding Strap Not Seated Correctly in the HDD Bracket

The 3.5-inch hard disk drive (HDD) bracket that is used in the Sun Server X3-2L incorporates a spring-loaded metal grounding strap, which is located on the right side of the HDD bracket. A deflection in the grounding strap can cause the strap to catch on the server disk cage, which can further damage the grounding strap. Once damaged, the grounding strap cannot be repaired and the HDD bracket must be replaced.

If the grounding strap is not seated correctly, or is protruding past the outer edge of the HDD bracket, the HDD bracket should be replaced. See the following figure for an example of a grounding strap that is not seated correctly.
