**Netra Blade X3-2B**  
**(formerly Sun Netra X6270 M3 Server Module)**

Product Notes

Part No.: E26405-03  
November 2012

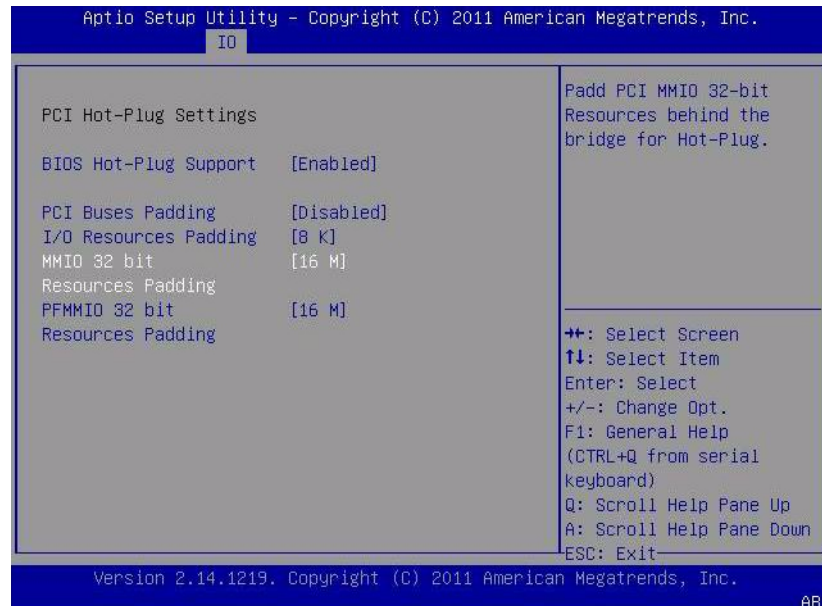
## ▼ Blade With Solaris 10 8/11 Fails to Bring Up a Supported NEM After Hot Insertion (7121662)

```
WARNING: (pcieb9): failed to probe the Connection Slot4
```

1. Shut down the affected blade.
2. Reboot the server and enter the BIOS Setup Utility.
3. Allocate 32 MB of MMIO by changing the BIOS menu option **MMIO 32-bit Resource Padding** from 16M to 32M.

4. Reboot the server.
