Oracle® Server X5-2L Product Notes

Part No: E48334-26
August 2021

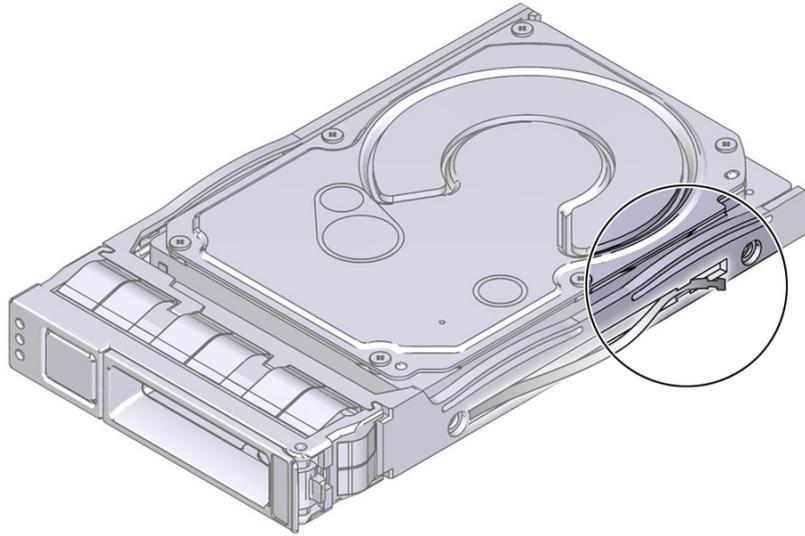
FIGURE 2 Grounding Strap Not Seated Correctly in the HDD Bracket

The 3.5-inch hard disk drive (HDD) bracket that is used in the Oracle Server X5-2L incorporates a spring-loaded metal grounding strap, which is located on the right side of the HDD bracket. A deflection in the grounding strap can cause the strap to catch on the server disk cage, which can further damage the grounding strap. Once damaged, the grounding strap cannot be repaired and the HDD bracket must be replaced.

If the grounding strap is not seated correctly, or is protruding past the outer edge of the HDD bracket, the HDD bracket should be replaced. See the following figure for an example of a grounding strap that is not seated correctly.

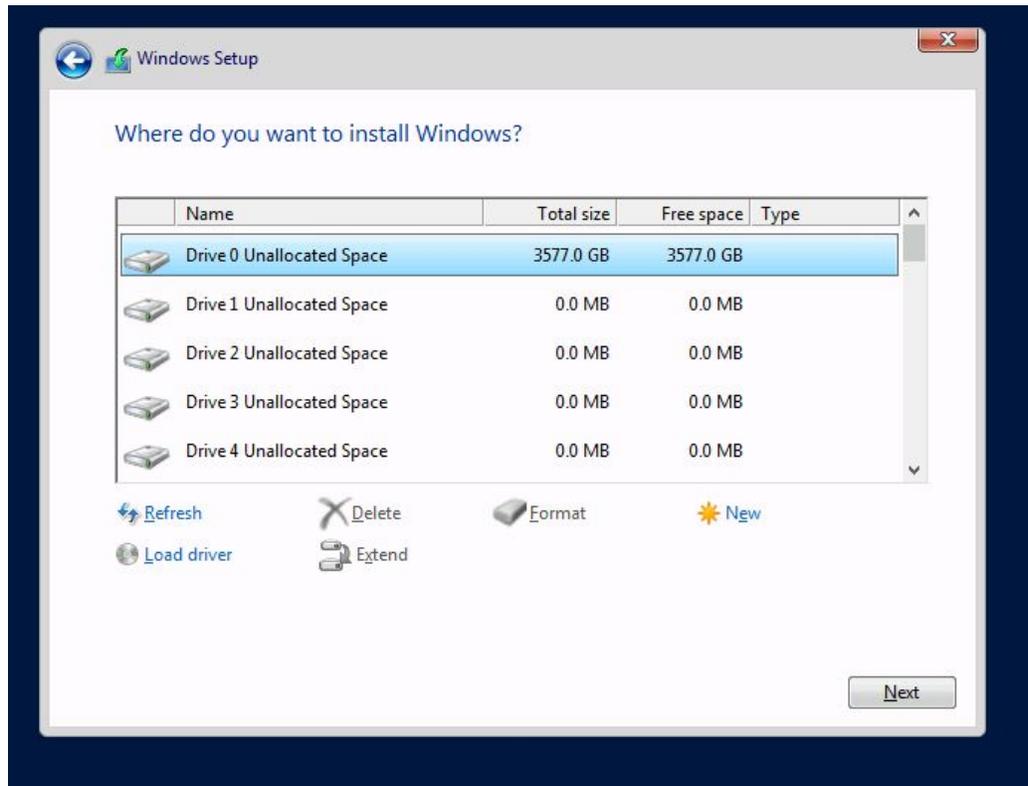
Issue: During Windows Server 2016 installation on a system with an NVMe storage drive, Windows Setup lists the NVMe storage device and 127 phantom listings of the same NVMe

storage device. These phantom storage devices each show a total size and free space of 0.0 MB. For example:

After you install Windows Server 2016, the 127 phantom drives also appear in Windows Device Manager. This issue is due to an out-of-date inbox Windows Server 2016 NVMe driver that does not support the multiple namespace feature of some NVMe storage devices.
