Sun SPARC® Enterprise M8000/M9000 Servers Product Notes

For XCP Version 1060

Part No. 820-3611-10
November 2007, Revision A

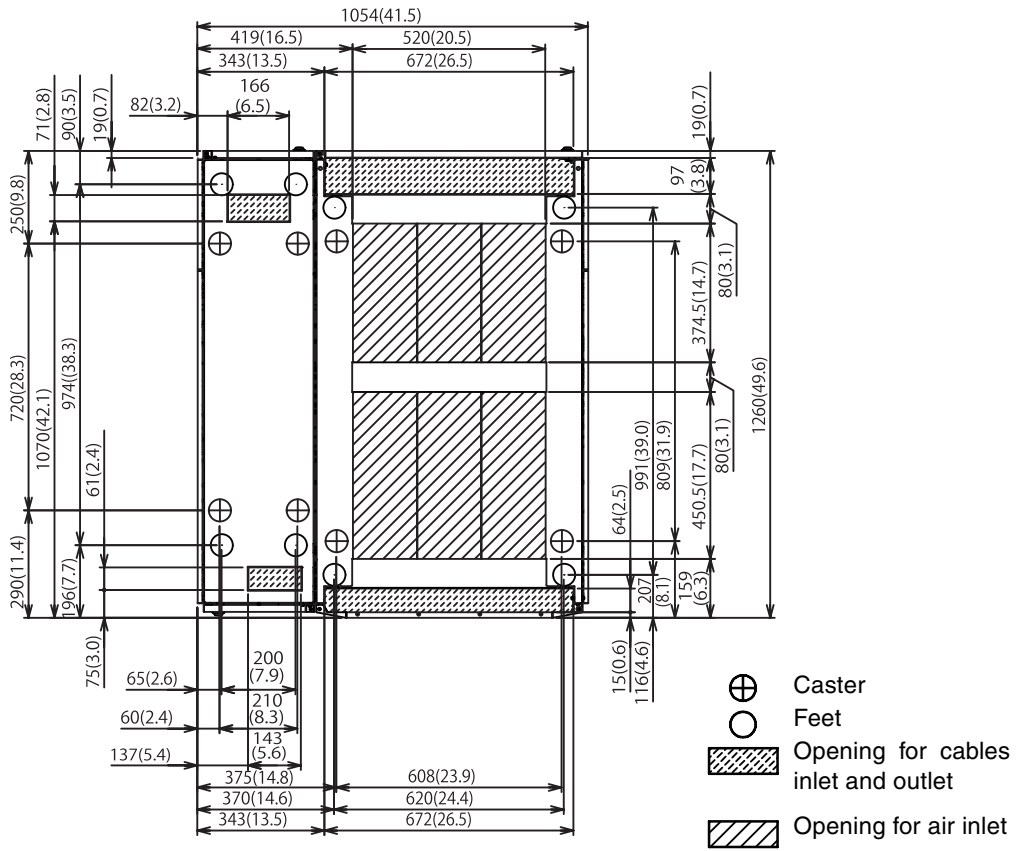
FIGURE 1 Sun SPARC Enterprise M8000 Server + Power Cabinet Bottom View

(Front)

Unit: mm (inch)

FIGURE 1 shows the Sun SPARC Enterprise M8000 Server + Power Cabinet Bottom View.
