Sun StorageTek™ 5800 System Release Notes

Version 1.1

Part No. 819-7559-10
November 2007, Revision A

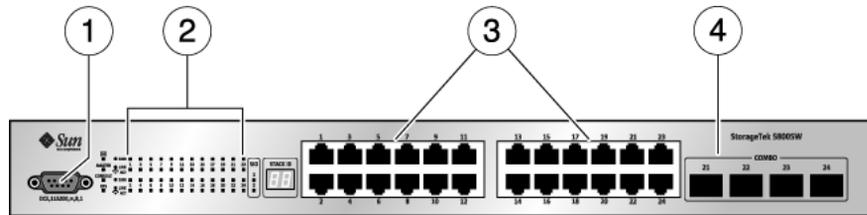
FIGURE 3 Back of Switch

If you receive email alerts and syslog messages indicating that one or more nodes are offline, inspect the 5800 system to determine if the secondary switch (the top switch on the system) is active. [FIGURE 3](#) shows the components on the back of the switch. If the port connection status LEDs are mostly lit for the top switch, that secondary switch is active.

If the secondary (top) switch is active, contact Sun service immediately to arrange for a replacement of the primary (bottom) switch.
