Sun StorEdge™ 6320 System 1.0 Release Notes

Part No. 816-7880-12
July 2003, Revision A

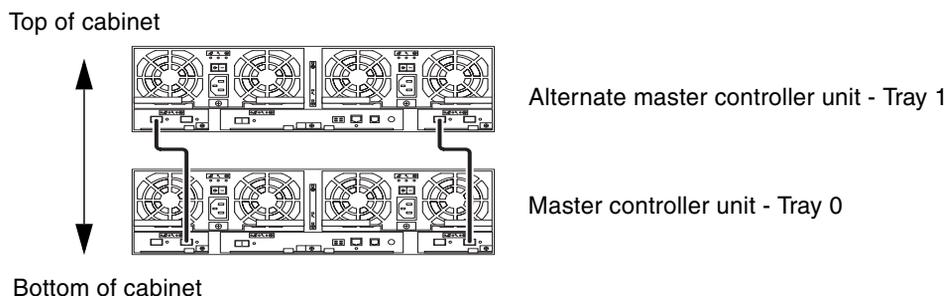
FIGURE 1 2x2 HA Configuration and Corresponding Tray Numbers

Figure 1 illustrates the HA configurations and the corresponding tray number in the Sun StorEdge Configuration Service software.

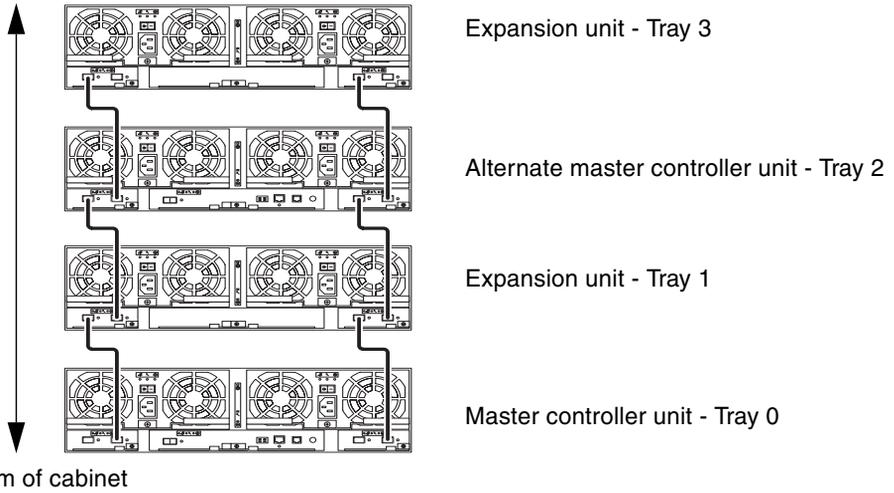
FIGURE 2 2x4 HA Configuration and Corresponding Tray Numbers

FIGURE 2 illustrates a Sun StorEdge 6020 array 2x4 HA Configuration and Corresponding Tray Numbers.

Top of cabinet

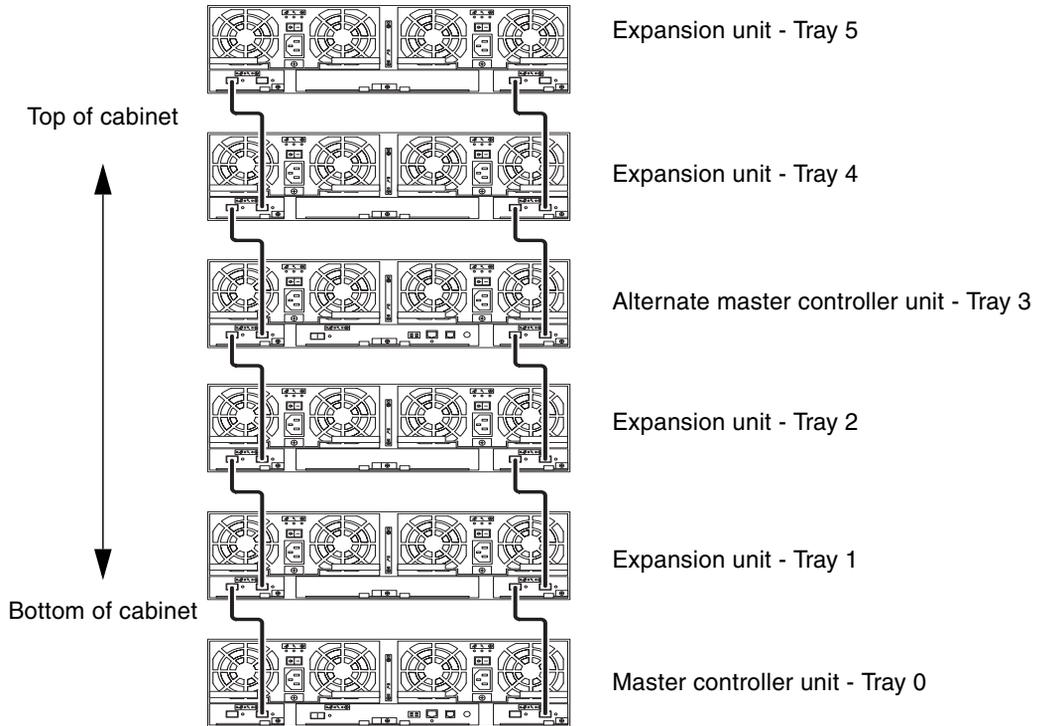
FIGURE 3 2x6 HA Configuration and Corresponding Tray Numbers

FIGURE 3 illustrates a Sun StorEdge 6020 array 2x6 HA Configuration and Corresponding Tray Numbers.
