Sun Storage 2500-M2 Arrays

Hardware Release Notes, Release 6.9.x Update

Part No.: E36765-01
December 2012

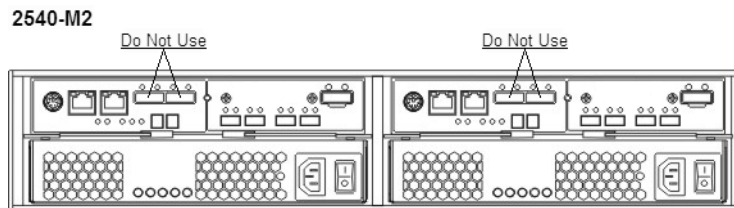
FIGURE 1 SAS Host Ports on the 2540-M2

Although SAS host ports are physically present on the Sun Storage 2540-M2 array controller tray, they are not for use, not supported, and are capped at the factory. [FIGURE 1](#) shows the location of these ports. The Sun Storage 2540-M2 only supports Fibre Channel host connectivity.
