Sun Storage 2500-M2 Arrays

Hardware Release Notes, Release 6.10

Part No.: E52318-01
June 2014

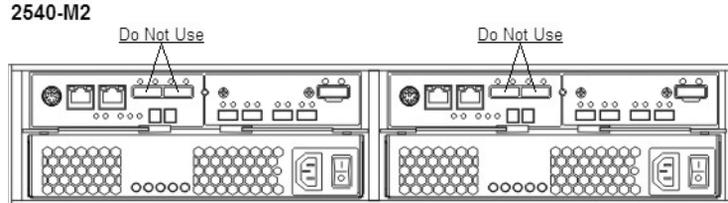
SAS Host Ports on the Sun Storage 2540-M2

Although SAS host ports are physically present on the Sun Storage 2540-M2 array controller tray, they are not for use, not supported, and are capped at the factory. The following figure shows the location of these ports. The Sun Storage 2540-M2 only supports Fibre Channel host connectivity.
