Release Notes for Fabric Director and XgOS 3.9.0

These release notes document information about the Fabric Director (VP780 and VP560) and version 3.9.0 of Oracle's XgOS command-line interface. Additional release notes exist for:

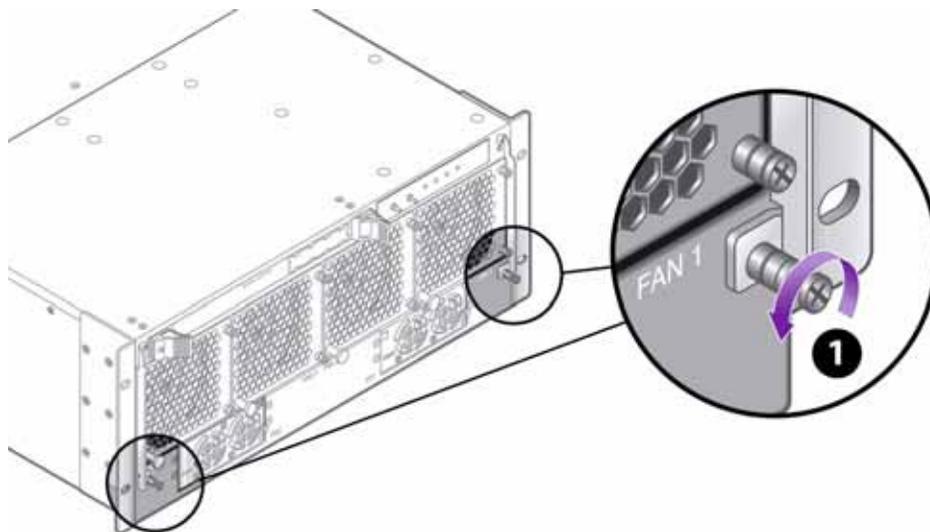
Step 2 Using the screwdriver, release the two spring-loaded screws (1) securing the release levers to the chassis. See [Figure 1](#).

Figure 1 Loosening the VP780 Front Panel Assembly Screws

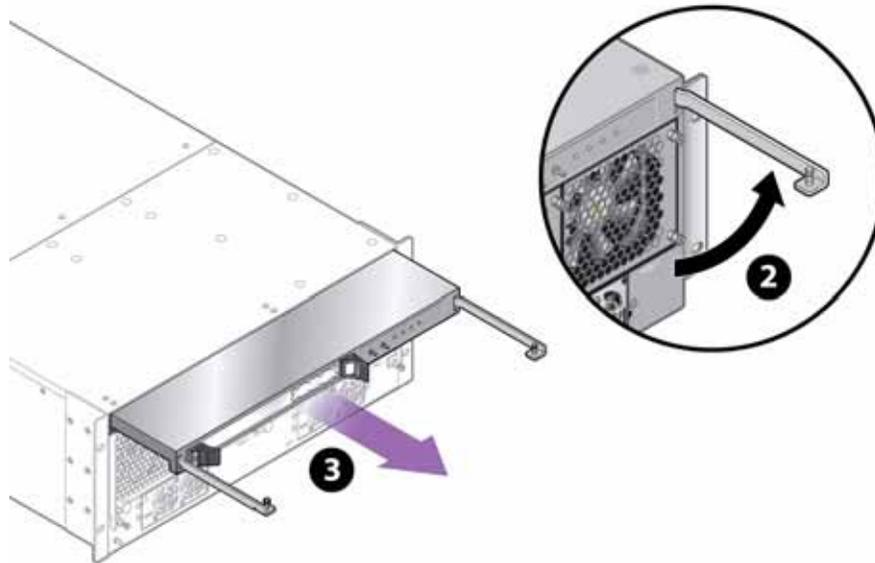
Step 3 Simultaneously grasp both of the release levers and slowly raise them until they are horizontal (2), then use the levers to carefully slide the assembly out of the chassis (3). See [Figure 2](#).

Figure 2 Removing the VP780 Front Panel Assembly

- Step 1 Carefully align the FP-2 with the Front Panel bay in the chassis. Make sure that the FP-2 is facing up, and the handles are pointing straight towards you as shown in (3) in [Figure 2](#).
- Step 2 Keeping the FP-2 level and holding it by the edges, gently slide the FP-2 into the chassis until you feel some resistance when the FP-2 is almost all the way inserted.

- Step 3 When the FP-2 plug has contacted the socket inside the chassis, simultaneously grasp both of the release levers and slowly lower them until they are vertical and flush with the chassis. This step is the reverse of (2) in [Figure 2](#).
- Step 4 Using the screwdriver, tighten the two spring-loaded screws securing the release levers to the chassis. This step is the reverse of [Figure 1](#). *Do not overtighten the screws!*
- Step 5 Power on the system.
- Step 6 As an option, you can attach to serial port 1 (SER-1) at 115200 baud and leave the session open to watch the progress of the installation and start up while the Fabric Director is brought back online.
- Step 7 When the chassis is up, log on as admin/admin.
