# **Tekelec Signaling Products Maintenance Manual**

## **Maintenance Manual Volume 1**

**910-4593 Revision M**

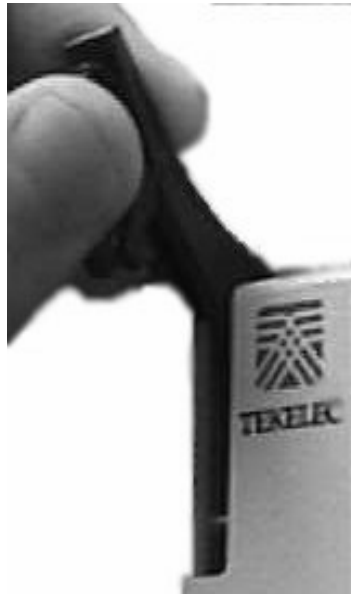
**Figure 3-6.** Push Inject/Eject Clamps Outward

1. The card is located in slot 1117. Push the inject/eject clamps outward from the card's faceplate (top clamp in the "UP" position, bottom clamp in the "DOWN" position). Pull the levers away from the shelf until they are parallel to the floor. Gently pull the card towards you until the card clears the shelf.

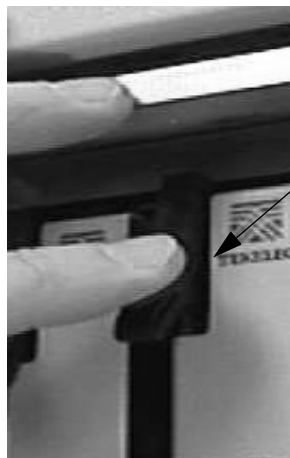
**Figure 3-7.** Push in Inject/Eject Clamps

4. Press the left edge of the card's faceplate using constant pressure until you feel the card's progress cease.
- 
5. Push in the top and bottom inject/eject clamps. This locks the card in place and ensures a strong connection with the pins on the target shelf backplane.

Push in the inject/eject clamps to lock the card in place.

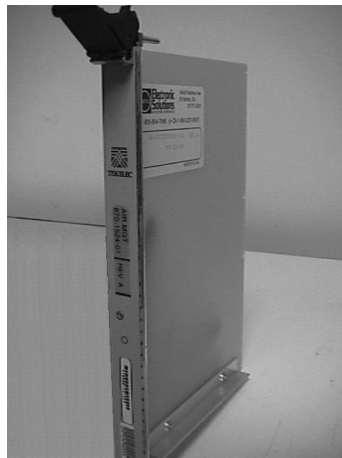
**Figure 5-6.** Air Management Card (P/N 870-1524-01)

← Replacement  
Air Management Card

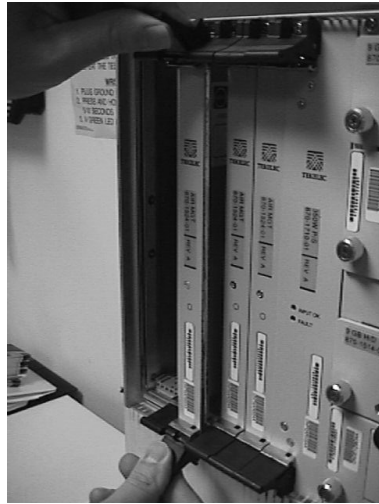
**Figure 5-8.** Inserting the Replacement Air Management Card

- 
10. Carefully align the replacement card's edges with the channels in the top and bottom card guides. Refer to Figure 5-8. Then push the card along the length of card guides until you feel the card's progress cease.

Push the card along the length of card guides until you feel the card's progress cease.

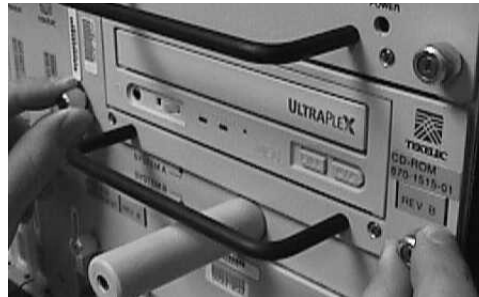
**Figure 5-29.** CD-ROM Drive Card Captive Screws

**NOTE:** The heads on the captive fasteners should spring outward when freed.

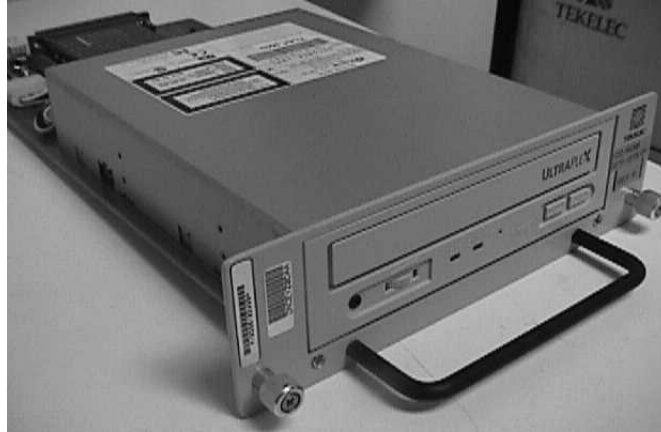
**Figure 5-31.** CD-ROM Drive Card (P/N 870-1515-03)

13. Remove the CD-ROM drive card assembly from the shipping container.

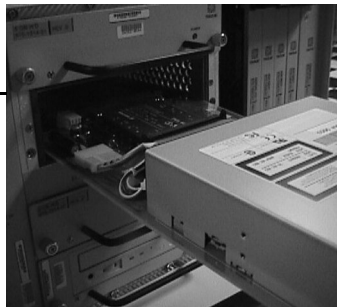
**Figure 5-32.** Install the CD-ROM Drive Card

15. While facing the front of the drive bay, carefully insert the card through the proper opening. Align the edges of the card with the channels in the card guides. Then push the assembly until the rear connectors on the drive card begin engaging the mated connectors on the backplane.

Align the edges  
of the card with  
the card guides.

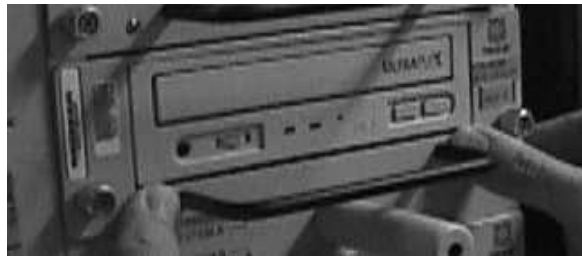
**Figure 5-33.** Press the Faceplate

- 
16. Press the faceplate of the assembly using constant pressure until connections are fully seated.

Press the faceplate near the areas where the handle is in contact with the faceplate.

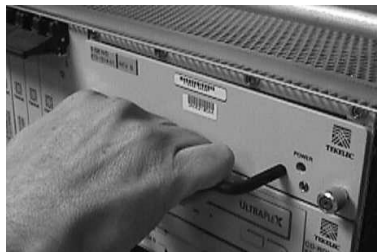
**Figure 5-44.** Free Hard Drive Card from the EOAP Card Cage

- 
9. Grasp the drive assembly handle with one hand and carefully pull the assembly toward you. Pull until the rear connectors on the board are freed from the connectors on the backplane.

a. Grasp the handle with one hand.

b. Pull until connectors are freed from the backplane.

9. Grasp the drive assembly handle with one hand and carefully pull the assembly toward you. Pull until the rear connectors on the board are freed from the connectors on the backplane (see Figure 5-44 for instructions on removing a hard drive or CD-ROM drive assembly).
10. Continue pulling the card directly toward you until it clears the EOAP drive bay completely. Always support the drive assembly from underneath, when possible, using the other hand.

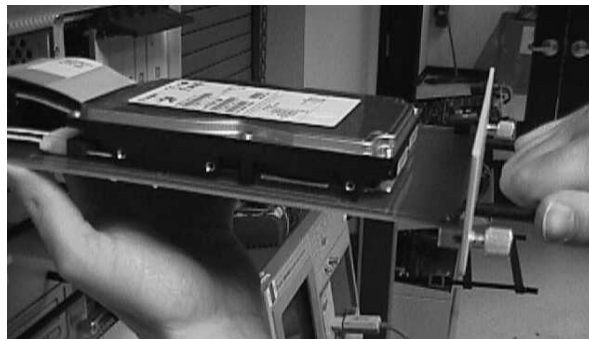
**Figure 5-45.** Support the Hard Drive Card With Both Hands

- 
10. Continue pulling the card directly toward you until it clears the EOAP drive bay completely. Always support the drive assembly from underneath, when possible, using the other hand.

- 
14. Use one hand to support the card assembly from underneath and the other hand to grasp the faceplate handle (see Figure 5-45).

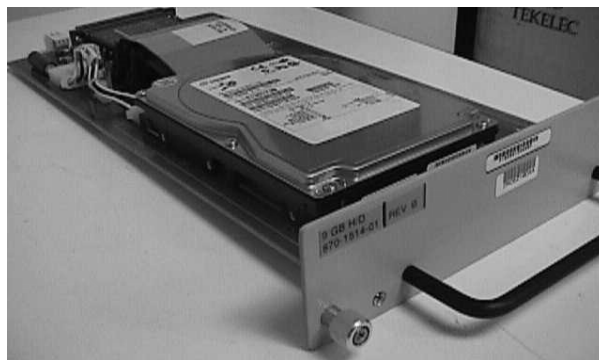
**Figure 5-47.** Hard Drive Card (P/N 870-1514-03)

- 
13. Remove the new drive card assembly from the shipping container.

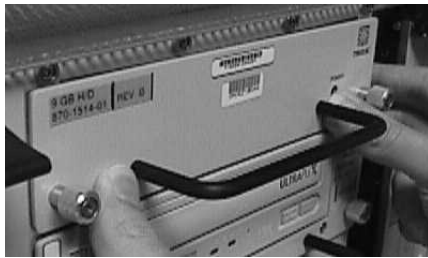
**Figure 5-49.** Pressing the Faceplate

16. Press the faceplate of the assembly using constant pressure until the connections are fully seated.

Press the faceplate near the  
areas where the handle is in  
contact with the faceplate.

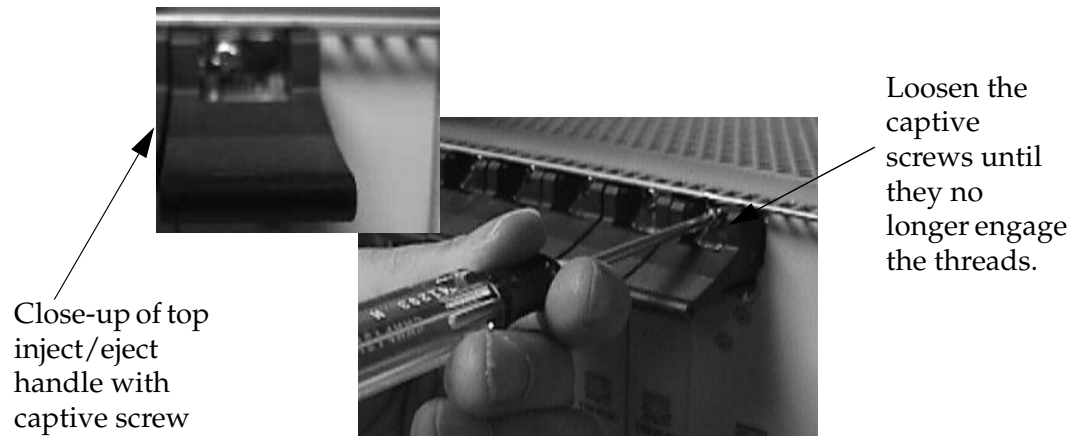
**Figure 5-51.** Loosening Captive Screws of Power Supply Card

4. While facing the card to be replaced, locate the two captive screws attached to the top and bottom inject/eject handle brackets on the faceplate. Figure 5-51 shows a close-up of the top handle with captive screw.
5. Using a small Phillips head screwdriver, loosen the captive screws until they no longer engage the threads. **Do not remove the screws** from the ejector handle brackets.

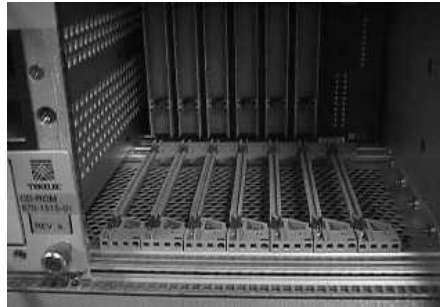
**Figure 5-53.** EOAP Backplane Connector Pins

7. Pull the card directly towards you until it clears the card guides and guide rails.
8. Immediately store the card properly to avoid any damage due to handling or ESD.
9. Prior to inserting the replacement card, examine the pins in the EOAP backplane connector for any misalignment, evidence of shorts, or other signs of damage.

← Prior to inserting the replacement card, check connectors\* for any kind of damage.

← Card guides

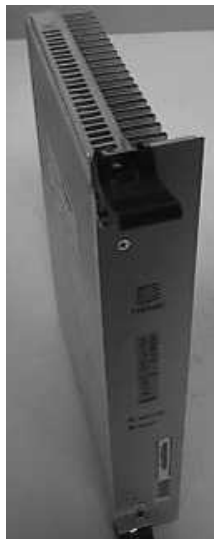
**Figure 5-54.** Power Supply Card (P/N 870-1521-01)

**10.** Remove the replacement power supply card from the shipping container.

← Replacement Power Supply Card

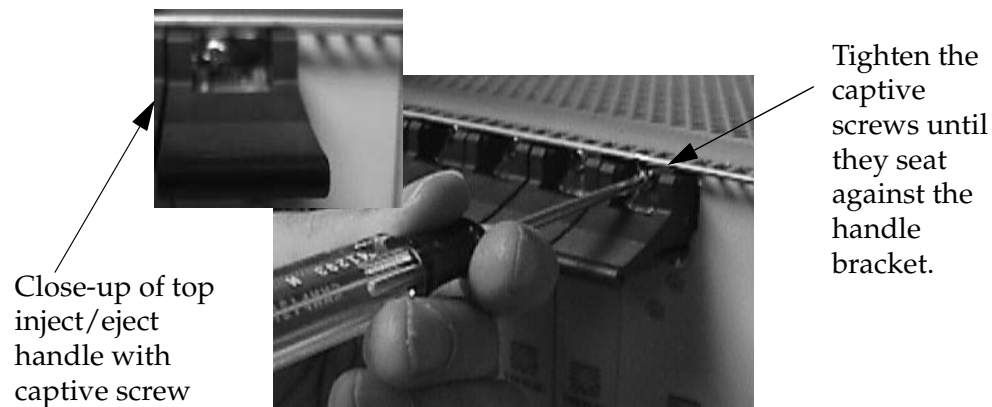
**Figure 5-58.** Tighten Captive Screws

16. Using a small Phillips head screwdriver, tighten all captive screws in the handle brackets until they seat against the handle bracket.

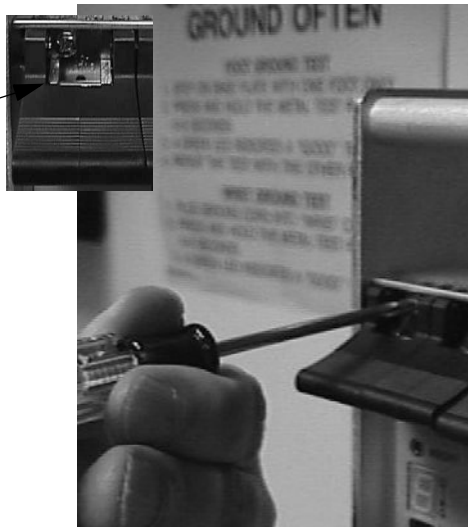
**Figure 5-60.** Processor Card Captive Screws

9. Locate the four captive screws attached to the top and bottom inject/eject handle brackets on the faceplate. Figure 5-60 shows a close-up of the top handle with a captive screw.
-

Top Handle  
and Captive  
Screw  
Enlarged

Loosen the  
screws until  
they no longer  
engage the  
threads in the  
guide rail.

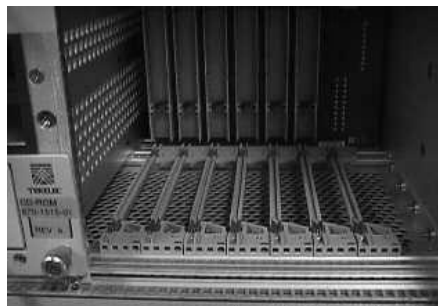
**Figure 5-62.** EOAP Backplane Connector Pins

- 14.** Prior to inserting the replacement card, examine the pins in the EOAP backplane connector for any misalignment, evidence of shorts, or other signs of damage.

← Prior to inserting the replacement card, check connectors\* for any kind of damage.

← Card guides

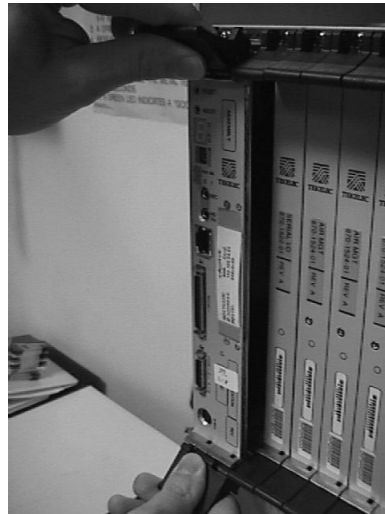
**Figure 5-65.** Inserting the Replacement Processor Card

- 
- 18.** Carefully align the replacement card's edges with the channels in the top and bottom card guides. Refer to Figure 5-65. Then push the card along the length of card guides until the rear connector on the card begins engaging the mating connector on the backplane.

Push the card along the length of the card guides until the rear connector on the card begins engaging the mating connector on the backplane.

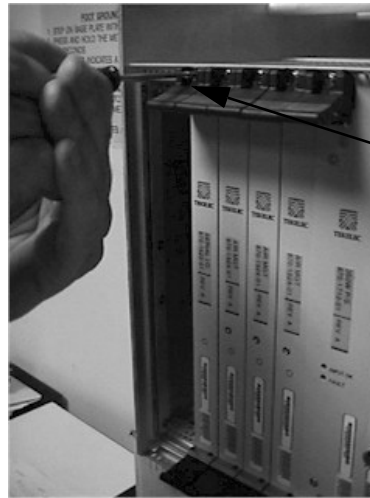
**Figure 5-70.** Top Handle and Captive Screw of Serial Card

4. While facing the card to be replaced, locate the two captive screws attached to the top and bottom inject/eject handle brackets on the faceplate. Figure 5-70 shows a close-up of the top handle with captive screw.
- 
5. Using a small Phillips head screwdriver, loosen the captive screws until they no longer engage the threads. **Do not remove the screws** from the ejector handle brackets.

Close-up of  
top inject/eject  
handle with  
captive screw

Loosen the  
captive  
screws until  
they no  
longer engage  
the threads.

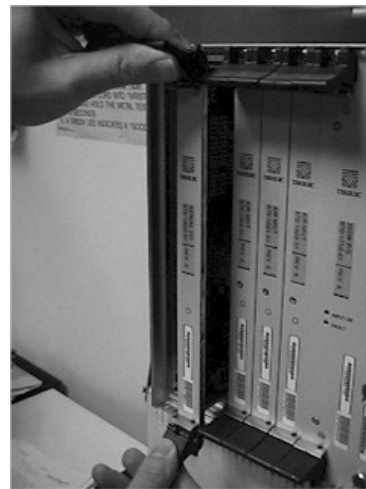
- 
6. Using the thumb and forefinger, push the top handle up and the bottom handle down simultaneously until the card is completely free from the backplane in the card cage.

Use thumb and forefinger  
to push top handle up.

Push the top handle up and  
the bottom handle down. →

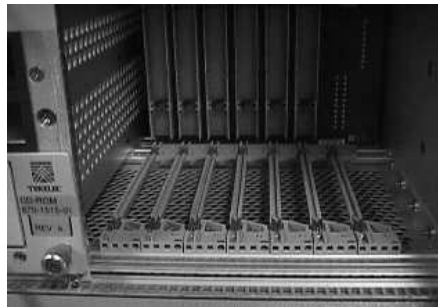
**Figure 5-72.** EOAP Backplane Connector Pins

9. Prior to inserting the replacement card, examine the pins in the EOAP backplane connector for any misalignment, evidence of shorts, or other signs of damage.

← Prior to inserting the replacement card, check connectors\* for any kind of damage.

← Card guides

- 
13. Carefully align the replacement card's edges with the channels in the top and bottom card guides. Refer to Figure 5-72. Then push the card along the length of card guides until the rear connector on the card begins engaging the mating connector on the backplane.

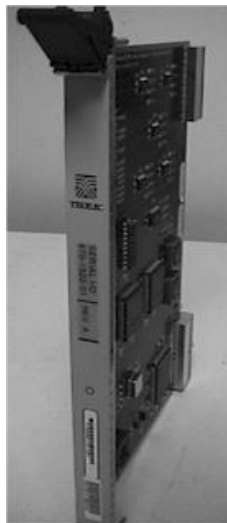
**Figure 5-73.** Serial Card (870-1522-01)

- 
10. Remove the replacement serial I/O card from the shipping container.

← Replacement Serial Card

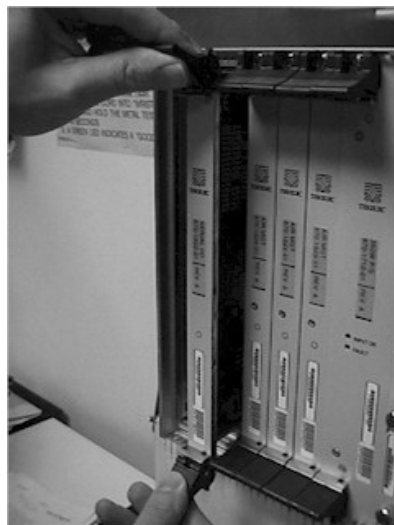
**Figure 5-75.** Inserting the Replacement Serial Card

Push the card along the length of the card guides until the rear connector on the card begins engaging the mating connector on the backplane.

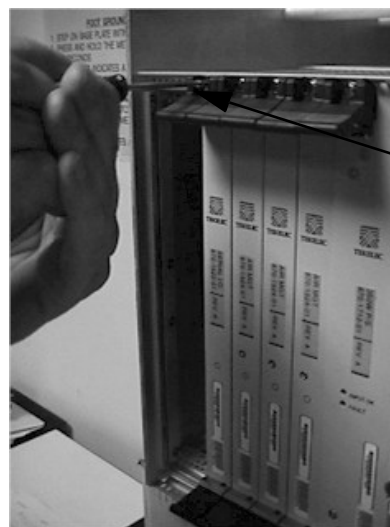
**Figure 5-77.** Tighten Captive Screws

16. Using a small Phillips head screwdriver, tighten all captive screws in the handle brackets until they seat against the handle bracket.

**WARNING:** Do not overtighten the screws as the heads could snap off. Reference Mechanical Assembly Torque Specification (906-0008-01).

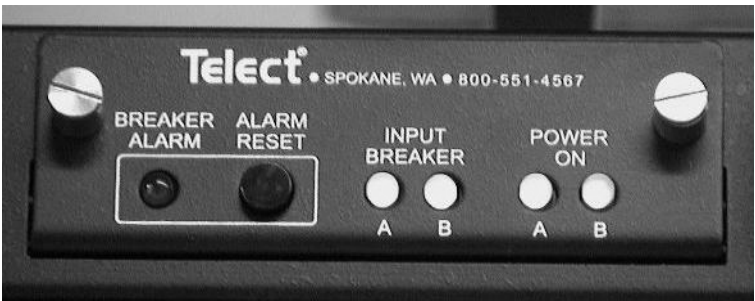
**Figure 6-6.** Breaker Panel LEDs

The power module, also called the “Indicator Panel,” is in the center of the front of each breaker panel (see Figure 6-6). The power module contains two pairs of LEDs labeled A and B with respect to the side of the breaker panel that the LED represents. The pair labeled **INPUT BREAKER** is on (illuminated green) for normal operation. If one of the rear input breakers pops out, its respective LED is off (not illuminated).

The pair of LEDs labeled **POWER ON** is also on (illuminated green) for normal operation. If power is lost coming to the breaker panel, the affected LED is off (not illuminated.)

**NOTE: If one of the POWER ON LEDs is off, the respective INPUT BREAKER LED will also be off.**

1. Check the “Input Breaker” LEDs (see Figure 6-6 on page 6-32). If one is off, then the respective Input Circuit Breaker has popped out. If this is the case, perform the following steps; a Volt Ohm Meter is required:

3. Check the "Power On" LEDs (see Figure 6-6 on page 6-32). If one is off, then power has been lost to that LED's side of the breaker panel. Have an electrician examine the circuit providing power to that side of the breaker panel.
-

1. Inspect the Breaker Alarm LED (see Figure 6-6 on page 6-32). This is a red LED in the center on the front of the breaker panel. If this light is on, one or more breakers are open.

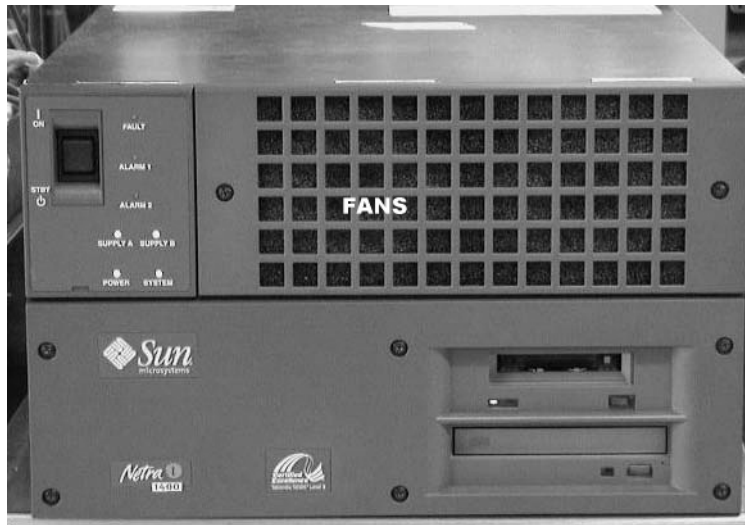
**Figure 6-68.** MPS Fans

This alarm indicates that a fan on the system is either working too hard or has failed completely. In either case, there is a danger of component failure due to overheating.

1. Ensure that nothing is blocking the fan's intake or its exhaust (see Figure 6-68 on page 6-80). Remove any blockage.
2. Run the system health check.  
Reference: "System Health Check Procedure" on page 6-36  
If the alarm has been cleared, the problem is resolved.  
If the alarm has not been cleared, continue with the next step.
3. Clean the faulty fan's filter:
  - a. Go to the front of the MPS with the faulty fan.
  - b. Remove the screws located to the left and right of the fan cover.

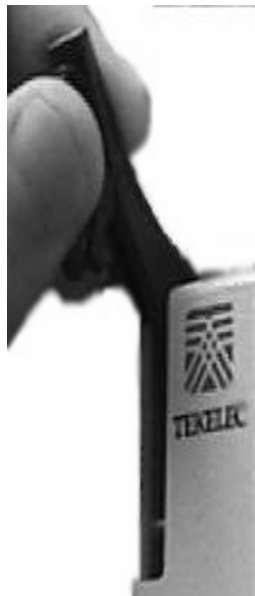
**Figure A-16.** Push Inject/Eject Clamps Outward

1. Locate the card to be removed.
- 
2. Push the inject/eject clamps outward from the card's faceplate (top clamp in the "UP" position, bottom clamp in the "DOWN" position). Pull the levers away from the shelf until they are parallel to the floor. Gently pull the card towards you until the card clears the shelf.
