Sun Fire[™] X4600 M2 Server
Product Notes

Part No.: 819-5032-24,
December 2010, Revision A

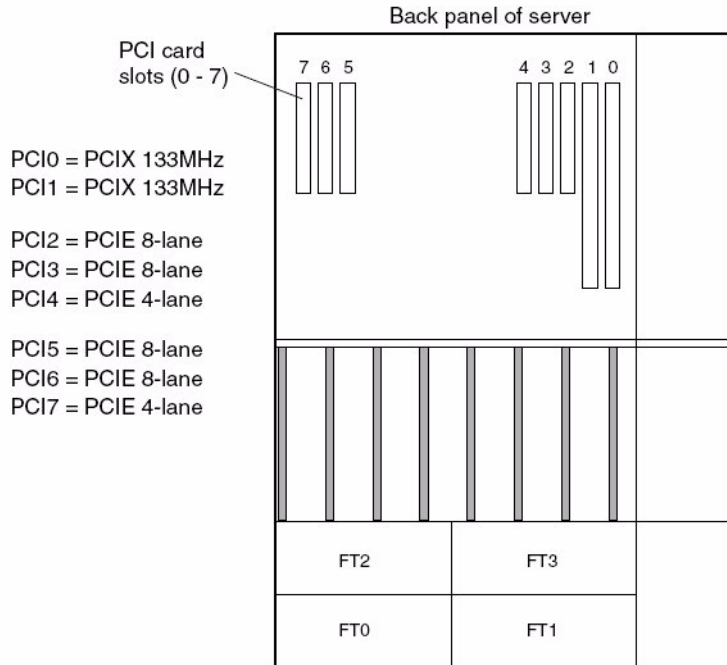
FIGURE 2-1 PCI Designation and Speeds of PCI Slots

A change in the system BIOS, introduced after Software 1.3, changes the way the system enumerates PCIe cards in slots 5, 6, and 7, as well as the devices connected to these cards. Upgrading the BIOS can cause the names of disk partitions and network interfaces to change.
