# Sun Fire X4450 Server

## Product Notes

Part No.: Part No.: 820-2703-32,  
September 2012, Revision A

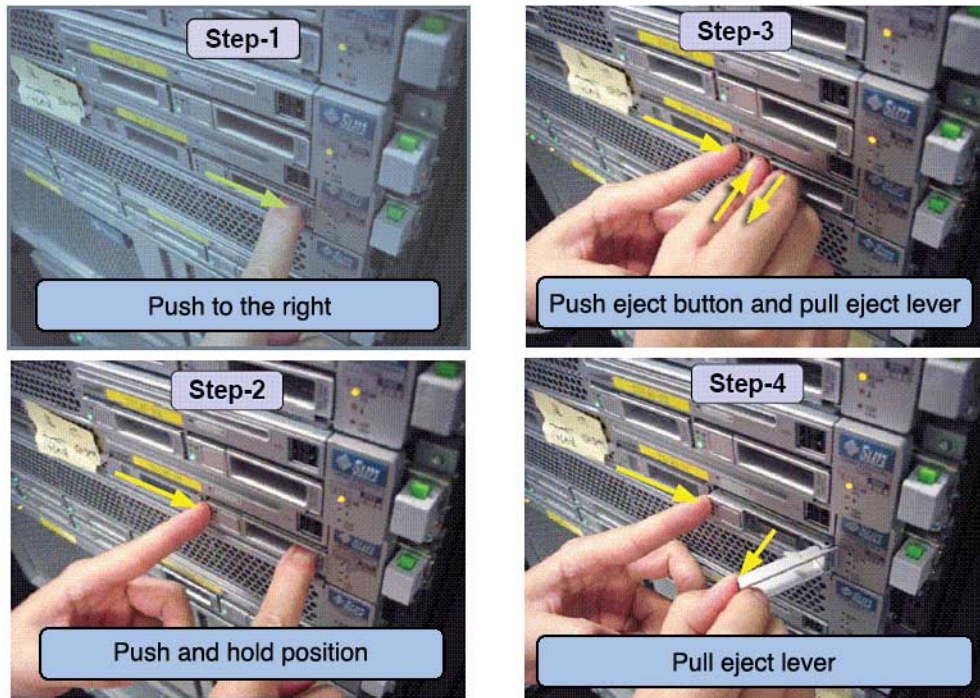
- 1. Press the drive to the right. See Step 1 in the following figure.**
- 2. Push in on the drive, while holding it pressed to the right. See Step 2 in the following figure.**
- 3. Press the drive eject button and pull on the eject lever. See Step 3 in the following figure.**
- 4. Use the eject lever to slide the drive out of the bay.**

**FIGURE 1** Removing Hard Drives From Right-Side Bays
