# Sun SPARC® Enterprise M8000/M9000 Servers Product Notes

For XCP Version 1060

Part No. 820-3611-10  
November 2007, Revision A

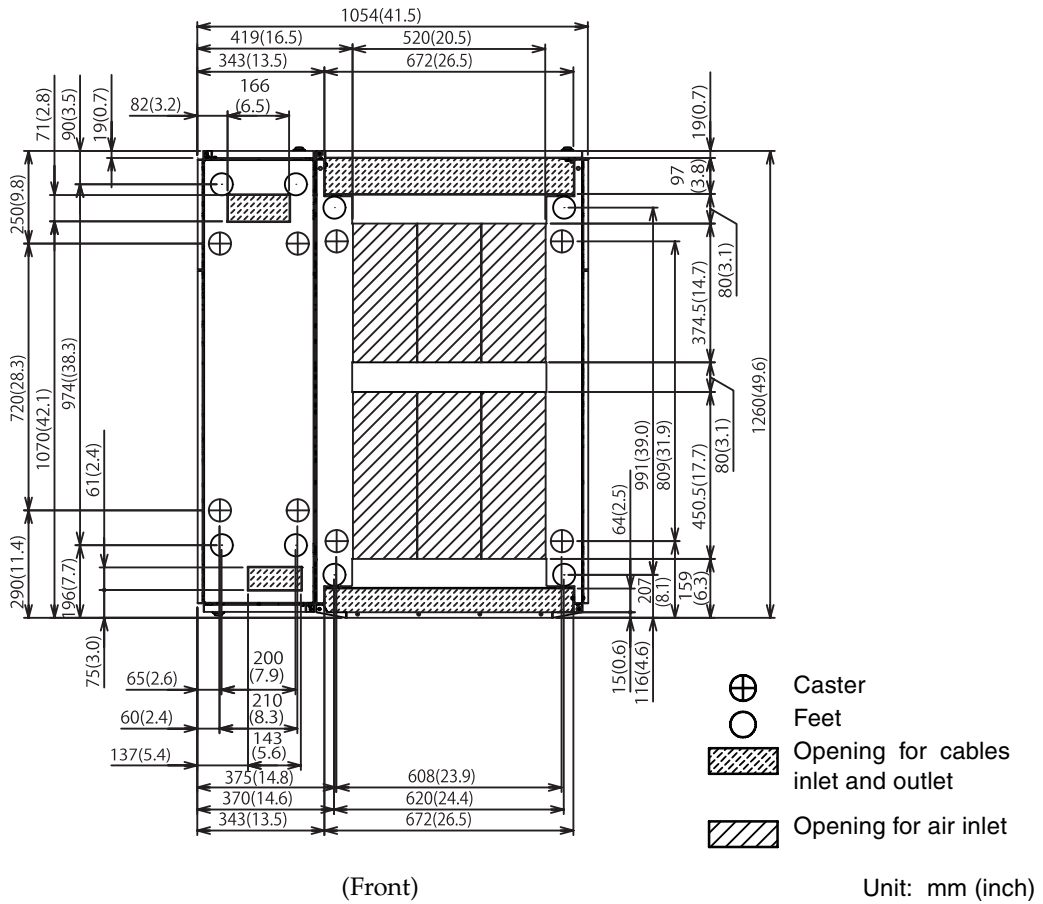
**FIGURE 1** shows the Sun SPARC Enterprise M8000 Server + Power Cabinet Bottom View.

**FIGURE 1** Sun SPARC Enterprise M8000 Server + Power Cabinet Bottom View

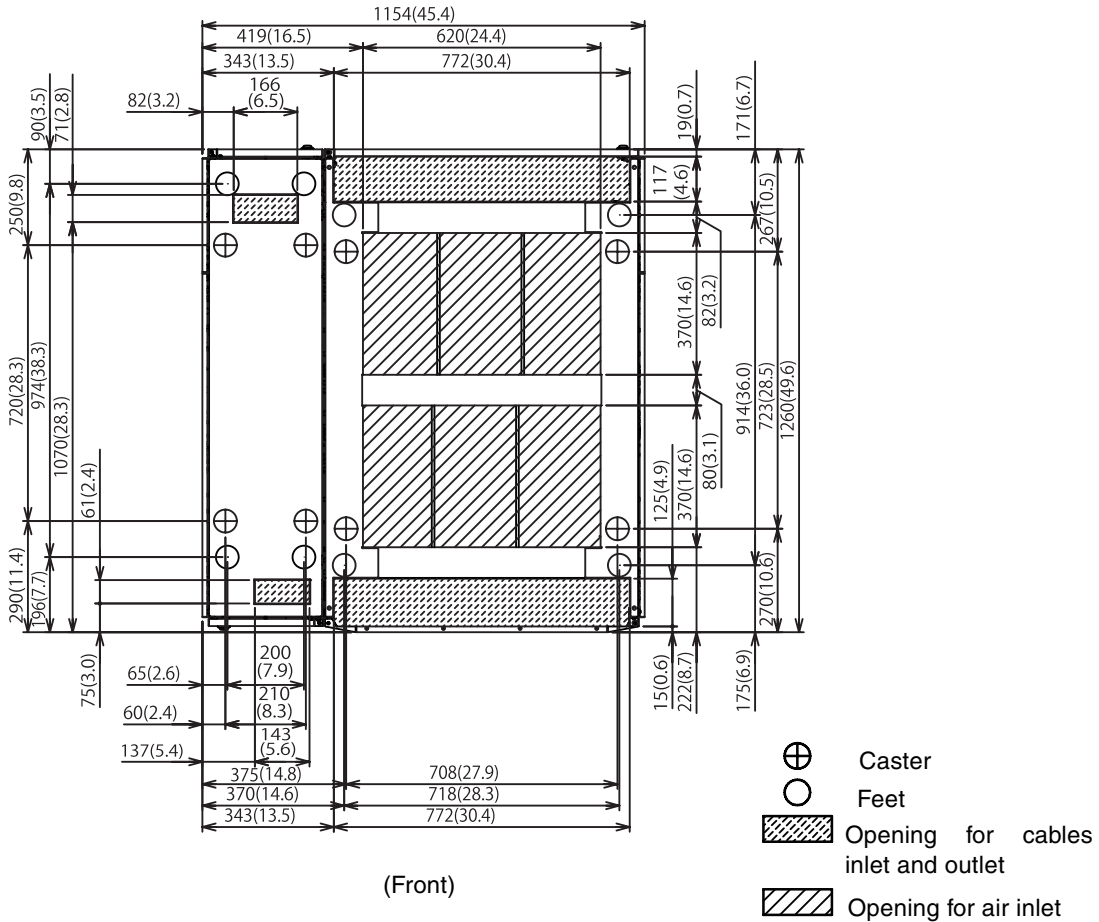
**FIGURE 2** shows the Sun SPARC Enterprise M9000 Server (Base Cabinet) + Power Cabinet Bottom View.

FIGURE 2 Sun SPARC Enterprise M9000 Server (Base Cabinet) + Power Cabinet Bottom View
