# Sun SPARC® Enterprise M8000/M9000 Servers Product Notes

For XCP Version 1081

Part No. 820-7236-11  
March 2009, Revision A

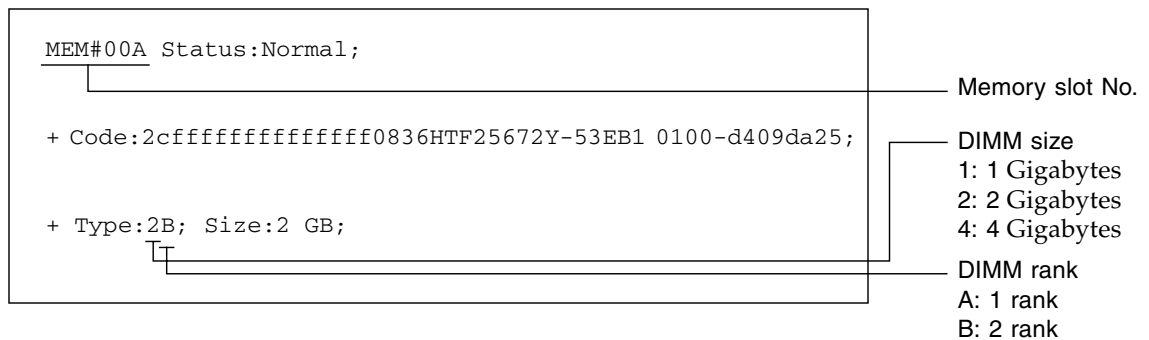
**FIGURE 6-20** Example of DIMM Information

The figure here corrects FIGURE 6-20, “Explanation of DIMM Information,” on page 6-31 in Section 6.4.2.1, “Confirmation of DIMM Information.” The corrected figure is as follows.

FIGURE 6-20 shows an example of how to read the DIMM information displayed in the Type field.

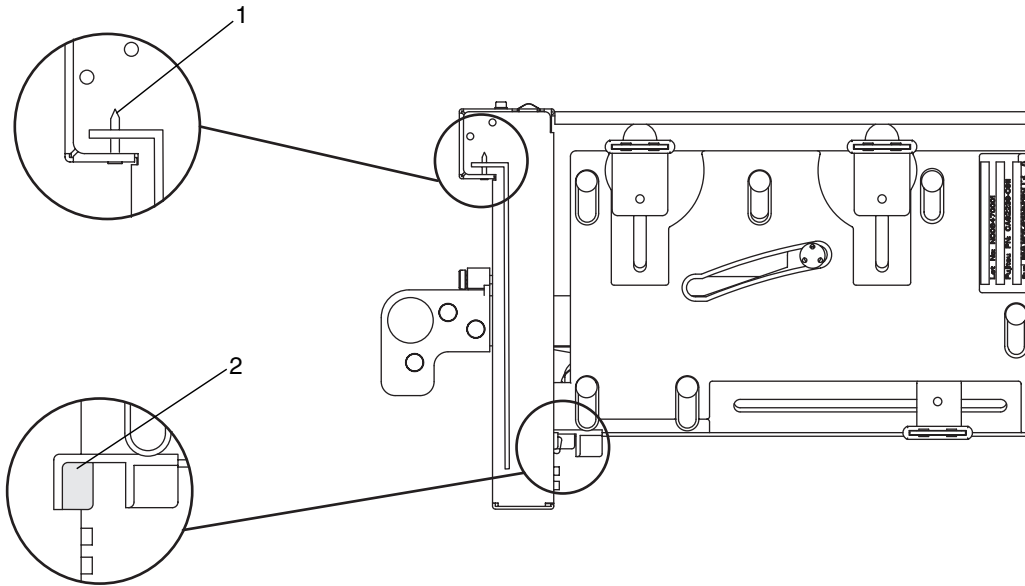
**FIGURE 13-6** Card positioning post and card positioning tab

FIGURE 13-6 shows card positioning post and card positioning tab.

Item	Description
1	Card positioning post
2	Card positioning tab

The post (item 1 in FIGURE 13-6) is seated in the notch of the bracket of the PCI card. If the post is not properly seated in the notch, the mounting bracket of the card may be bent and the card may end up being affixed in an inclined position on the PCI cassette. If a card is affixed in an inclined position, it will not be in proper electric contact with the socket on the IOU.

The tab (item 2 in FIGURE 13-6) fits in the notch on the lower part of the PCI card. This tab is helpful in positioning the card when it is mounted on the PCI cassette (however, some types of cards do not have the notch).

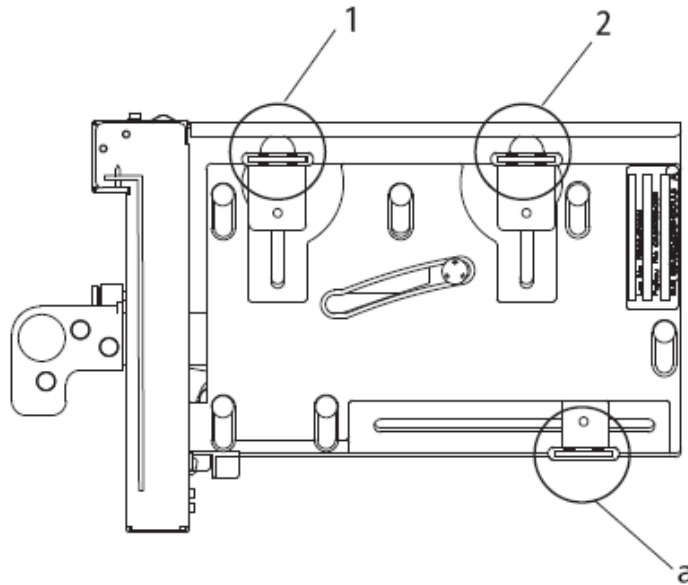
**FIGURE 13-8** Sequence of Fixing the PCI Card in Position

To shift the location of the bottom screw for the PCI card, first secure the card at the lower latch (part a in FIGURE 13-8). Then, tighten the fixing screws in the sequence shown in FIGURE 13-8 to fix the card in position.

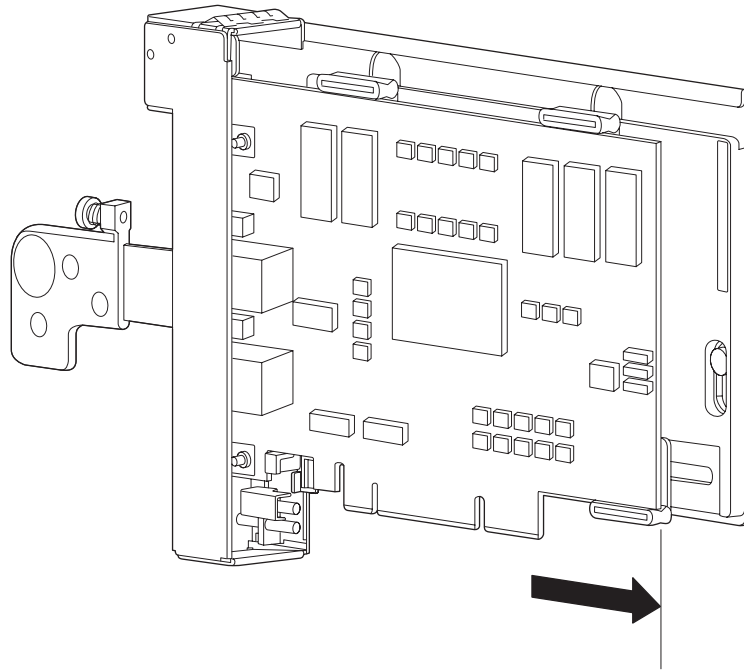
**FIGURE 13-9** Latch Positions at the Bottom of the Cassette

**Note** – To ensure that the PCI card is properly mounted, you need to confirm that the PCI card base is properly centered at the latches and securely fastened in position (FIGURE 13-9 reference).

**Caution** – If the card is short, move the screw at the bottom of the cassette as required. In such cases, place the latches as close as possible to the far end of the card.
