Sun StorEdge™ 6920 System Release Notes

Release 2.0.5

Part No. 817-5229-14
May 2005, Revision A

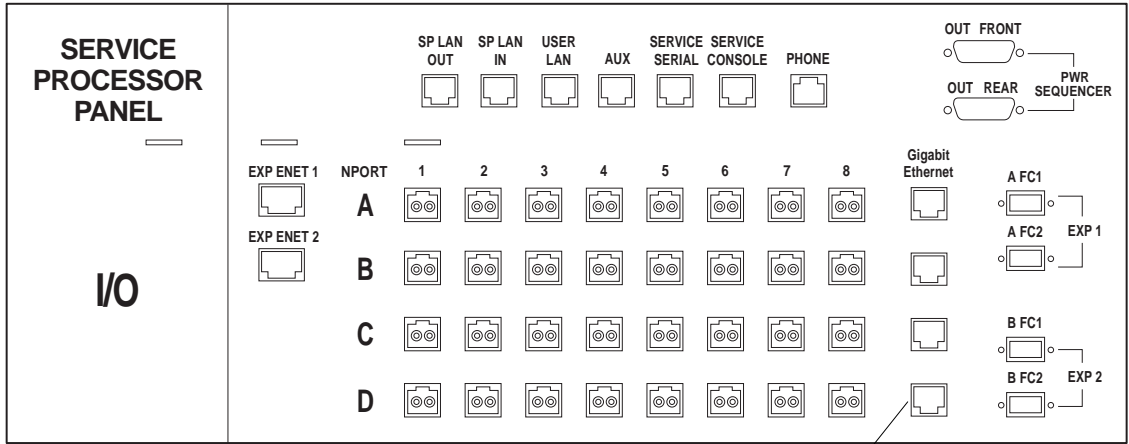
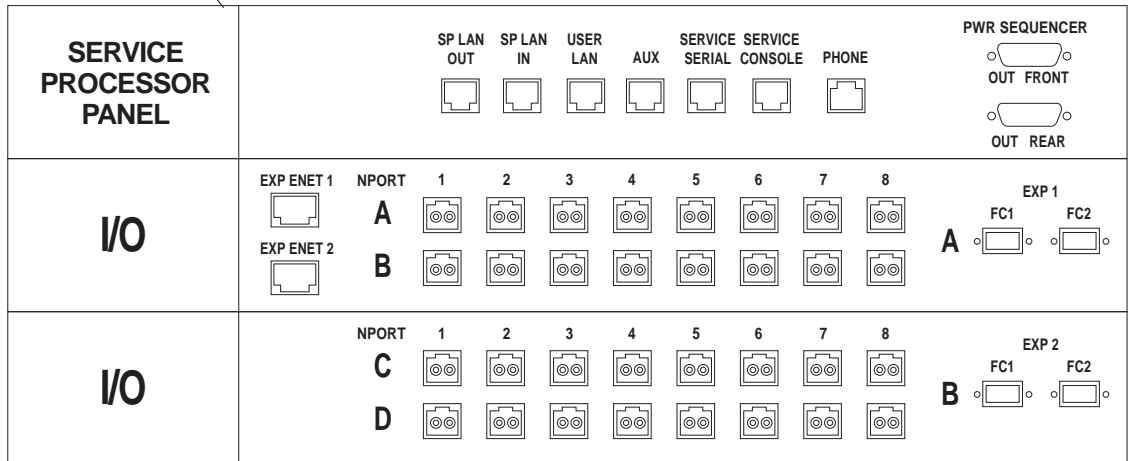
FIGURE 1 The New and Original Service Panels

The Sun StorEdge 6920 system documentation shows the original service panel design, which is shown in FIGURE 1. However, all Sun StorEdge 6920 systems have been shipped with a new design, as shown by the top unit of FIGURE 1.

Original design

New design

Four new gigabit Ethernet ports

The service panel of the base cabinet 0 has two sets of Fibre Channel ports (EXP 1 and EXP 2) to connect to the expansion cabinets (see FIGURE 1). The service panel of the expansion cabinet has redundant FC ports (see FIGURE 2).

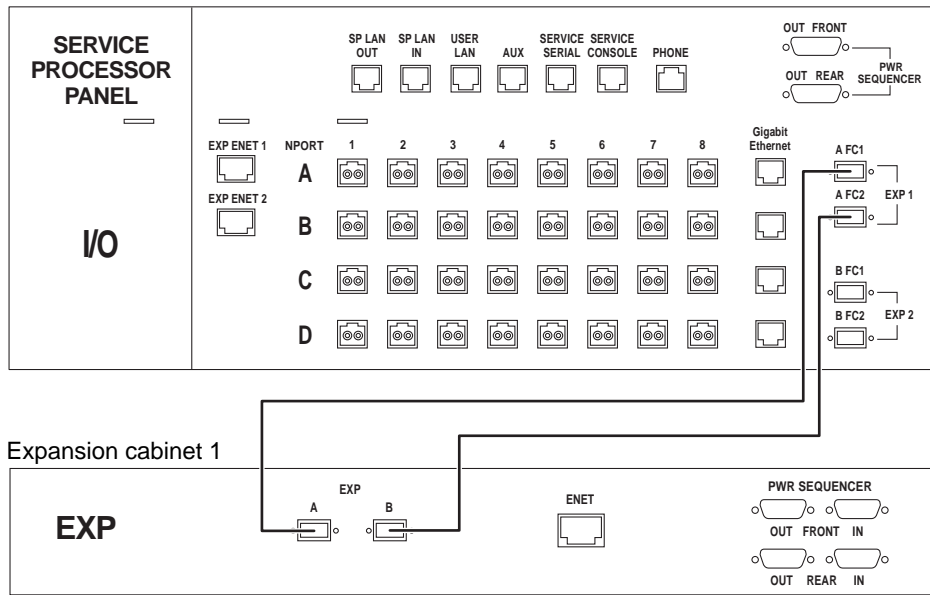
FIGURE 3 FC Cabling Between a New Service Panel of the Base Cabinet 0 and Expansion Cabinet 1

Connect redundant Fibre Channel (FC) cables (part number 537-1060-01) as follows (see FIGURE 3):

- Connect port EXP 1 A FC1 of the base cabinet 0 to port EXP A of the expansion cabinet 1 service panel.
- Connect port EXP 1 A FC2 of the base cabinet 0 to port EXP B of the expansion cabinet 1 service panel.

Base cabinet 0

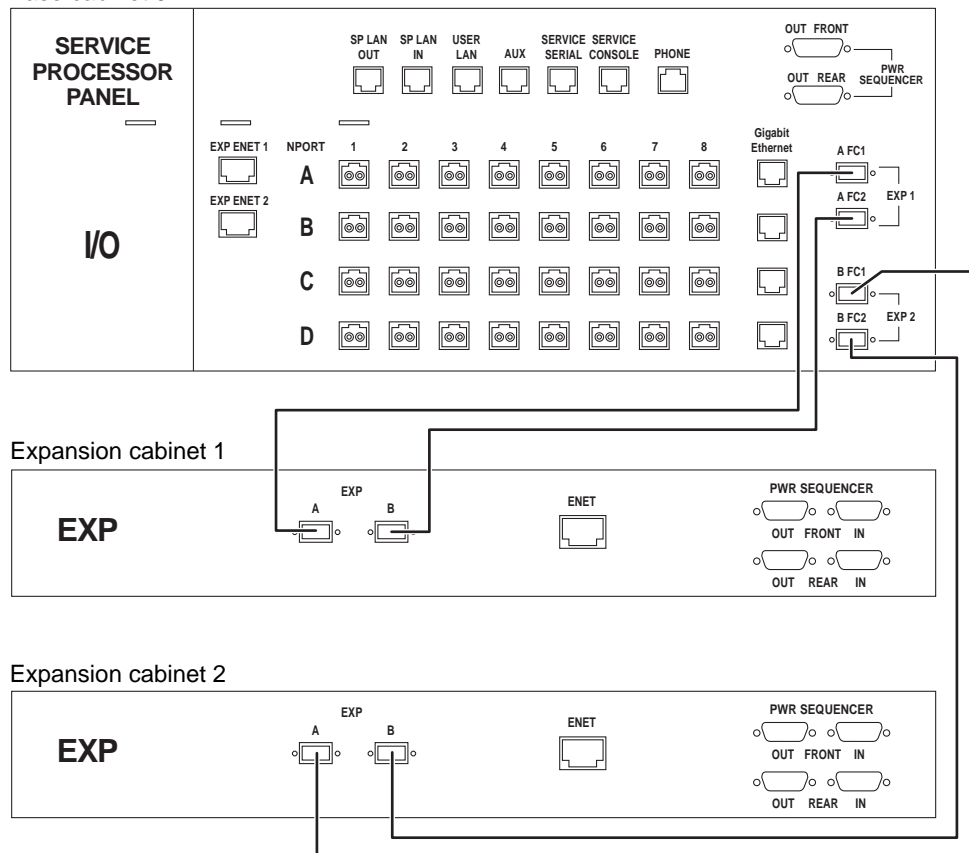
FIGURE 4 FC Cabling Between a New Service Panel of the Base Cabinet 0, Expansion Cabinet 1, and Expansion Cabinet 2

Connect redundant Fibre Channel (FC) cables (part number 537-1060-01) as follows (see FIGURE 4):

- Connect port EXP 1 A FC1 of the base cabinet 0 to port EXP A of the expansion cabinet 1 service panel.
- Connect port EXP 1 A FC2 of the base cabinet 0 to port EXP B of the expansion cabinet 1 service panel.
- Connect port EXP 2 B FC1 of the base cabinet 0 to port EXP A of the expansion cabinet 2 service panel.
- Connect port EXP 2 B FC2 of the base cabinet 0 to port EXP B of the expansion cabinet 2 service panel.

Base cabinet 0

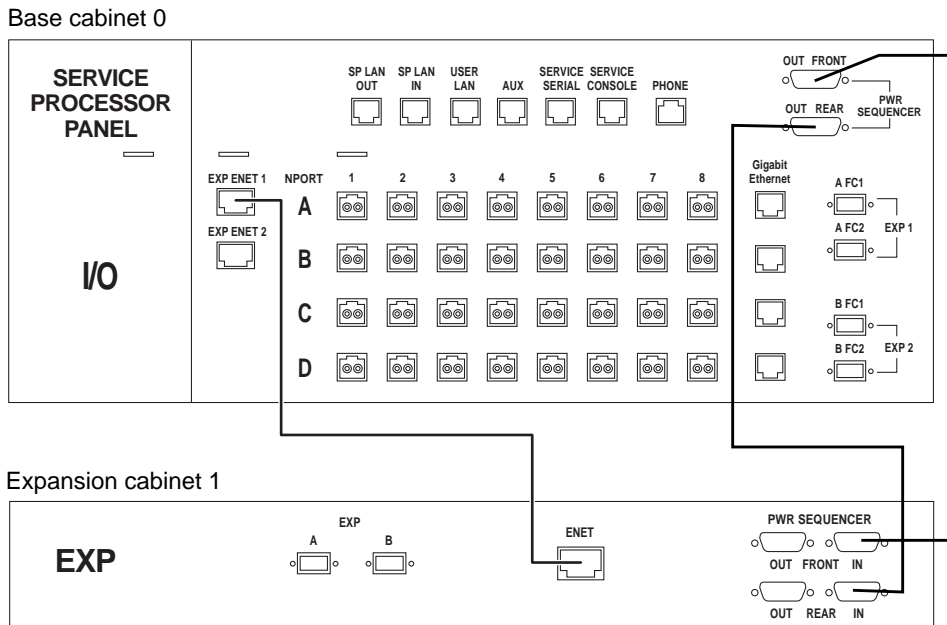
FIGURE 5 Ethernet and Power Sequencer Cabling Between a New Service Panel of Base Cabinet 0 and Expansion Cabinet 1

To connect to one or two expansion cabinets, use one or two Ethernet cables (10M RJ45/RJ45 Rollover, part number 530-3138-01) as shown in FIGURE 5 or FIGURE 6.

If you are setting up the system to enable remote power management, you must also connect two or four power sequencer serial cables (part number 530-3210-01) between the base cabinet 0 and one or both expansion cabinets as shown in FIGURE 5 or FIGURE 6.

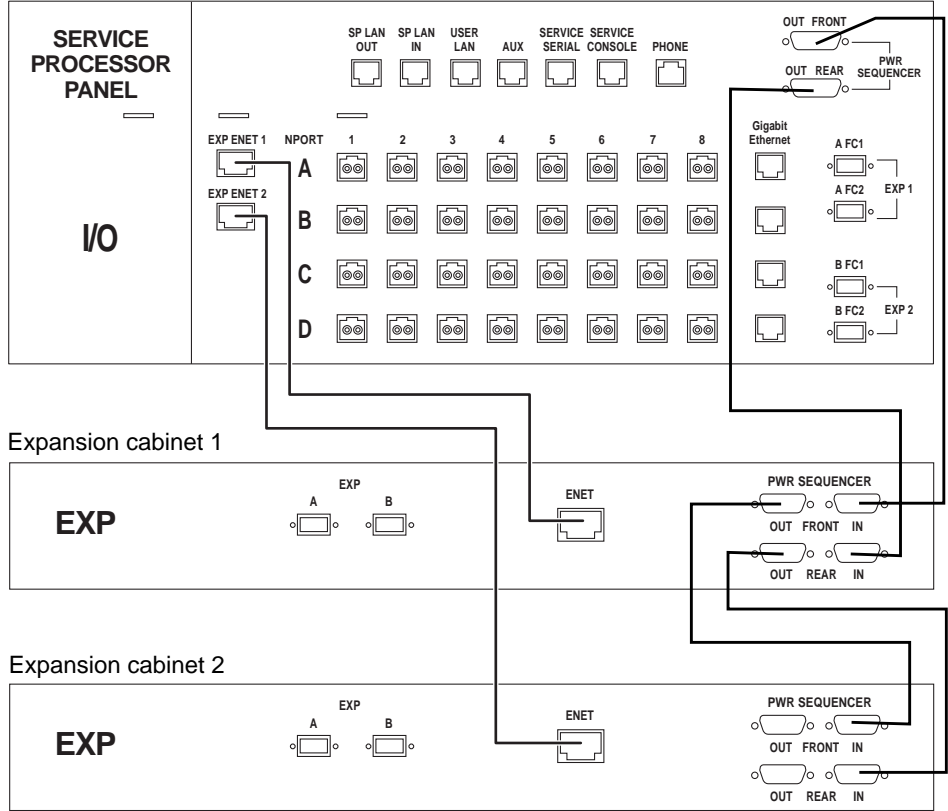
FIGURE 6 Ethernet and Power Sequencer Cabling Between a New Service Panel of Base Cabinet 0, Expansion Cabinet 1, and Expansion Cabinet 2

Base cabinet 0

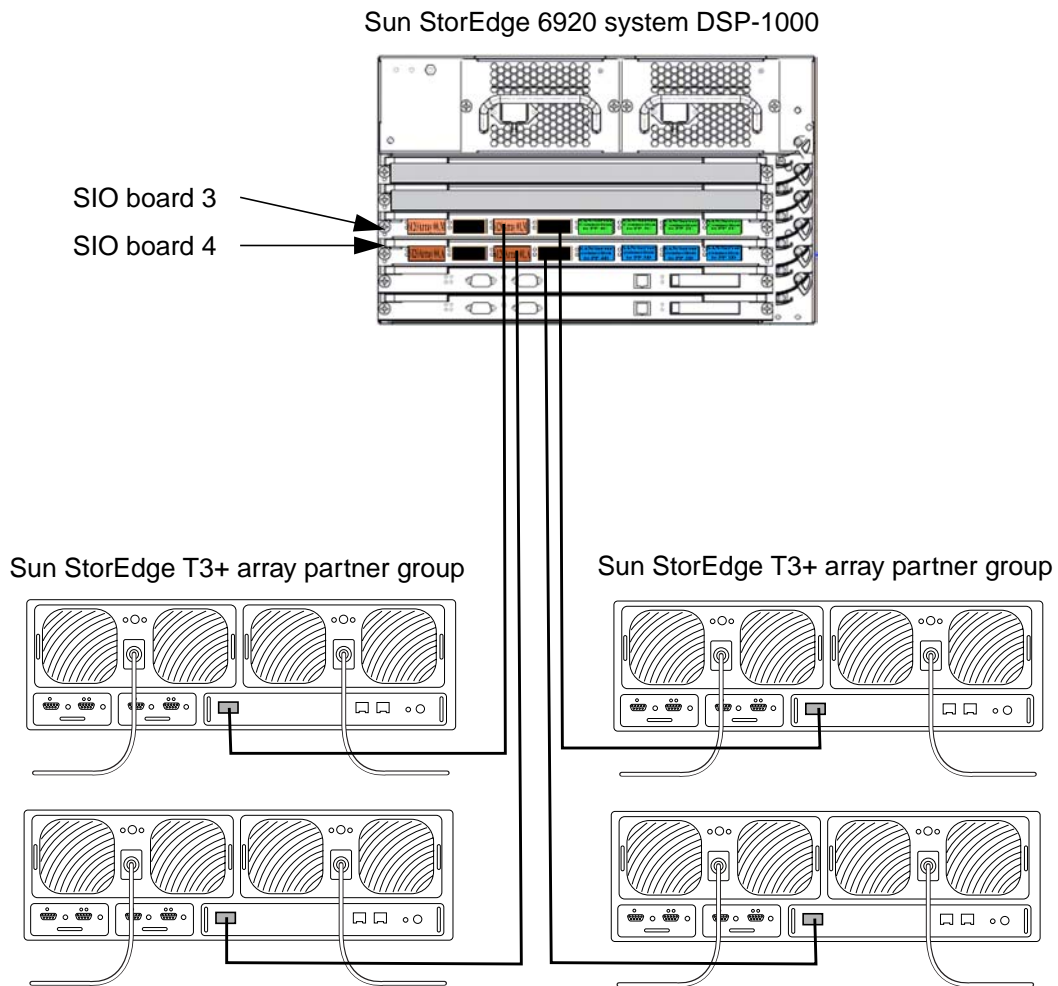
FIGURE 7 Cable Connections Between the DSP-1000 and T3+ Array Partner Groups in a Sun StorEdge 6920 Base Cabinet 0

1. Install the Sun StorEdge T3+ array partner groups as explained in the *Sun StorEdge T3 Cabinet Installation Guide, 806-7979-xx*.
2. Connect the LC Fibre Channel connector end of a cable from the cable set 537-1035-01 (four cables) to the Sun StorEdge T3+ arrays and the SC Fibre Channel connector end to the DSP-1000, as shown in FIGURE 7.

- g. The SC end of the cable labeled “DSP to Array-03 (M)” to the DSP-1000 port 5 board 3.
 - h. The SC end of the cable labeled “DSP to Array-03 (A/M)” to the DSP-1000 port 5 board 4.

Note – The Sun StorEdge T3+ arrays are not connected to the Sun StorEdge 6920 system Ethernet/Storage Service Processor infrastructure. They use an independent Ethernet.
