SANtricityTM Storage Manager

Product Release Notes for Version 8.33

AQ13282-E1, First Edition

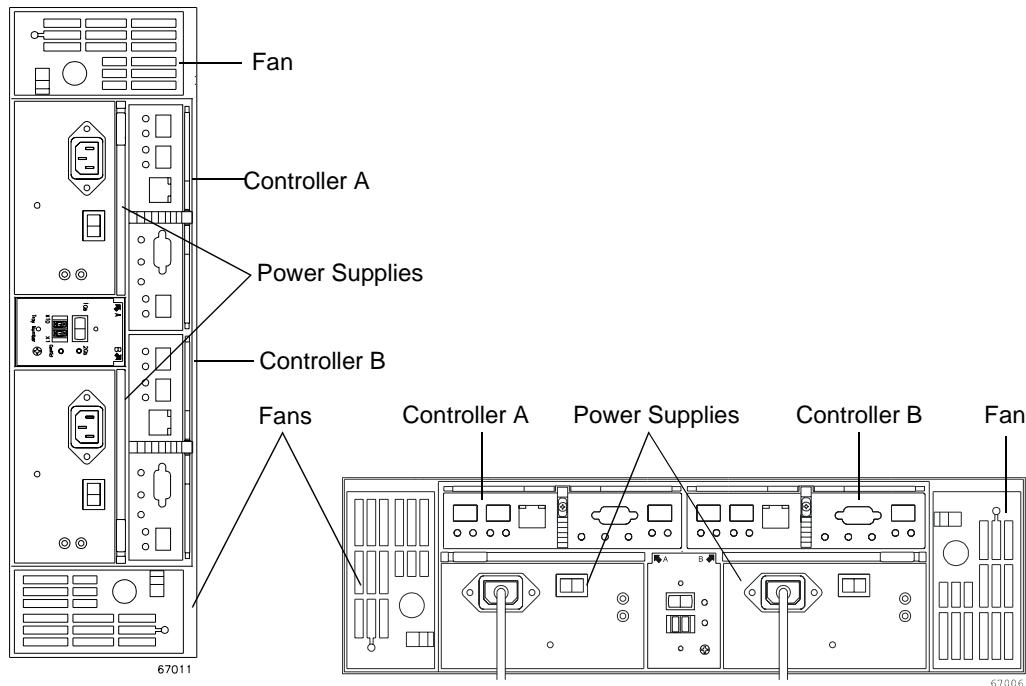
Figure 1-1 Back View of an D240 Array Module

For a D240 array module in a deskside configuration, the controller must be in the top slot. In a rackmount configuration, it must be in the left slot ([Figure 1-1](#)).

Figure 1-1. Back View of an D240 Array Module 1-4

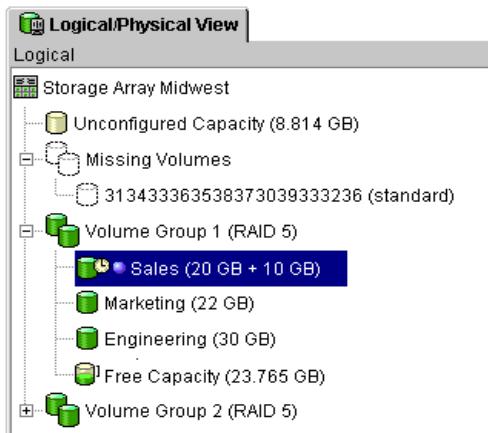
Figure 2-1 DVE Modification Operation in Progress

During the modification operation, the volume having its capacity increased shows a status of Operation in Progress, together with its original capacity and the total capacity being added. After the increase in capacity is completed, the volume's expanded capacity is displayed, and the final capacity for the Free Capacity node involved will show a reduction in capacity. If all of the free capacity is used to increase the volumes size, then the Free Capacity node involved will be removed from the Logical View.

Figure 2-1. DVE Modification Operation in Progress 2-3
