# Sun Storage 6180 Array Release Notes

Release 6.6

Part No. 821-1428-10  
March 2010, Revision A

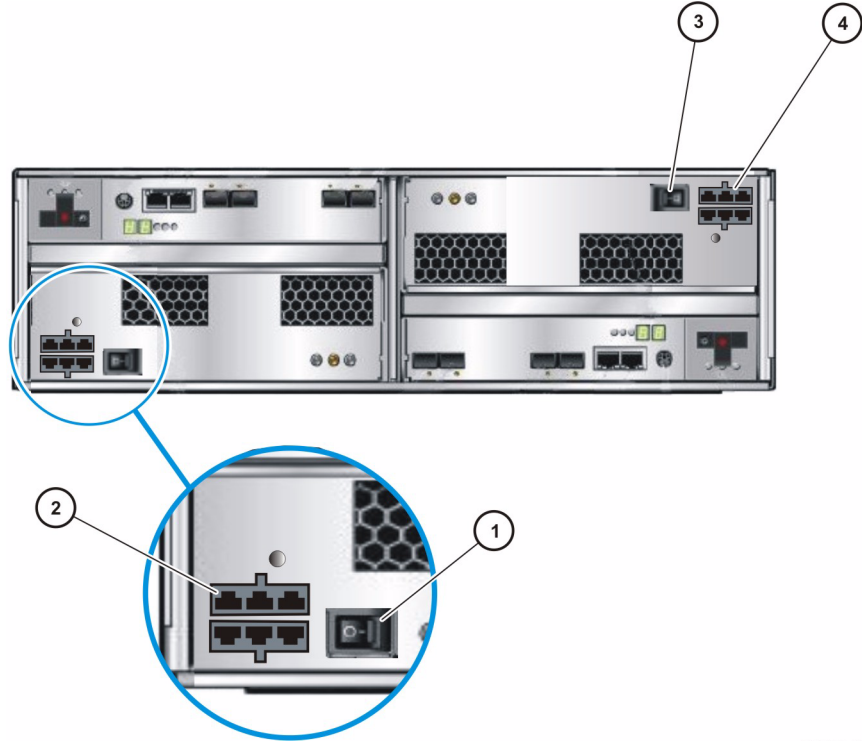
**FIGURE 1** Sun Storage 6180 Array DC Power Option (Rear)

Correction—[FIGURE 1](#) shows the location of the DC power connector and DC power switch at the back of each controller.

Power Supply B		Power Supply A	
1	DC power switch	3	DC power switch
2	DC power connectors	4	DC power connectors
