StorageTek 2500 Series Array

Release Notes, Release 6.9.x Update

Part No.: E39437-01
March 2013

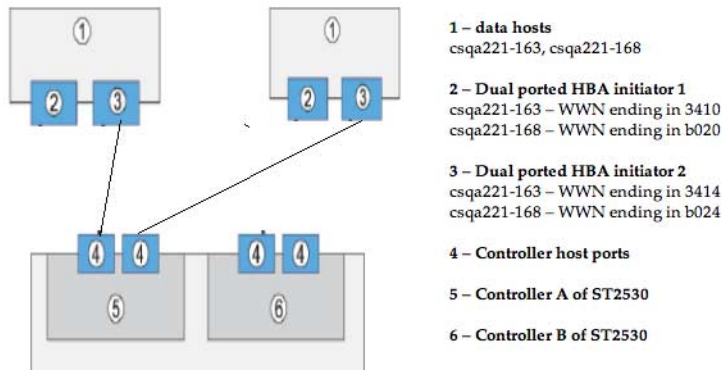
FIGURE A-1 Topology of the 2530 array when connected to data hosts

The StorageTek 2530 Array, if configured for SAS single path, does not have these capabilities. There is no utility to correlate the connections between initiators, HBA ports and controller ports. You have to plan the topology prior to configuring single path connections.
