# hp ultrium tape drives technical reference manual

## generation 2 SCSI drives

### volume 1: hardware integration guide

*Part Number:* C7379-90900 Volume 1

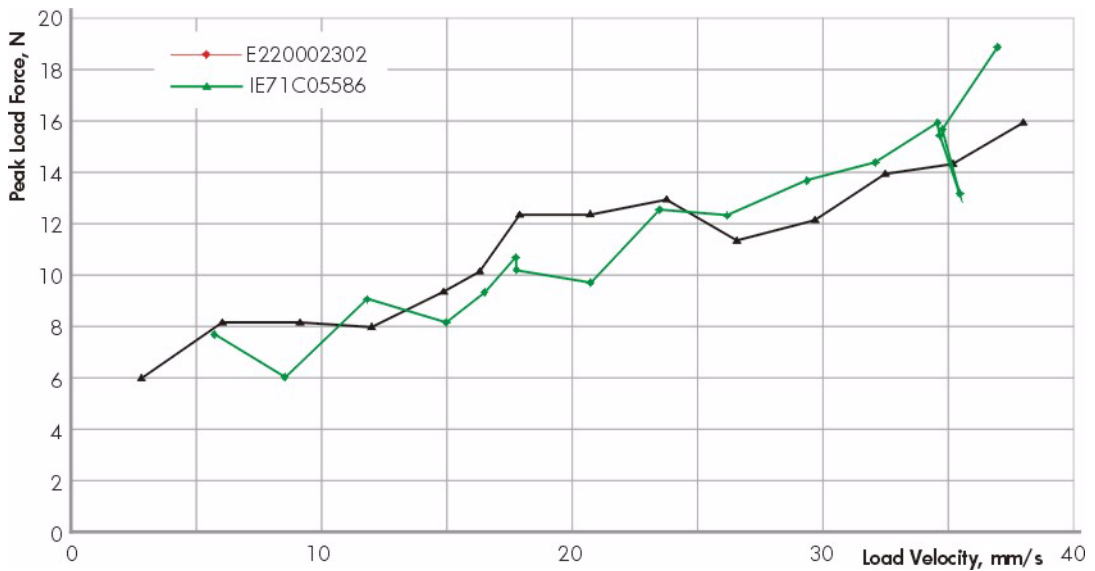
- 3 The library sends an ACI Unload command to eject the cartridge.
- 4 The drive ejects the tape to Eject Point.
- 5 The picker takes the cartridge from drive and places it in its storage slot.
- 6 Load Forces
- 7 The unload force is 4.45N maximum. The peak load force varies according to the speed at which the cartridge is inserted into the drive. The peak load force occurs when the cartridge begins to accelerate the drive carrier and only lasts for a short time. The following graph plots two examples of peak load force against load speed:

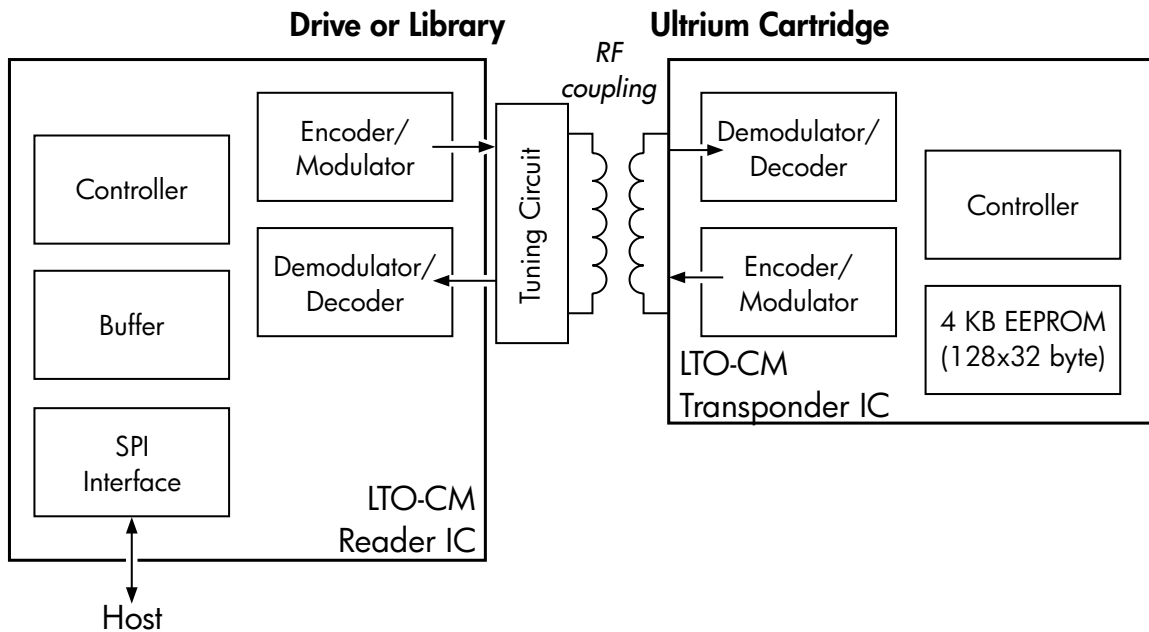
## Use in Libraries

Cartridge memory offers possibilities for use in libraries as an adjunct to or replacement for barcodes. The following diagram shows the architecture required. HP is working to provide a standard module with this functionality via a third party.

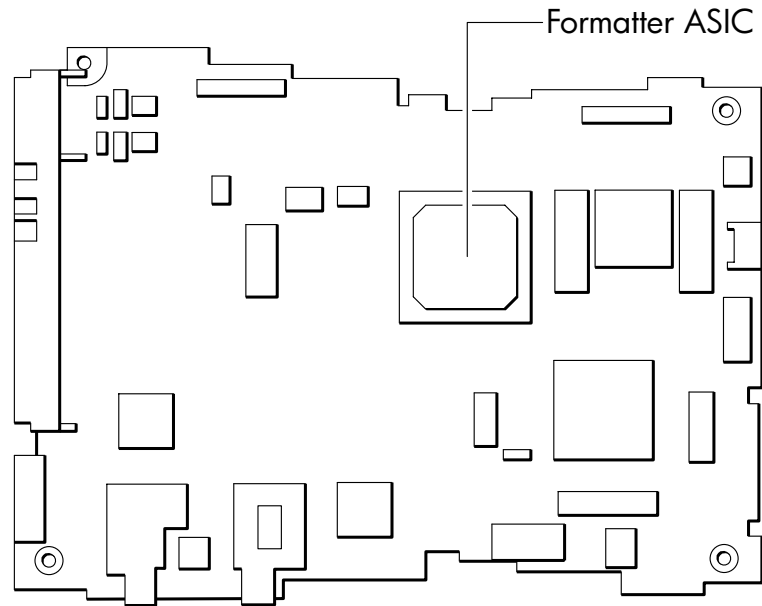
heat-sinks  
removed

The most accessible place to measure internal temperatures to ensure that airflow is adequate is the case lid of the Formatter ASIC (U6):

Use a properly-applied, thermally-conducting epoxy adhesive to attach the thermocouple in order to ensure that the case-lid temperature measurements are accurate.

Start the drive stream-writing for a period of at least one hour, monitoring component U6 case lid temperature during the write operation. Monitor also the ambient air temperature.
