**SPARC Enterprise M3000/M4000/M5000/
M8000/M9000 Servers**

Product Notes for XCP Version 1115

Part No.: E40564-03
April 2014

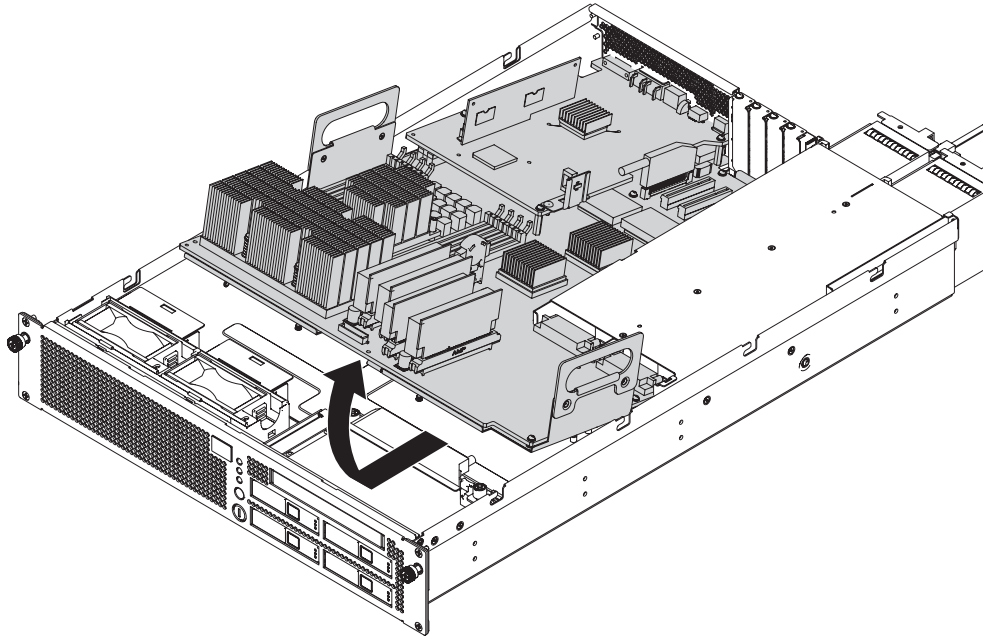
Daughter Card Installed on the MBU_A

The figure below replaces Figure 6-5 in the *SPARC Enterprise M3000 Server Service Manual*. This corrected figure shows the daughter card installed on the MBU_A.

Title	Page Number	Update
<i>SPARC Enterprise M3000 Server Service Manual</i>	B-1	Table B-1 "FRU List" Footnote should be added: "Do not remove or swap non-FRU components such as MEMR and DDCs as this interferes with the repair depot's ability to diagnose and repair field returns." Figure 6-5 is corrected to show daughter card installed on the MBU_A.

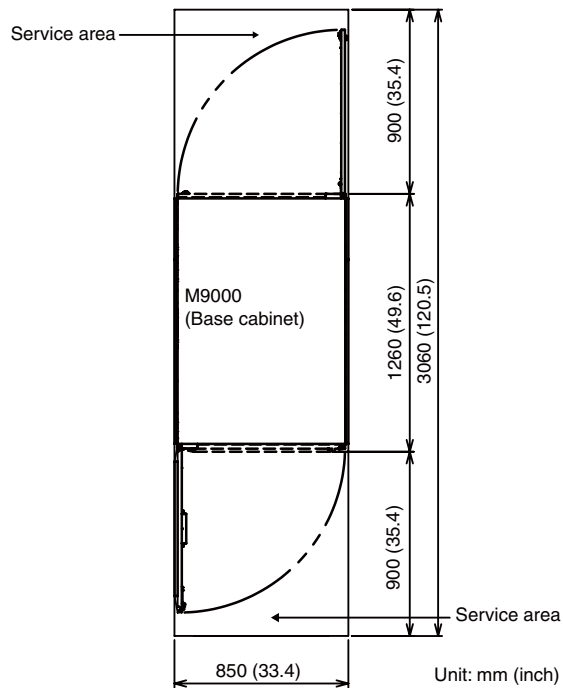
Figure 1-13 shows the M9000 server (base cabinet) installation area.

In the *SPARC Enterprise M8000/M9000 Servers Site Planning Guide*, Figures 1-13 – 1-16 required a correction to the metric conversion, 3060 mm (120.5 in.). The following illustrations show the corrected metric conversions.

<i>SPARC Enterprise M8000/M9000 Servers Site Planning Guide</i>	3-22	FIGURE 3-9, A warning label was attached to an M9000 server AC section to indicate a change in the terminal connection sequence.
	1-18- 1-21	FIGURES 1-13 – 1-16 have corrected metric conversion: 3060 mm (120.5 in.).
<i>SPARC Enterprise M8000/M9000 Servers Installation Guide</i>	3-32	FIGURE 3-28, A warning label was attached to an M9000 server AC section to indicate a change in the terminal connection sequence.
<i>SPARC Enterprise M8000/M9000 Servers Service Manual</i>	18-10	Step 10, Additional instructions were added regarding a warning label that was attached to an M9000 server AC section.

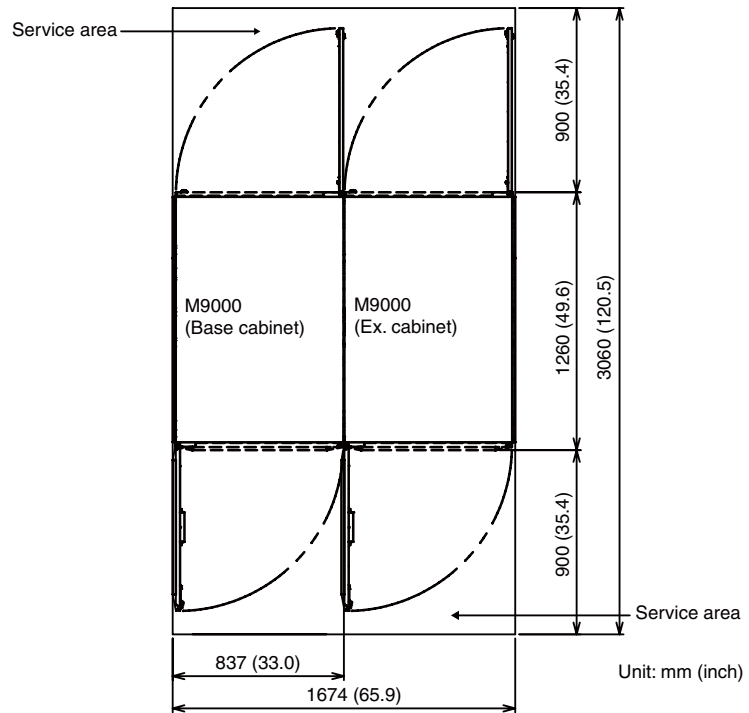
Figure 1-15 shows the M9000 server (base cabinet + expansion cabinet) installation area.

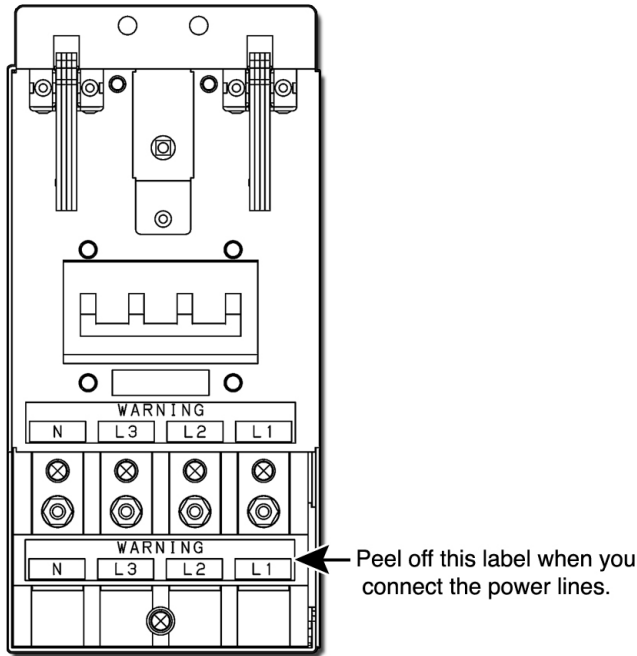
Warning Label on M9000 Server AC Section

The warning label on the AC section indicates that the terminal connection sequence has been changed. Connect in accordance with the terminal sequence described on the warning label.
