Solaris 7 11/99

Includes Additional Release Notes and
End-of-Support Statements for the Solaris 7 11/99
Operating Environment Running on Sun Hardware
Products

Part Number 806-2135-11
November 1999, Revision A

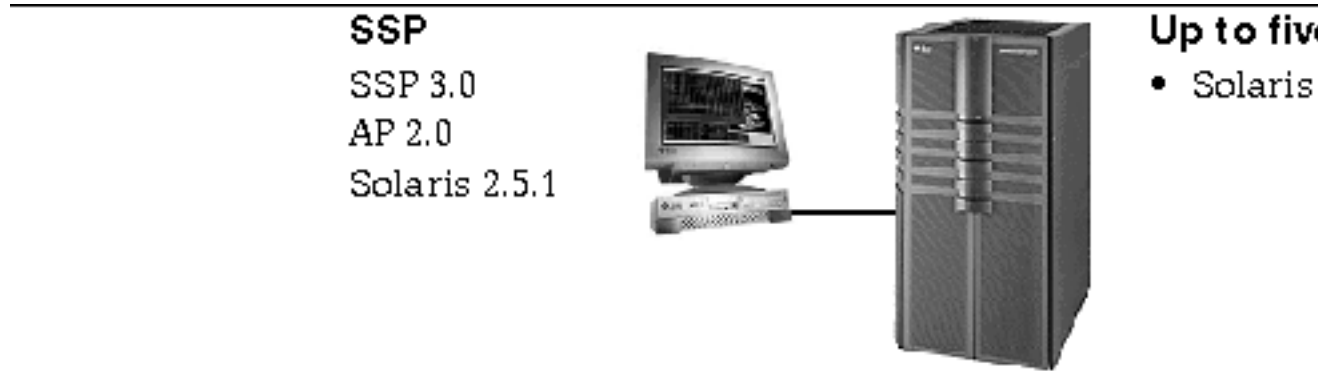
Figure 4-1 SSP 3.0, AP 2.0, and Solaris 2.5.1 on the Sun Enterprise 10000

software listed on the right of the figures. The version of the Solaris operating environment on the SSP and the version on the domain do not need to match.

Note - In the following figures, “base only” means no AP and no DR, unless otherwise noted. Mainly, “base only” refers to a domain that has only the Solaris operating environment installed. In addition, some of the scenarios below are possible only if you install a patch, or a set of patches, on the SSP or on the domain. For more information about what patch, or patches, refer to the patch descriptions at <http://sunsolve.sun.com>.

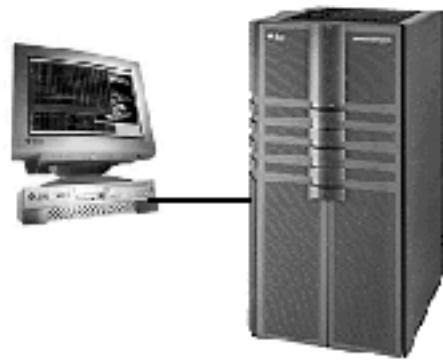
SSP
SSP 3.1*
AP 2.2
Solaris 2.5.1

* Requires
patch 105684
for Solaris 7
