Sun StorageTek™ 6540 Array Release Notes

Release 1.0

Part No. 819-6521-14
June 2008, Revision A

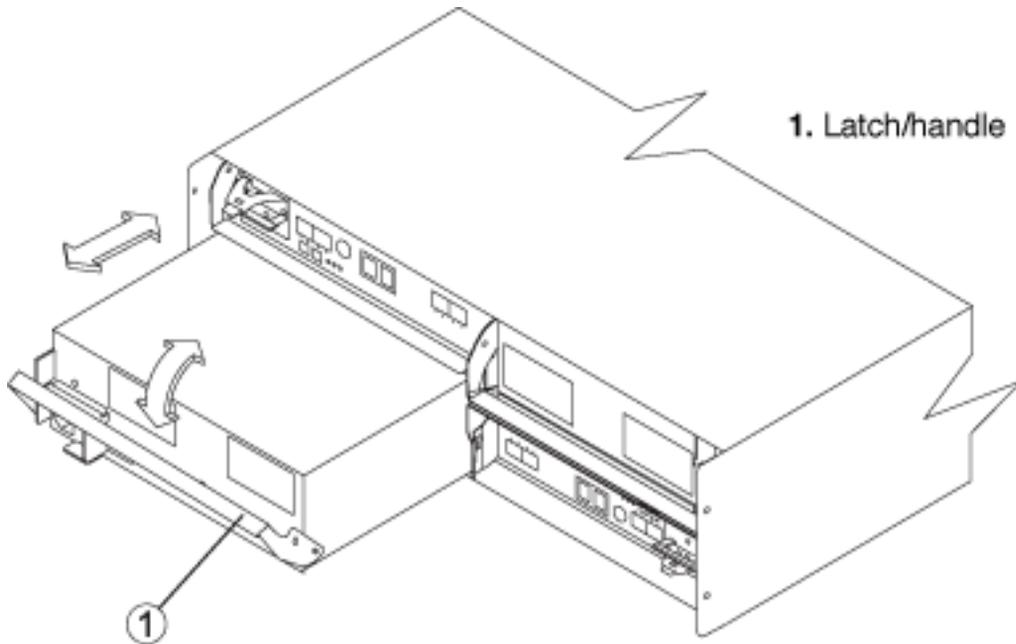
2. Push the power switch on the failed power cooling unit to the Off position.
3. Unplug the power cord from the failed power cooling unit.
4. If power cooling unit A is being replaced, lift the latch handle up to unlock the unit and pull it out of the tray. If power cooling unit B is being replaced, pull the latch handle down to unlock the unit and pull it out of the tray. [FIGURE 1](#) shows the removal of power cooling unit B.

FIGURE 1 Sample Removal of Power Cooling Unit B

5. Unpack the new power cooling unit, and save the packing materials for the failed unit. Use care when handling both the new and the failed power cooling units.
6. Ensure that the power switch on the new power cooling unit is in the Off position.
7. Insert the new power cooling unit until it connects with the midplane connector, and push the latch handle into the locked position.
8. Plug the power cord into the new power cooling unit.
9. Push the power switch to the On position.
10. The green power-fan LEDs should now be on. If this is not the case, contact your Customer Service representative.

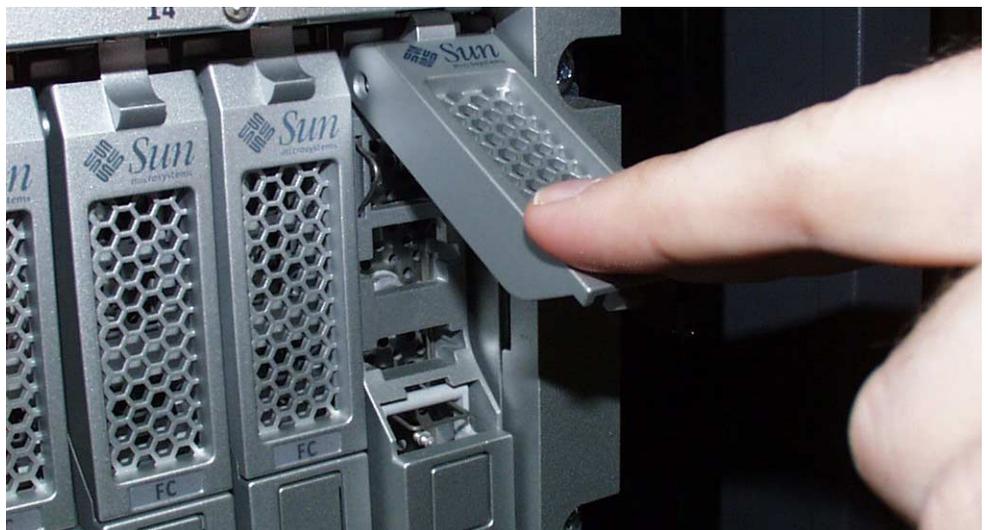
FIGURE A-1 shows a drive being inserted into the chassis the correct way.

FIGURE A-1 Inserting a Disk Drive

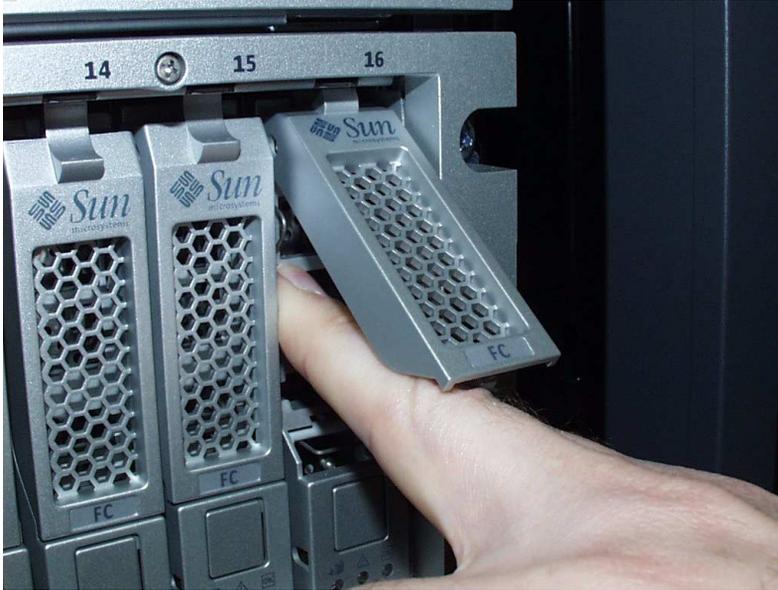
[FIGURE A-3](#) shows the wrong way to insert the drive.

FIGURE A-3 Incorrect Method of Inserting a Hard Drive

Caution – Do not insert a disk drive into a tray by pushing on its housing until it is all the way in. This can cause the handle to be stuck in the “up” position so it is unable to close.
