Sun StorageTek™ 6540 Array Release Notes

Release 6.4.1

Part No. 820-5533-10
June 2009, Revision A

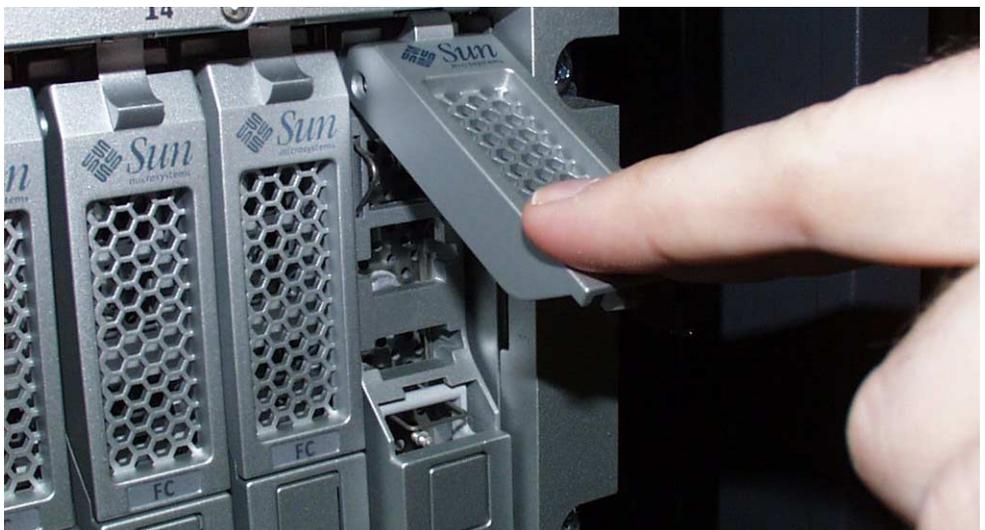
[FIGURE A-1](#) shows a drive being inserted into the chassis the correct way.

FIGURE A-1 Inserting a Disk Drive

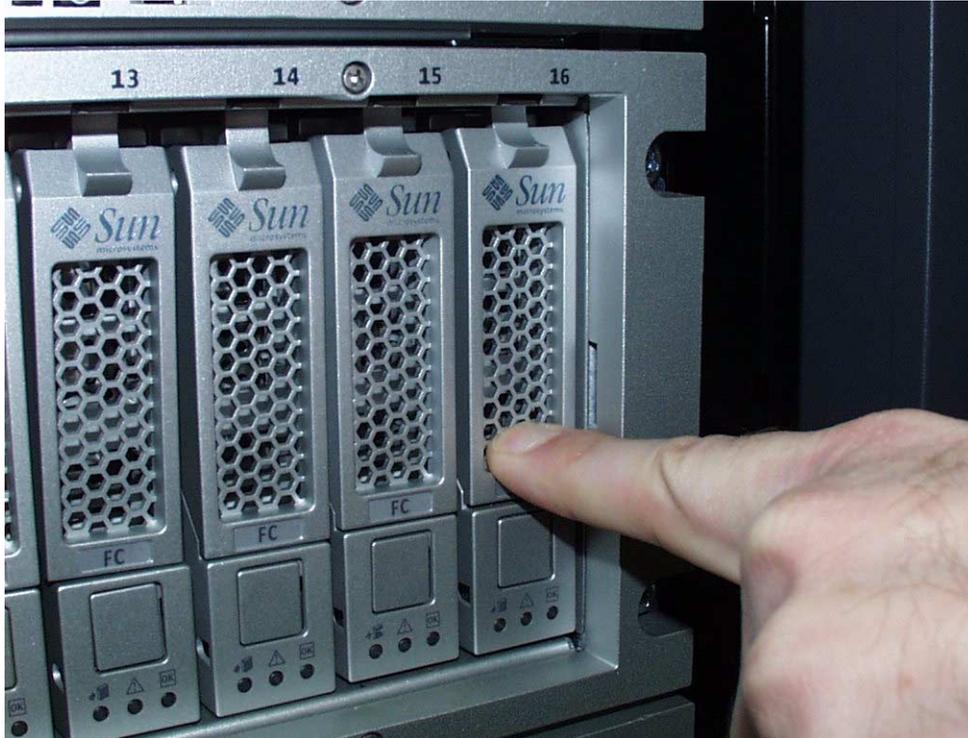
When the drive is completely installed, the drive and handle will be flush with the others, as shown in [FIGURE A-2](#).

FIGURE A-2 Successfully Inserted Disk Drive

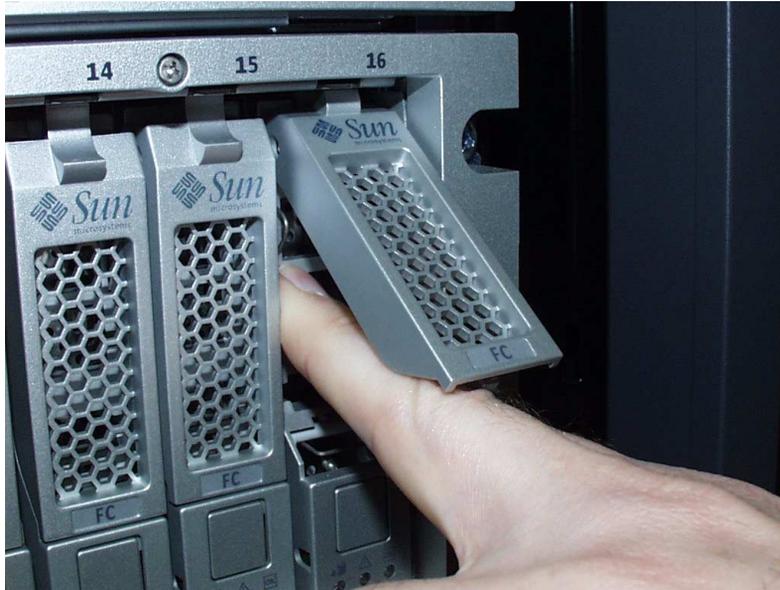
[FIGURE A-3](#) shows the wrong way to insert the drive.

Caution – Do not insert a disk drive into a tray by pushing on its housing until it is all the way in. This can cause the handle to be stuck in the “up” position so it is unable to close.

FIGURE A-3 Incorrect Method of Inserting a Hard Drive
