Sun Rack II Product Notes

Part No: E48370-11
July 2018

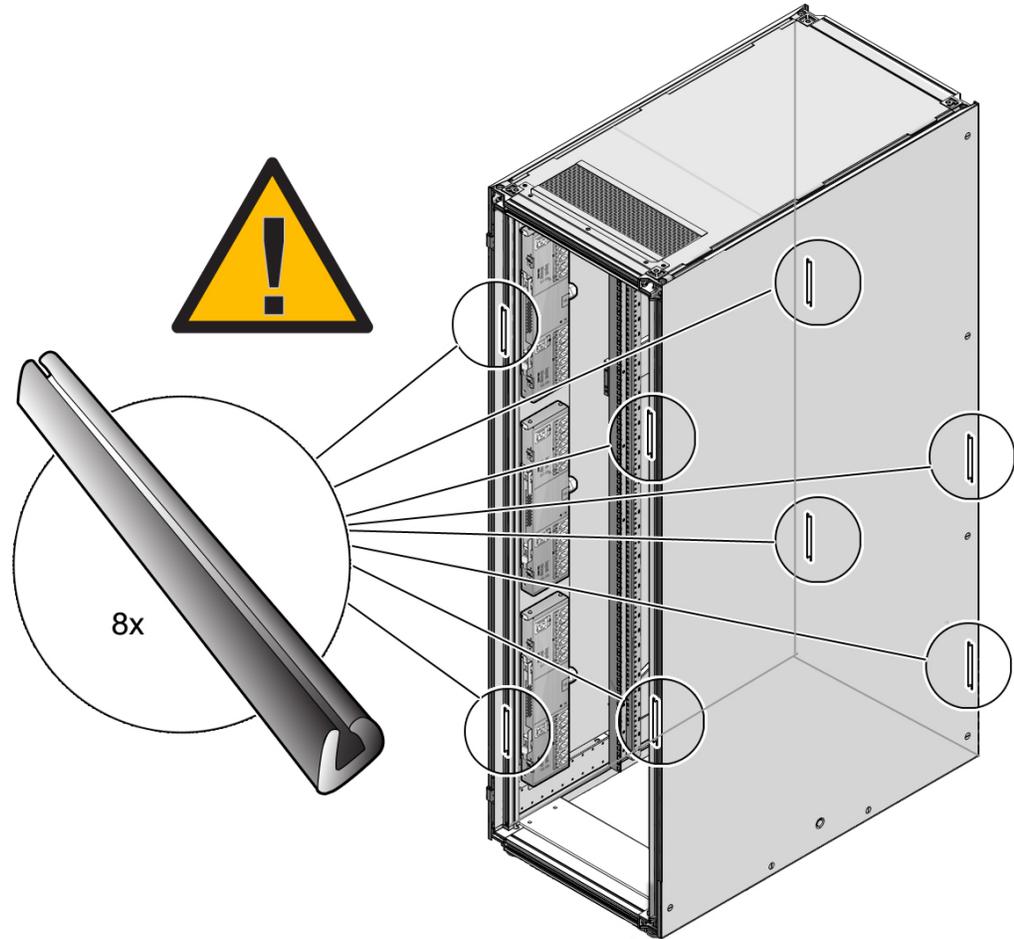
Remove and Dispose of the Plastic Bumpers That Are Shipped With the Rack

Racks are shipped with plastic bumpers installed on the rack doors. Remove and dispose of these bumpers when the rack is in its final location.
