Sun SPARC® Enterprise M4000/M5000 Servers Product Notes

For XCP Version 1050

Part No. 820-2853-11
October 2007, Revision A

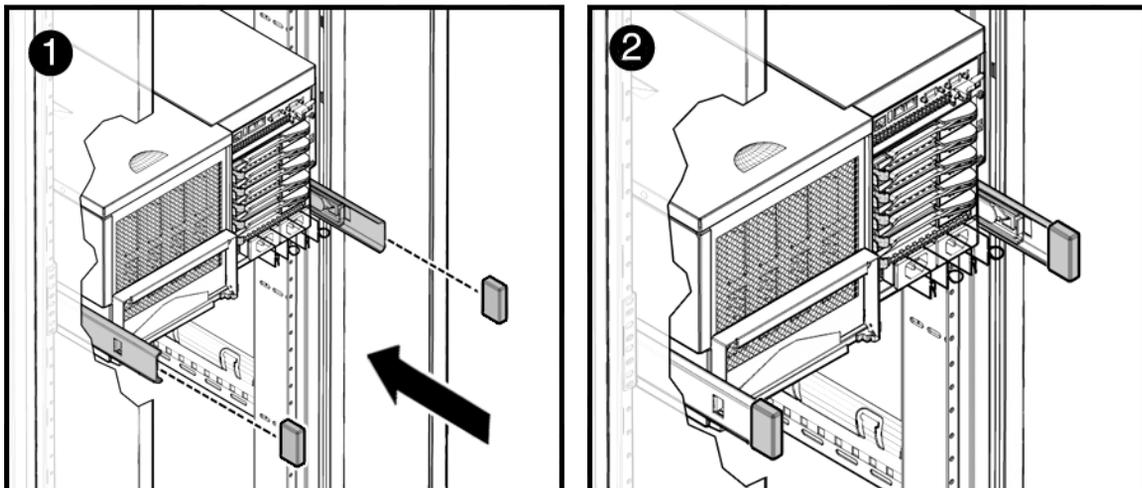
FIGURE 1 Installing End Caps on the Sun SPARC Enterprise M4000 Slide Rails

- For the Sun SPARC Enterprise M4000 server, an end cap is attached to both the right and left rear rails ([FIGURE 1](#)).
- For the Sun SPARC Enterprise M5000 server, both end caps are attached to the rails on the same side to which the CMA is not attached ([FIGURE 2](#)).

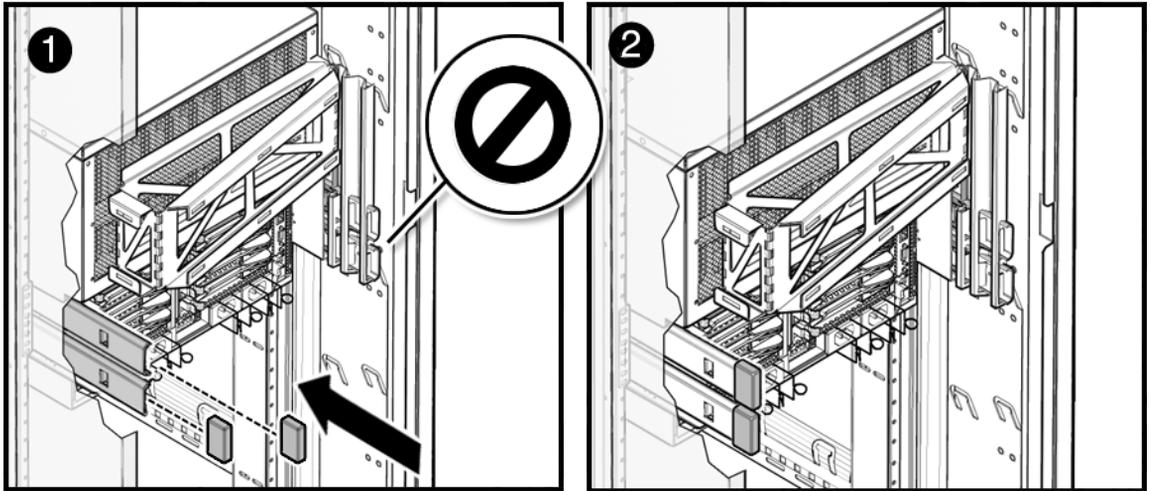
FIGURE 2 Installing End Caps on the Left Rear of the Sun SPARC Enterprise M5000 Slide Rails

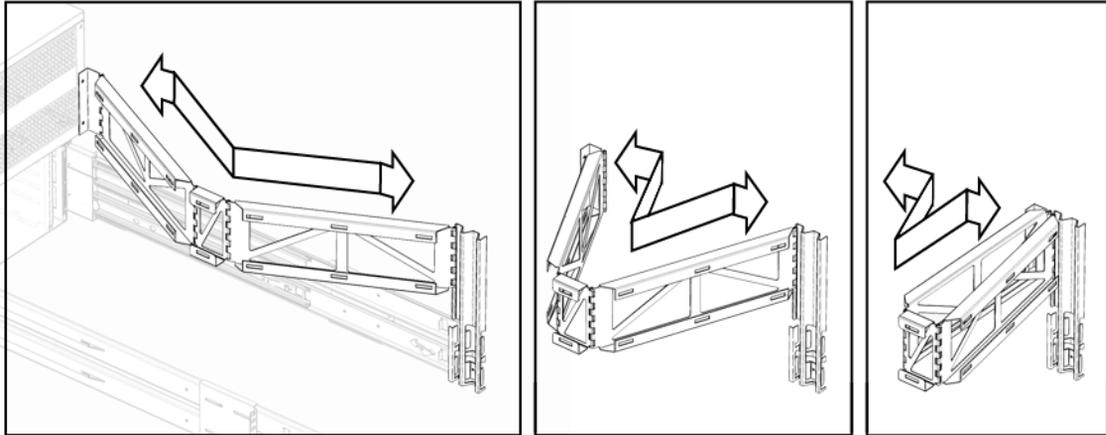
FIGURE 3 CMA Extended and Retracted on the Sun SPARC Enterprise M5000 Server

4. Run the power cables beneath the CMA and secure them in place with tie wraps. The power cables and infiniband cables should hang loosely in a service loop behind the server or the CMA might not be able to fully retract.

FIGURE 3 shows how the CMA extends and retracts.

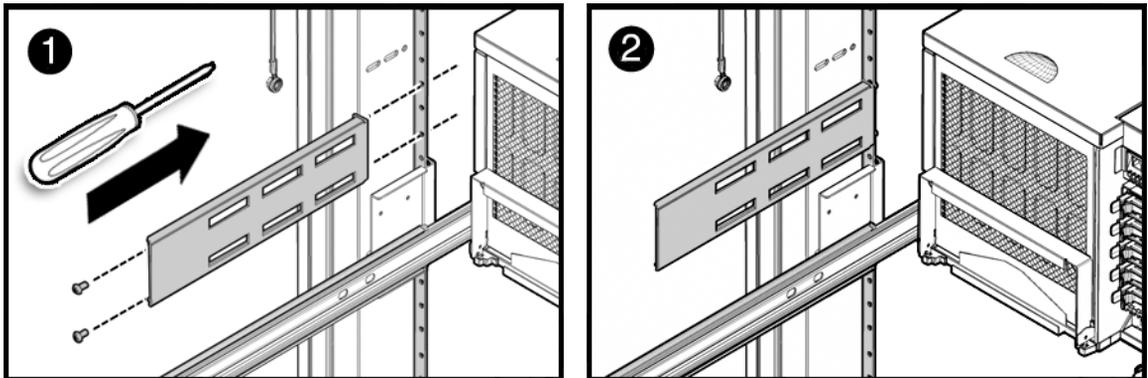
FIGURE 4 Installing the Extra Brackets in a Sun Rack 1000

1. **Extend the rack stabilizer.**
2. **Slide the server out of the rack several inches for access to the rear of the Sun Rack.**
3. **Position the cage nuts behind the threaded ears of the Sun Rack and insert the two (2) screws through the bracket and rack ear (FIGURE 4).**

4. **Twist the cage nuts onto the screws from behind the rack ears.**

The flat edges of the cage nuts should be aligned with the rack post to prevent the server from scraping against it.

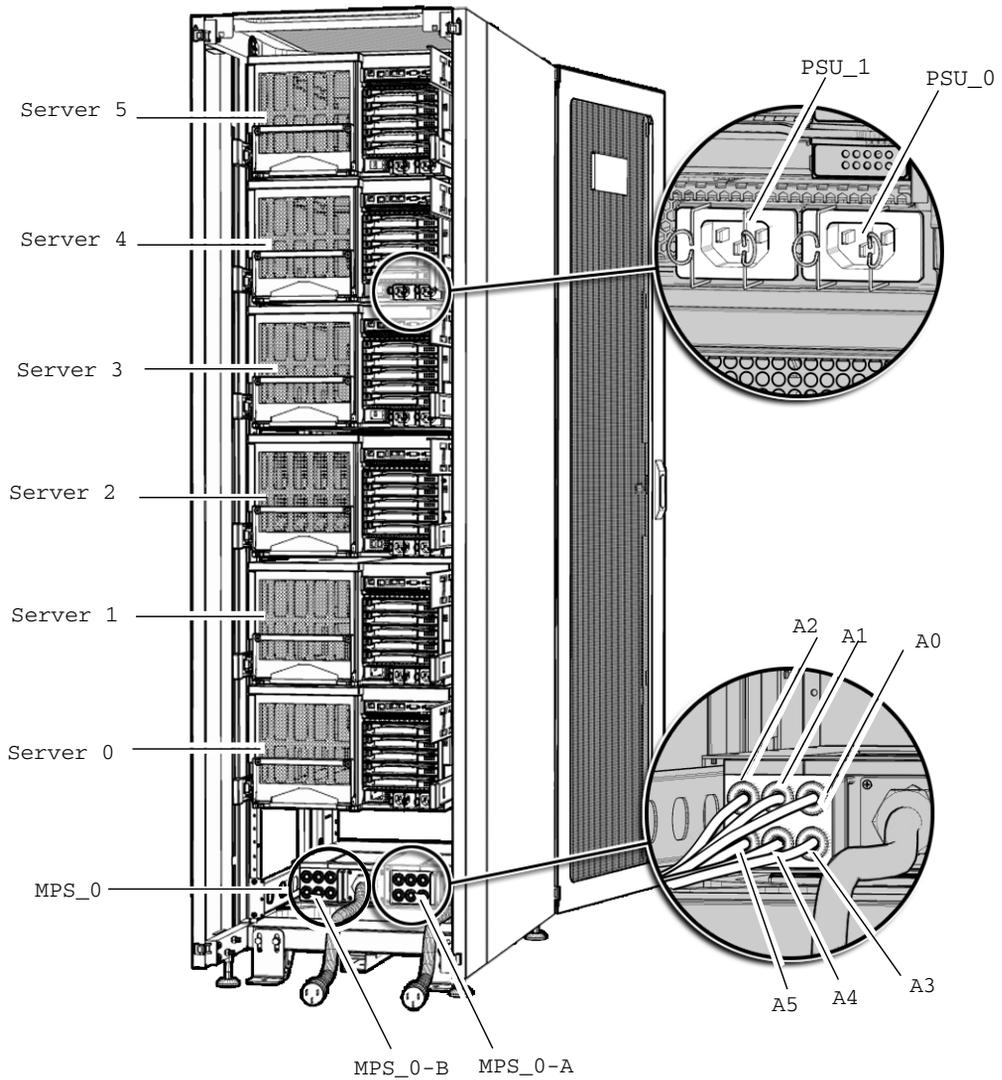
FIGURE 5 Sun Rack 1000 With Six Sun SPARC Enterprise M4000 Servers and One MPS

Note – The numbering in a Sun Rack reads from bottom to top and right to left.

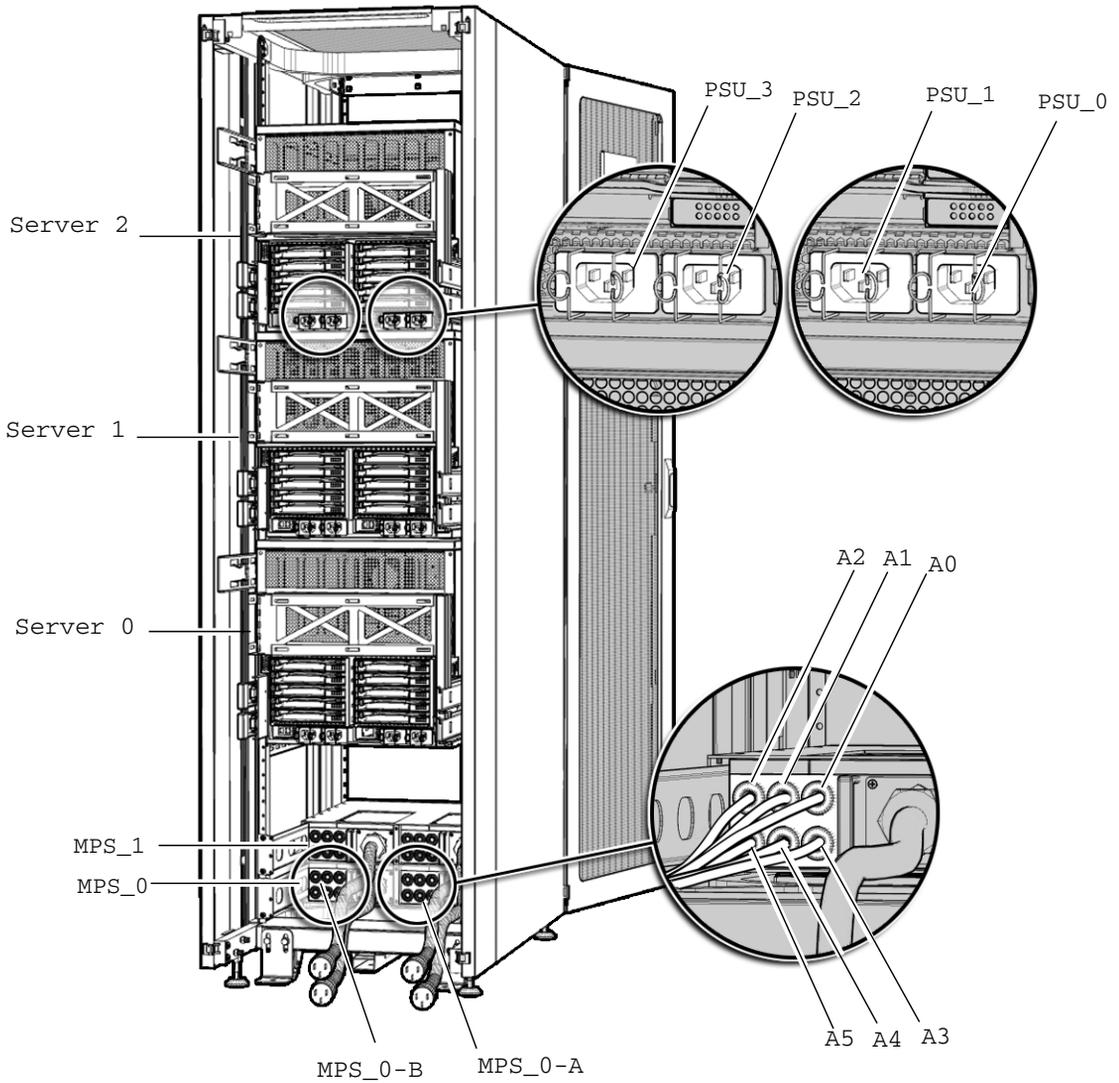
FIGURE 6 Sun Rack 1000 With Three Sun SPARC Enterprise M5000 Servers and Two MPS
