# Sun SPARC® Enterprise M4000/M5000 Servers Product Notes

For XCP Version 1060

Part No. 820-3612-10  
November 2007, Revision A

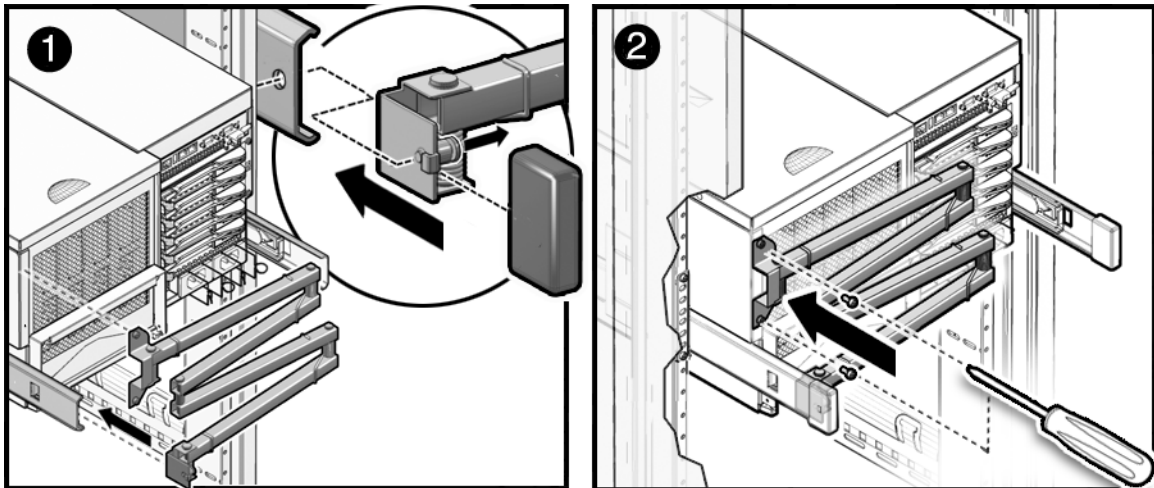
**FIGURE 1** End Caps on the Sun SPARC Enterprise M4000 Slide Rails

- For the Sun SPARC Enterprise M4000 server, an end cap is attached to both the right and left rear rails ([FIGURE 1](#)).
- For the Sun SPARC Enterprise M5000 server, both end caps are attached to the rails on the same side to which the CMA is not attached ([FIGURE 2](#)).

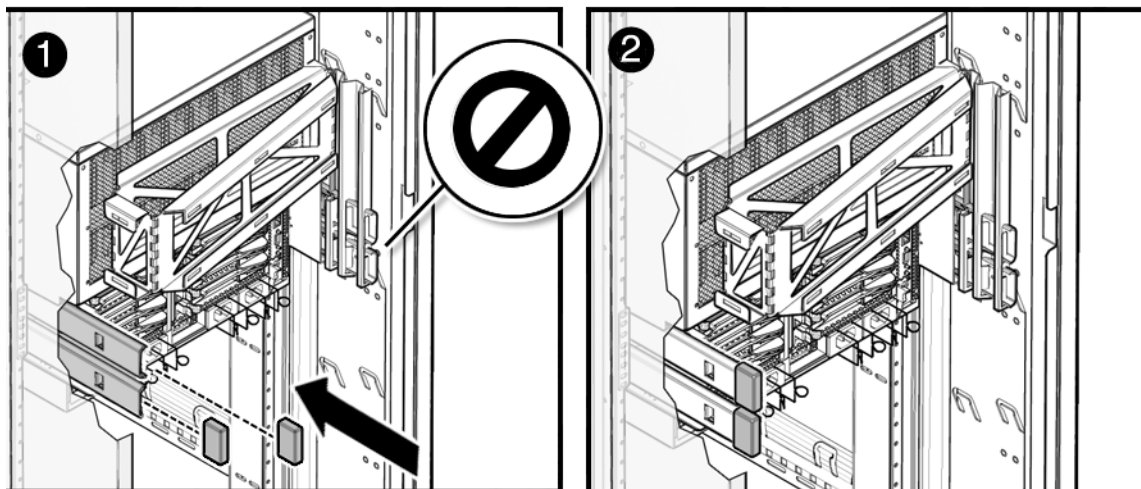
**FIGURE 2** End Caps on the Left Rear of the Sun SPARC Enterprise M5000 Slide Rails

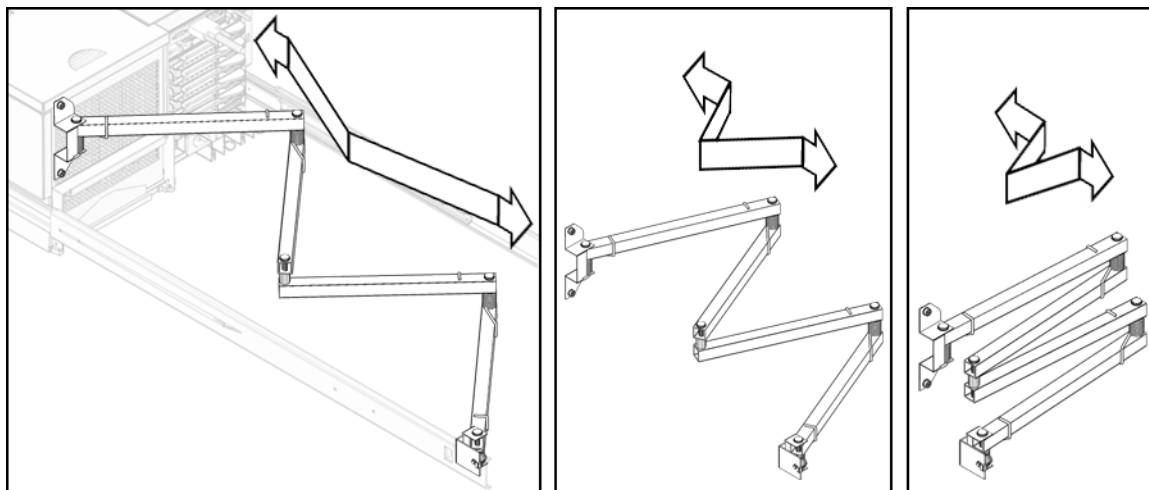
**FIGURE 3** CMA Extended and Retracted on the Sun SPARC Enterprise M4000 Server

[FIGURE 3](#) and [FIGURE 4](#) shows how the CMA extends and retracts.

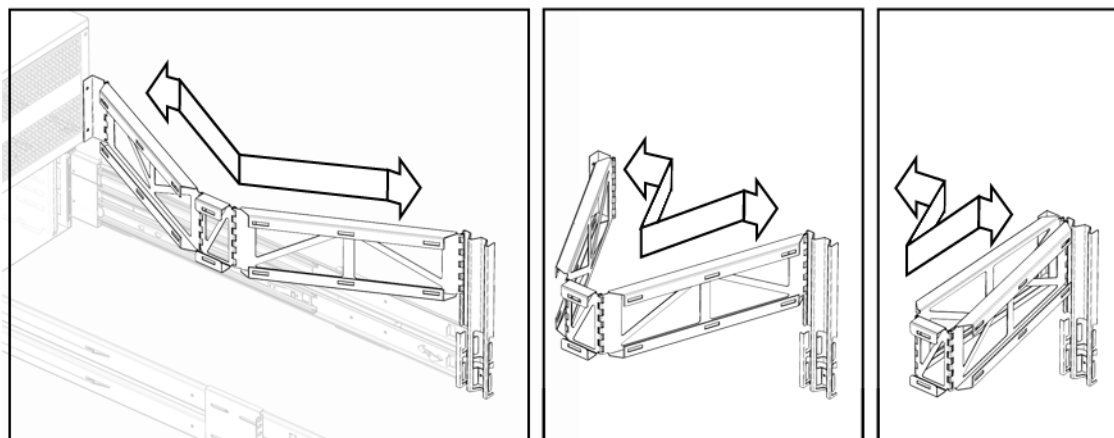
**FIGURE 4** CMA Extended and Retracted on the Sun SPARC Enterprise M5000 Server

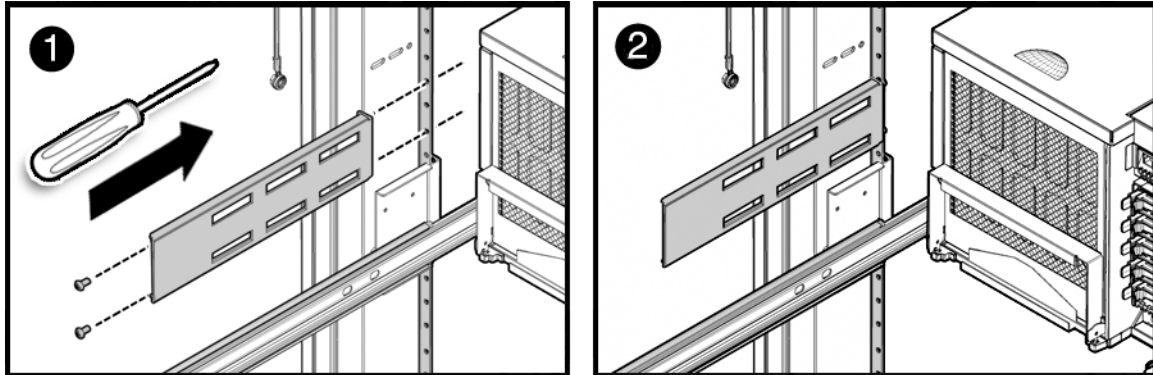
**FIGURE 5** Installing the Extra Brackets in a Sun Rack 1000

1. **Extend the rack stabilizer.**
2. **Slide the server out of the rack several inches for access to the rear of the Sun Rack.**
3. **Position the cage nuts behind the threaded ears of the Sun Rack and insert the two (2) screws through the bracket and rack ear (FIGURE 5).**

The flat edges of the cage nuts should be aligned with the rack post to prevent the server from scraping against it.

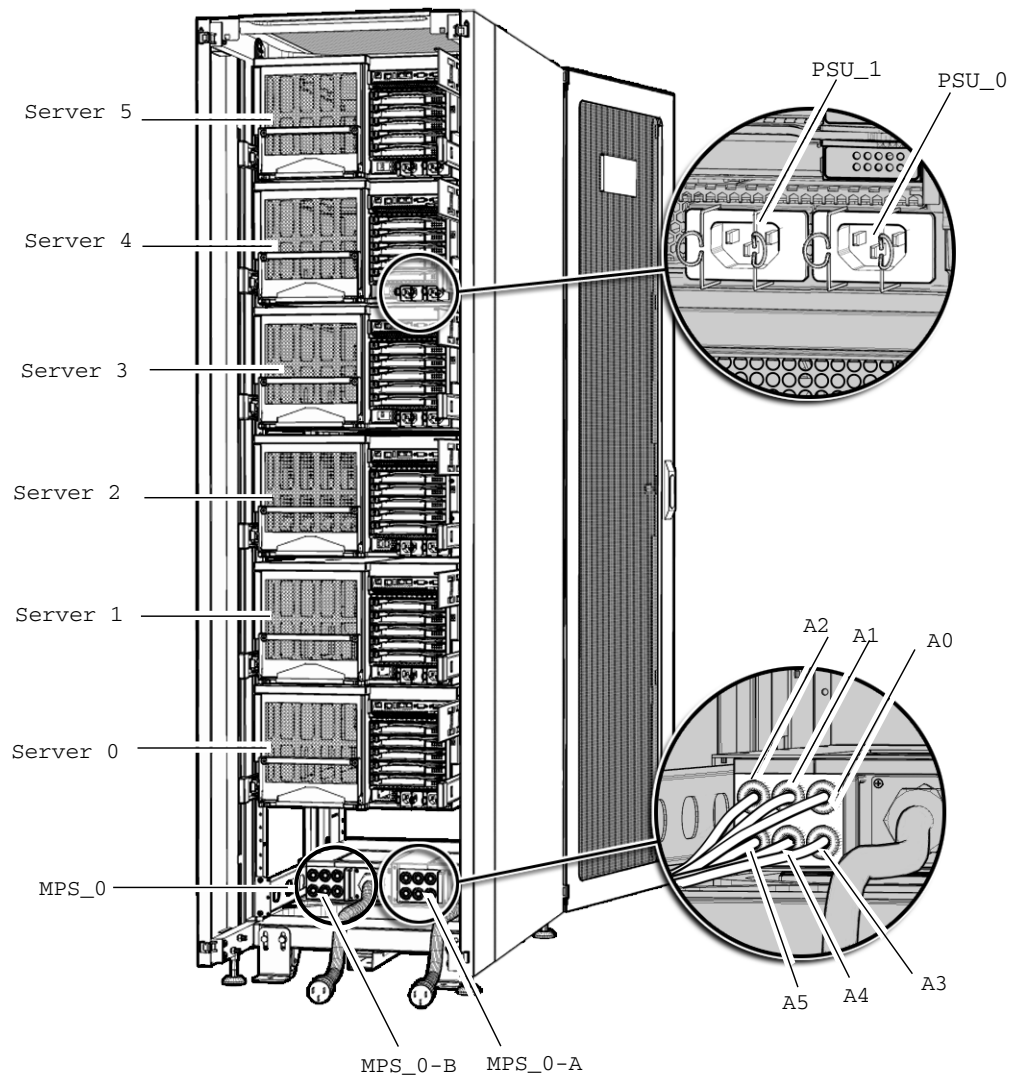
**FIGURE 6** Sun Rack 1000 With Six Sun SPARC Enterprise M4000 Servers and One MPS

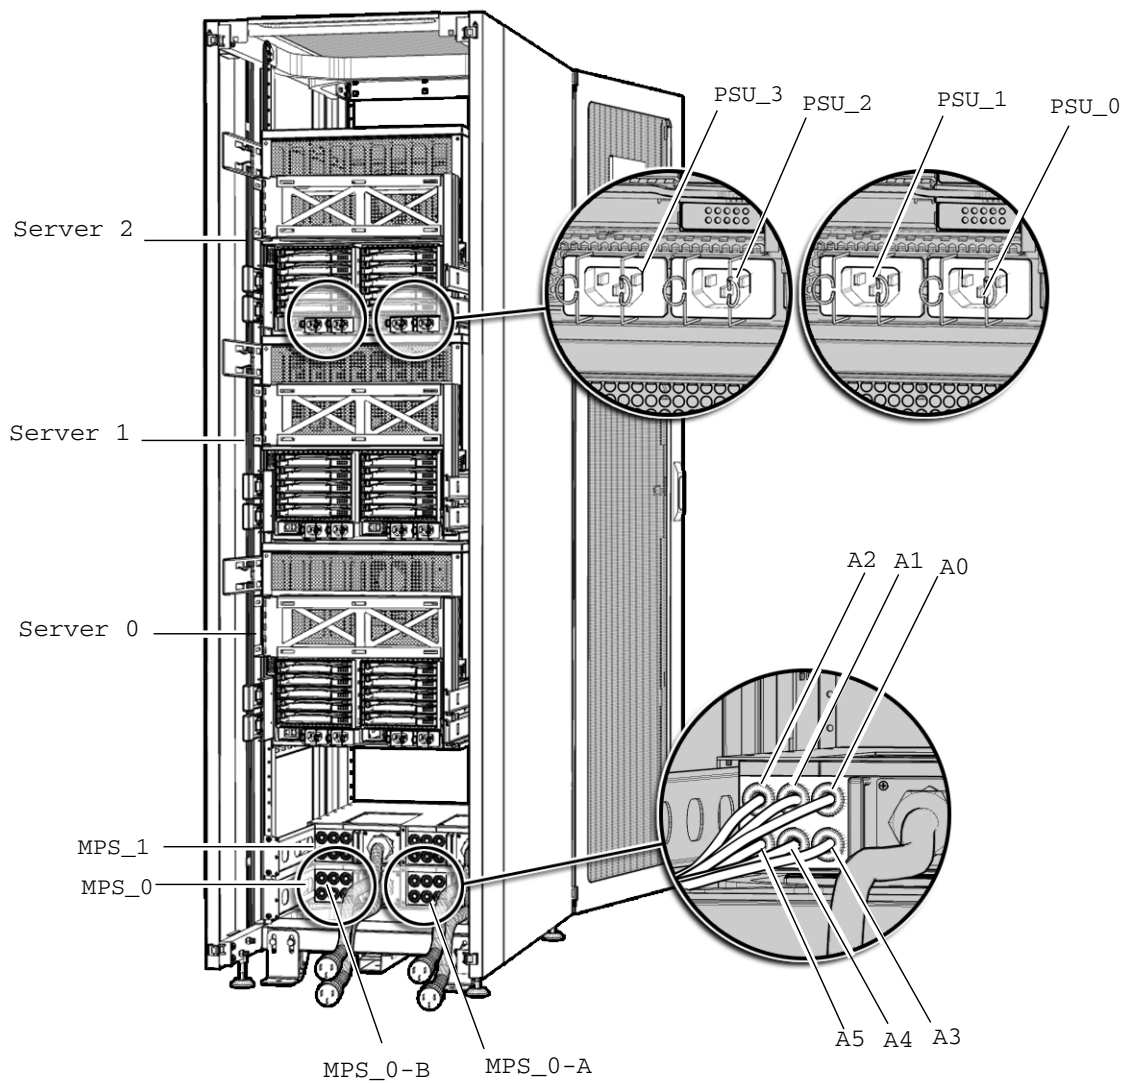
**FIGURE 7** Sun Rack 1000 With Three Sun SPARC Enterprise M5000 Servers and Two MPS
