Sun StorEdge™ A1000 and A3x00/A3500FC Best Practices Guide

Part No. 806-6419-14
[November 2002, Revision A](#)

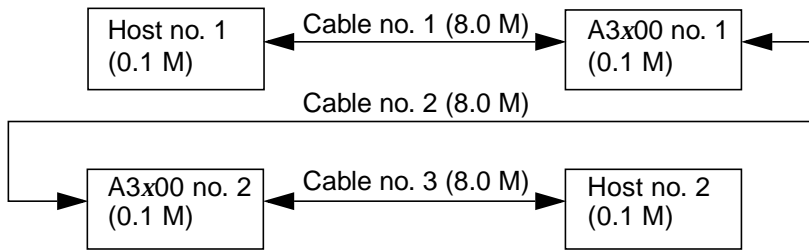
FIGURE 2-1 SCSI Bus Length Calculation

The example configuration in FIGURE 2-1 shows a daisy chained multi-initiator configuration consisting of two hosts connected to two A3x00 modules.

The total SCSI bus length for this example is 24.4 M. It is calculated as follows: each SCSI cable's length (Cable no. 1 + Cable no. 2 + Cable no. 3) + the internal SCSI bus length of each device (Host no. 1 + A3x00 no. 1 + A3x00 no. 2 + Host no. 2).

Each A3x00 is shipped from the factory with two 12-meter SCSI host cables. The recommended maximum SCSI bus length is 25 meters. Exceeding this length can cause SCSI or data errors. When calculating the maximum SCSI bus length in a particular configuration, remember to include the internal SCSI bus of each device which is 0.1 meters.

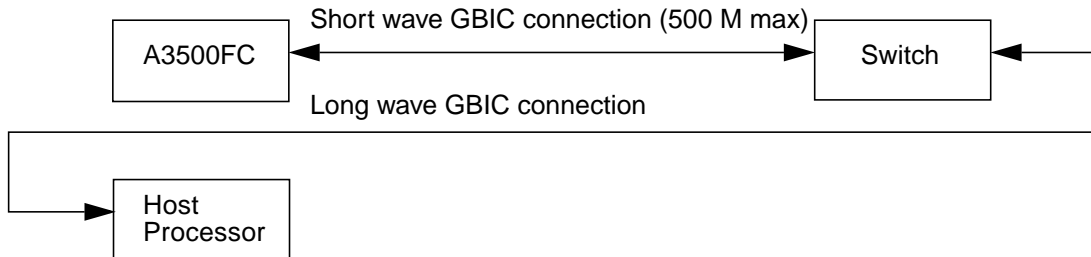
FIGURE 2-2 Fibre Channel Connection With Long Wave GBIC Support

Each A3500FC is shipped from the factory with one pair of 15 meter fiber-optic cables. The product will support a multi-mode fiber-optic connection up to 500 meters long using short wave GBICs only. The use of long wave GBICs is supported but the connection must be through a switch to the host processor (FIGURE 2-2). Refer to the switch documentation for the maximum cable length for the long wave GBIC connection.
